**Figure 1** – Flood Defence Embankment on Dutch River

**Client:** Environment Agency

**Consultants:** White Young Green

This project related to the effective maintenance of a section of the Dutch River Flood Defence System near Goole. The Dutch River is a re-engineered section of the River Don between the River Went and River Ouse. The Dutch River has a significant tidal influence.

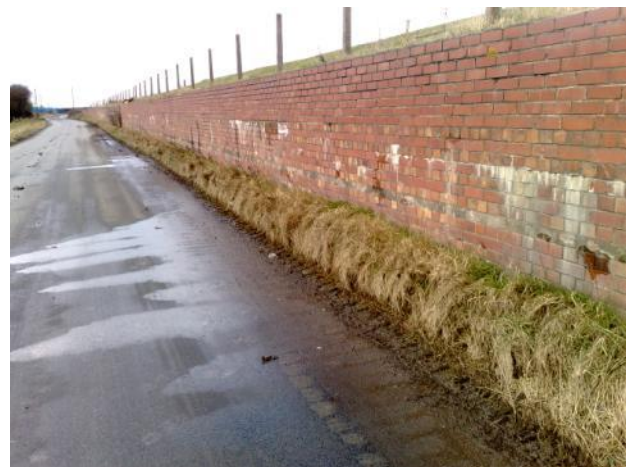
Seepage was occurring along an extended length of the embankment section requiring improvement. This seepage was clearly visible in a section supported by a retaining wall and in adjoining fields, where ponding was observed.

**Figure 2** – Evidence of Seepage through Embankment Retaining Wall.

Seepage through or under an embankment constitutes a failure of a flood embankment to perform its main function of water retention. However, especially in early stage failure, the volume of water lost is often relatively small and this seepage is considered acceptable.

If seepage is not addressed in the longer term, finer particles of soil will probably be washed out of the embankment / foundation by the flow. Progressive deterioration is likely to occur. As the soil becomes more permeable, the flow rates will increase and consequently more particles of soil will be eroded, leading ultimately to catastrophic failure.

On the basis of this identified seepage the Environment Agency commissioned WYG Environmental to undertake an investigation into the material properties within the embankment and to assist in the selection of an appropriate remedial solution. WYG proposed three potential solutions:-

- *Sheet pile cut-off wall extending into the natural material below the embankment,*
- *Soil mix wall to improve the existing embankment materials in situ,*
- *Slurry cut-off wall to replace the embankment core with concrete and/or an impermeable membrane.*

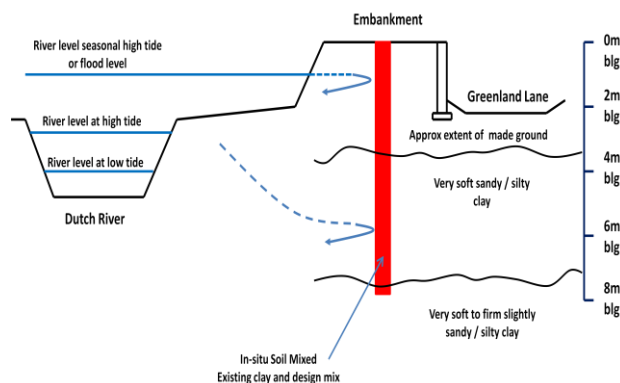
**Figure 3** – Envirotreat / Eco-Foundations Design.

mix. The objective was to ‘toe’ into the underlying clay to create a continuous cut-off curtain which would minimise water ingress and egress through the embankment during high tides and flooding. The water ingress / egress was considered to be as a consequence of fissures within the embankment structure and permeation through the embankment under constant hydraulic pressure.

In summary the design consisted of *in-situ* soil mixing of the embankment and underlying soils with a purpose designed cementitious / bentonite

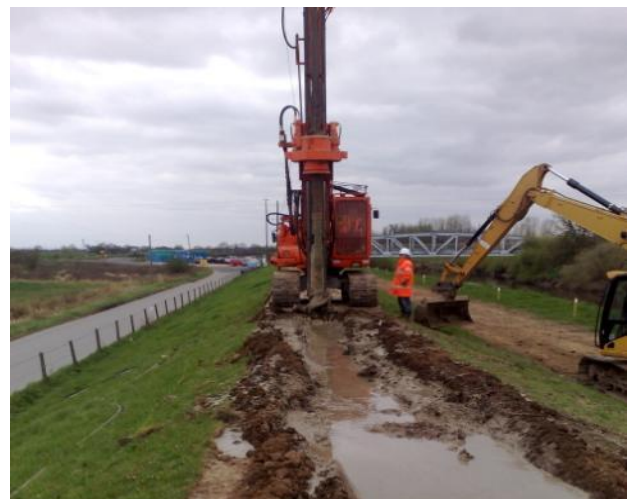
**Figure 4** – Barrier Installation.

Prior to installation, Eco Foundations conducted a series of pilot trials to determine the correct auger drilling / mixing head, additive consistency and mode of implementation. Eco Foundations undertook the installation. A Continuous Flight Auger (CFA) rig was employed to soil mix the additive slurry with the embankment material. The order of column mixing was column No.1 followed by column No. 3 then No.2, No.5 and No.4. This sequence was repeated along the length of the barrier.

The barrier was installed to a depth of 7.0 to 8.0m below ground level and keyed into underlying clay layer.

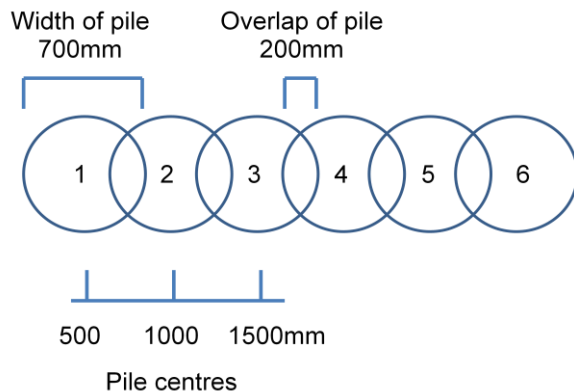
**Figure 5** – Column Arrangement.

The column diameter was 700mm with a column overlap of 200mm.

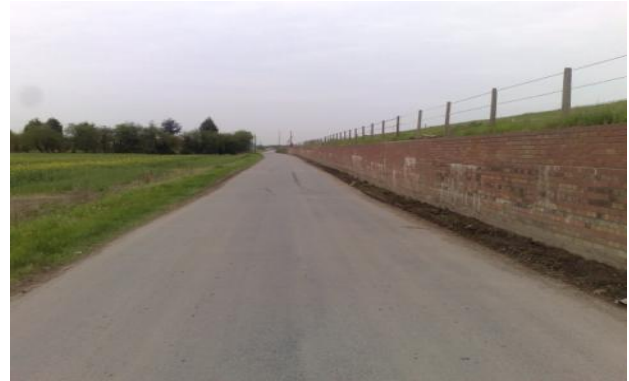
Several methods were utilised to demonstrate the efficacy of the process. Visual observations following installation demonstrated that the adjoining road and fields rapidly dried out. No water egress was observed through the embankment wall as shown in Figure 6. Borehole sample cores were taken along the barrier installation and analysed / evaluated to confirm compliance with target objectives (see Figure 7). All core samples

**Figure 6** – Adjacent road following installation – significant improvement compared with Figure 2.

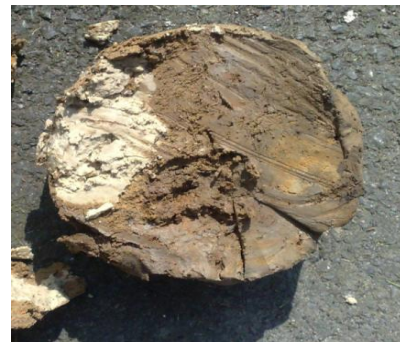
demonstrated effective mixing with permeability values less than  $10^{-9}$ m/s. WVG also installed a series of boreholes complete with data loggers which demonstrated that the barrier was functioning in accordance with the design. The complete barrier installation is shown in Figure 8.

**Figure 7** – Borehole Core - showing Bentonite Plugging.

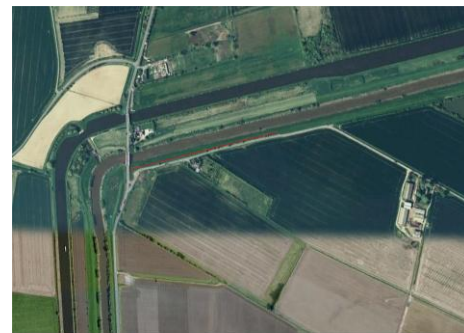
**Figure 8** – Location and Extent of Complete Embankment Barrier Installation.

The original proposal required the repair of a 270m stretch of embankment - this was later extended to 500m.
