Site Overview

Objectives

On- Site Works

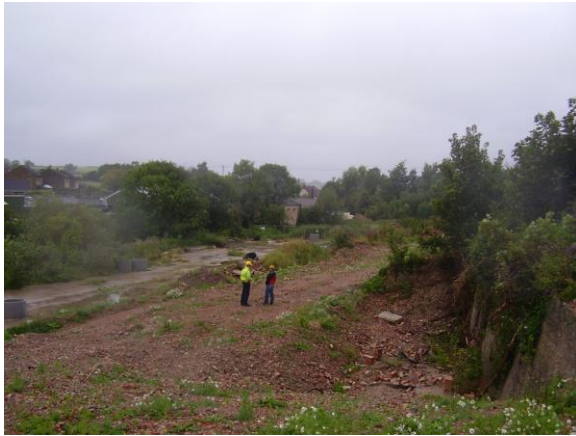
Figure 1 - Site prior to remediation

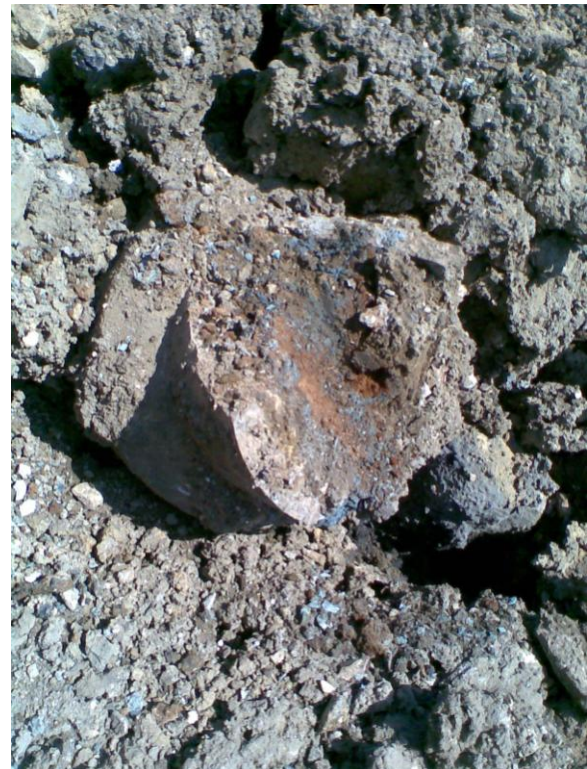
Generally, the southern and the eastern part of the site had moderate / low concentrations of contaminants. High levels of arsenic, cadmium and chromium were generally present in the north western portion of the site. It was considered that the contamination identified within these areas was a result of the former on-

site processes, in particular the drip-drying of tanned hides in the open areas of the site.

Chemical testing indicated that the arsenic was highly leachable and dissolved phase arsenic had been identified within the groundwater. Arsenic levels in the north-west of the site were typically in the order 4,000 to 8,300mg/kg, with one identified hotspot as high as 46,100mg/kg.

Figure 2 -Typical site contamination.

The contaminated material was excavated using conventional plant and equipment and delivered to the treatment zone by the main contractor. Excavations were validated by the consultant.

A specialist processing (*allu*) bucket mounted on an excavator was used to mix the contaminated soil and treatment reagents in 10m³ batches within the bespoke mixing bin.

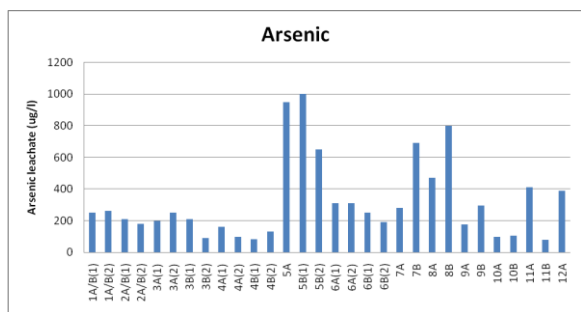
The P20 risk assessment derived maximum leachate levels for treated soils were as follows:

- Arsenic 1,130ug/l
- Cadmium 33ug/l
- Total Chromium 565ug/l
- Total Petroleum Hydrocarbon 600ug/l

Chart1: Validation Results for Arsenic

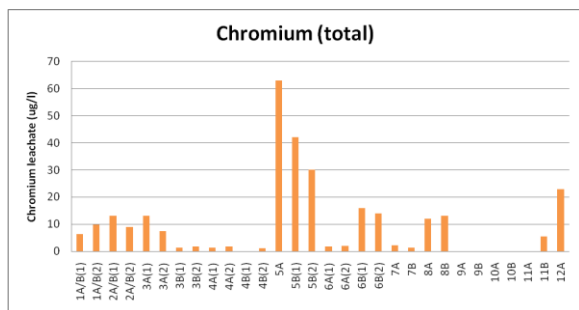
Chart2: Validation Results for Chromium
