### Site Background & History

The site is located on Village Farm Industrial Estate in Pyle, South Wales. The site is used as a storage yard for vehicles / trailers and recovered materials (old electrical transformers, wires, etc.). The client operates a recycling business.

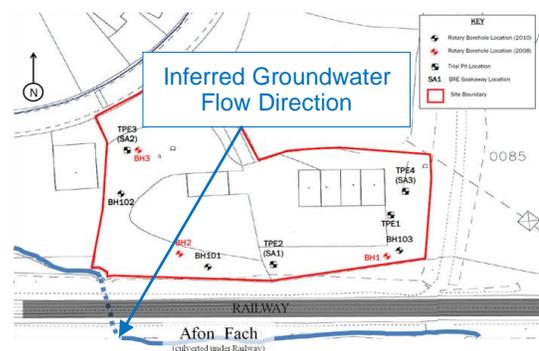
Figure 1 – Site Plan

The site plan is shown in Figure 1 below. The previous occupants of the site had levelled the site / raised the levels of the site using made ground. The site levels were previously much lower in the south and west of the site.

Contaminated groundwater was shown to be migrating through the made ground in a south westerly direction (as shown in Figure 1 below) – there was clearly an identified risk to the controlled water receptor located in close proximity to the site (the Afon Fach)

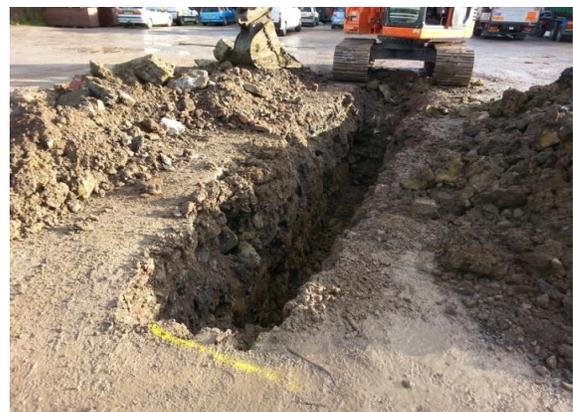
Figure 3 – Source Investigation

The residual source contamination was located under a large concrete slab – this contamination was considered to be potentially problematic as the groundwater monitoring in this area of the site indicated the presence of contamination potentially arising from this source. The slab was vital to the ongoing operation of the site and the removal of the slab (temporary or permanent) would have created major operational difficulties for the client. It was therefore decided to excavate a trench along the southern edge of the slab to the full depth of the made ground - the shallower soils and groundwater exhibited a slight hydrocarbon odour – there was no evidence however of any significant source contamination associated with the soils underlying the slab.

The excavated soils (and associated groundwater) were treated with E-Clay before being reinstated - the reinstated yard was subsequently returned back to operational use.

The trench excavations are shown in Figure 3 below.
