Site Background & History

The site is located at 200, Cambuslang Road in Rutherglen, Glasgow. The site historically comprised of a laundry facility (including dry cleaning capabilities), a lorry yard and a timber treatment facility. The historical site is shown in Figure 1 below.

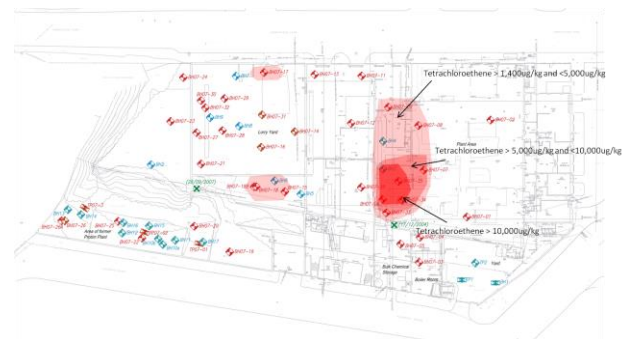
Figure 2 – TCE Contamination

Chlorinated hydrocarbons were identified in the area of the site predominantly occupied by the laundry – Tetrachloroethene [TCE] was present in concentrations exceeding 10,000ug/kg in the prime contamination area – see Figure 2 below.

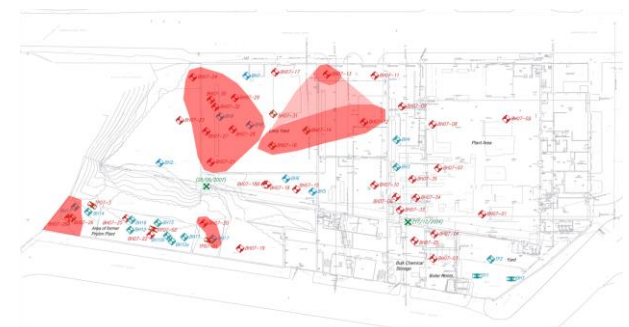
Figure 3 – Hydrocarbon Contamination

Petroleum hydrocarbons were identified in the area of the site predominantly occupied by the lorry yard and the timber treatment facility – petroleum hydrocarbons were present in concentrations exceeding 12,000mg/kg in the prime contamination areas – see Figure 3 below. Tributyltin was also identified in the former 'Protim' timber treatment facility.

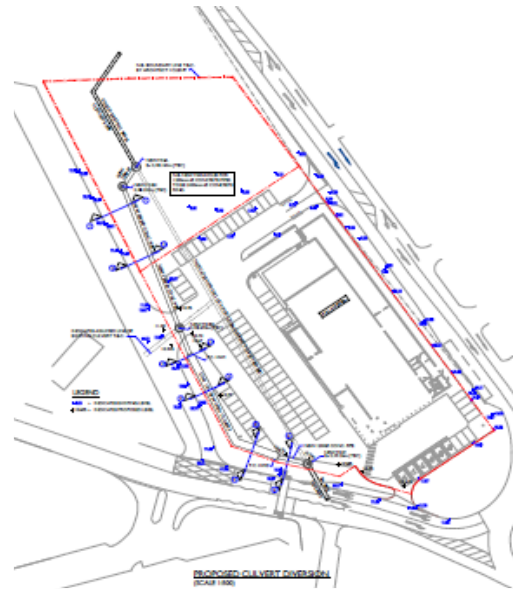
Figure 4 – Location of Realigned Culvert

The Scion Burn was considered to be of prime importance as the box culvert was clearly damaged in a number of locations and as a consequence there was every possibility that the burn was being directly impacted by contaminated groundwater present on the site. It was also evident that the flow of the burn was being constrained by blockages (primarily caused by the brick culvert collapsing in places). It was therefore an implicit requirement of the remediation works that the culvert was repaired / replaced to protect the Scion Burn from the risk of contamination and to enable the burn to flow through the site without constraint. It was considered that the box culvert could not be economically or practically repaired and it was therefore decided to replace the culvert as part of the remediation works. The culvert was also realigned with the approval of SEPA to enable the store development to proceed – the location of the realigned culvert is shown in Figure 4 below.

The culvert realignment works were undertaken in parallel with the remediation works – there was minimal overlap as the culvert realignment only directly affected one area of the site impacted by contamination (the ‘Protim’ timber treatment area).

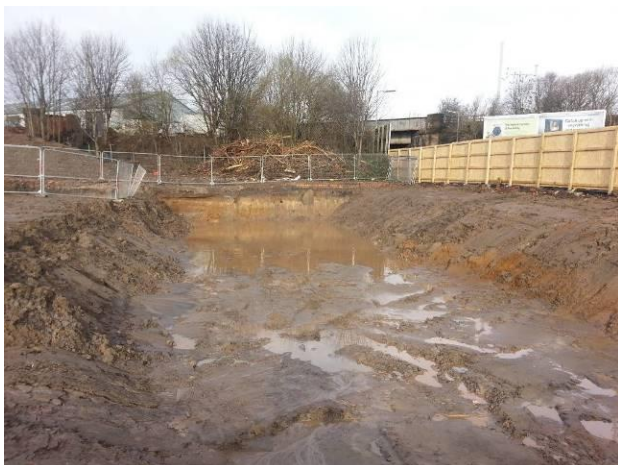
Figure 5 – Site Excavations

Groundwater was observed in all of the excavations - the recharge was slow and non-directional indicating that the groundwater was most likely perched in nature.

The excavated materials were stockpiled pending subsequent treatment *ex-situ* utilising E-Clay Stabilisation.
