Site Background & History

The site was located adjacent to the hospital complex at RAF Lakenheath. The storm water drainage system in this area was impacted with mercury contamination (resulting from historical spillages).

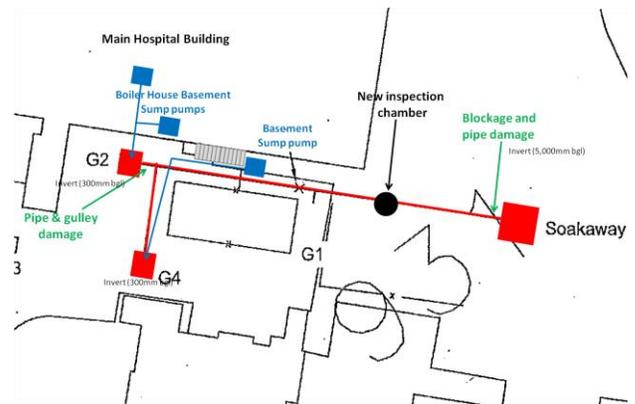
Figure 1 – Site Plan / Drainage System

The client had previously commissioned a CCTV survey of the impacted storm water drainage system. This survey identified a major blockage in the main drainage run near the soakaway - additionally it showed that the drainage system was damaged in a number of locations and most significantly showed the presence of elemental mercury within at least one gulley pot and within the drainage run. The drainage system was flushed out as far as practically possible and recovered waste was removed from site for offsite disposal. The CCTV survey identified a breakage (hole) in the main drainage pipe close to the mercury contaminated gulley pot (G2). Storm water contaminated with mercury had clearly discharged through this hole into an adjacent inspection chamber - the mercury contamination had subsequently discharged through a hole around a redundant pipe into the basement boiler house (located directly below the inspection chamber) - this was clearly evident on the CCTV survey.

R&D removed the identified blockage in the pipework near the soakaway (the location of the blockage is shown in Figure 1). A new inspection chamber was installed and the remaining drainage pipework was replaced – see Figure 5 below.

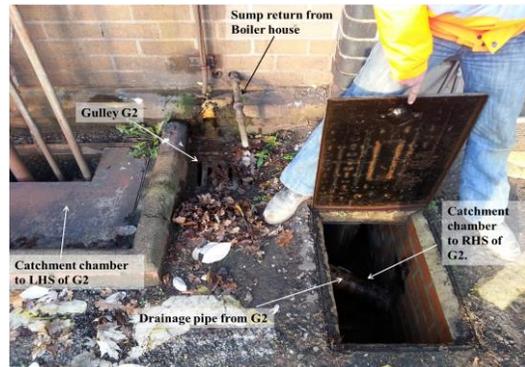
Figure 3 – Gulley G2 – Surrounding Drainage

The initial works involved the replacement of the damaged gulley (G2) and the associated drainage pipe. *Ex-situ* XRF testing of the gulley contents indicated the presence of mercury contamination. The inspection chamber and a further catchment chamber located to the left hand side of the gulley were also shown to be contaminated with mercury.

Both the gulley G2 and the inspection chamber were excavated by R&D as part of the drainage repair works. The associated soils were visibly impacted with mercury - these soils were placed into a lined skip. The area was fully excavated and the resultant sides and base were *ex-situ* tested by XRF to demonstrate the removal of mercury contamination. The catchment chamber was manually cleaned and validated.

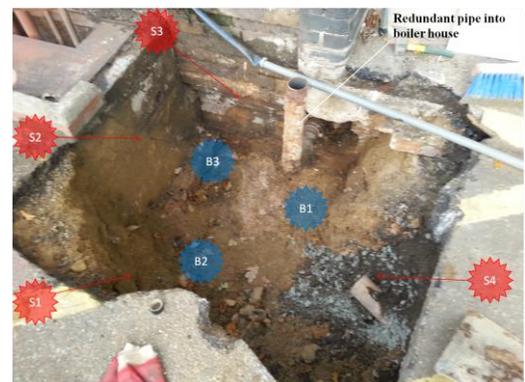
Figure 4 – Validated Area Surrounding Gulley G2

The drainage arrangement surrounding gulley G2 is shown in Figure 3 below. The validated area is shown in Figure 4 below (the redundant pipe is highlighted).

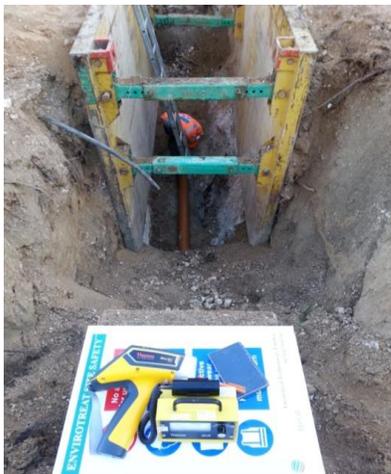
Figure 5 – Replacing Damaged Drainage System

The drainage pipe had become disconnected from the soakaway (presumably as a consequence of the blockage). The soils surrounding the soakaway were therefore potentially contaminated - it was therefore necessary to validate the area surrounding the soakaway by XRF to ensure that all mercury contamination had been effectively removed prior to reinstatement.
