### Site Background & History

The site is located at Yarmouth on the Isle of Wight and is currently used as a boatyard. The site borders onto the River Yar Estuary and occupies 0.64 hectares. The high tide line bounds the site to the north and east. The Freshwater Gas Company was established on the site in 1899. The Gas Works was expanded in the 1940's with the addition of two further gas holders. It is believed that the gasworks closed in the 1960's.

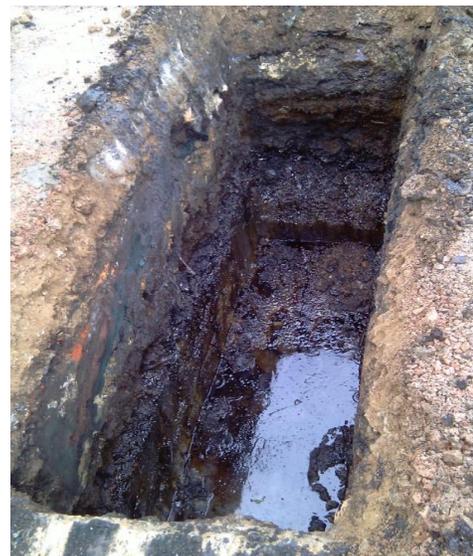
Figure 2 – Typical Contamination

Site investigations undertaken by Card Geotechnics [Card] have identified the presence of both soil and groundwater contamination. The identified pollutants are predominantly gas works derived and include Total Petroleum Hydrocarbons (TPH), Polycyclic Aromatic Hydrocarbons (PAHs), copper, zinc and cyanide.

The prime source of contamination was in the south western corner of the site (associated with a former gas holder). The identified contamination was not considered to pose a future risk to human health as the development plans for the site incorporate the provision of significant hardstanding, thereby providing an effective 'pathway break' to protect human receptors.

The typical contamination encountered on site is shown in Figure 2.

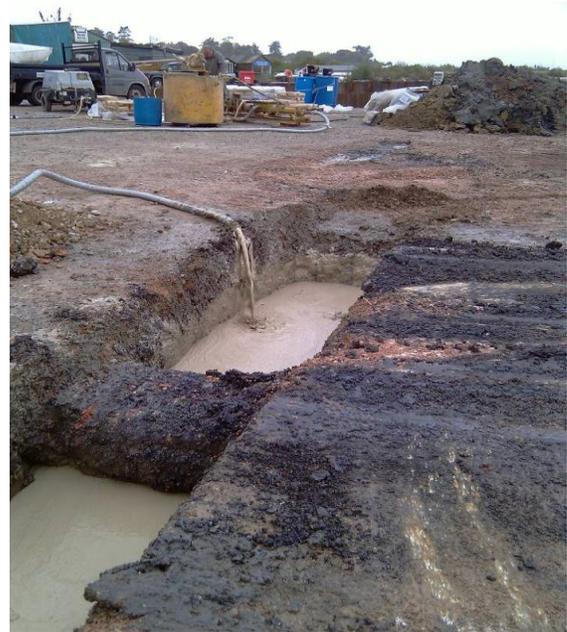
Figure 3 – Adding E-Clay Slurry to Deeper Soils

The addition of E-Clay slurry to the excavated trench for subsequent *in-situ* treatment to create the deeper reactive barrier sections is shown in Figure 3. The treatment of re-emplaced soils / materials with E-Clay slurry (to create the shallower reactive barrier sections is shown in Figure 4.
