Greenenergy

Site Background & History

The Cattedown Fuel Terminal is situated in the Cattedown area of Plymouth approximately 1.5 km south-east of the city centre. The site is adjacent to the northern bank of the River Plym estuary and is shown in Figure 1 below.

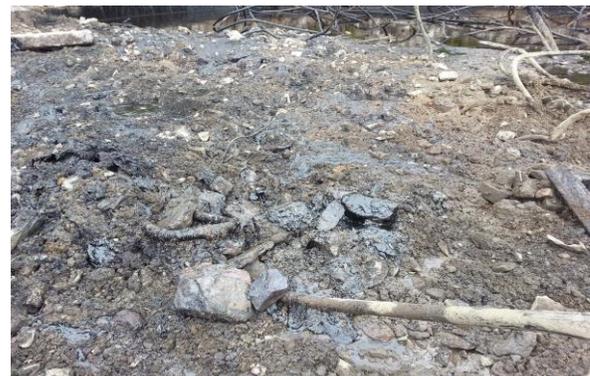
The tank base was determined to be approximately 1.5m high with an overall diameter of 26m. Trial pits confirmed that the steel tank base had been left *in situ* and that the void space within the tank base had been infilled with various spoil materials. The spoil materials were shown to be contaminated – the nature of the contamination was consistent with previous usage of the site for the production, storage and distribution of bitumen – the prime contaminants of concern were total petroleum and polycyclic aromatic hydrocarbons. The contaminated spoil material is shown in Figure 2 below.

Figure 2 – Contaminated Spoil Material

Enviro-treat was commissioned by Jones Brothers (Henllan) Limited [JBHL] to develop a remediation strategy to address the contaminated spoil materials within the tank base (and directly surrounding the tank base) – the total remediation volume was estimated to be circa 1,000m³. The remediation strategy was designed to address potential risks to human health and controlled waters (as identified in the site conceptual model). E-Clay Stabilisation was proposed for the treatment of the tank contents and surrounding soils. The remediation strategy was approved by PDE on behalf of the client.

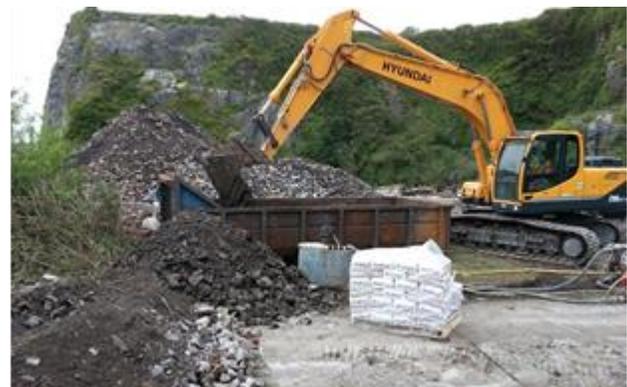
Figure 3 – *Ex-Situ* E-Clay Stabilisation of Contaminated Materials

The *ex-situ* treatment process involved mixing the contaminated materials with the designated E-Clay and cementitious treatment materials in batches of known volume – the treatment was carried out in a mixing bin as shown in Figure 3 below. The E-Clay was added in slurry form and the cementitious materials were added in dry form – the slurry mixing process utilised contaminated water which had accumulated within the tank base – this water was then incorporated into the treatment process negating any requirement for offsite disposal or for additional contaminated water treatment facilities.

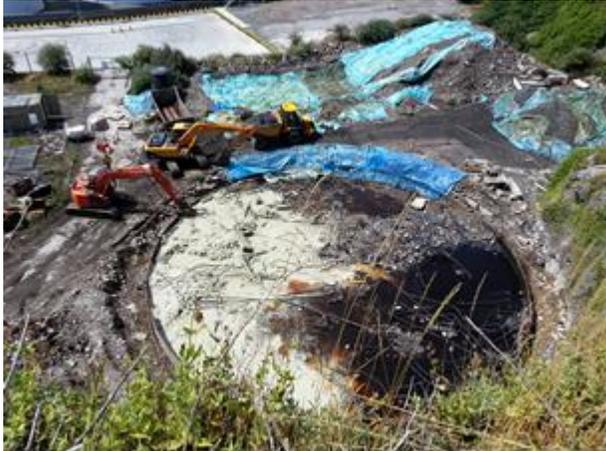
Figure 4 – *In-Situ* E-Clay Stabilisation of Contaminated Materials

The *in-situ* treatment process involved the addition of bentonitic materials to absorb excess residual water followed by the addition of the required volume of E-Clay slurry - the slurry was pumped over the tank surface and then mixed with the contaminated materials until a homogenous mass was produced. Cementitious materials were then added to provide the necessary geotechnical improvement to the treated material (this was particularly important in relation to the bitumen residue which exhibited very poor geotechnical properties in an untreated state). The *in-situ* treatment process is shown in Figure 4 below.

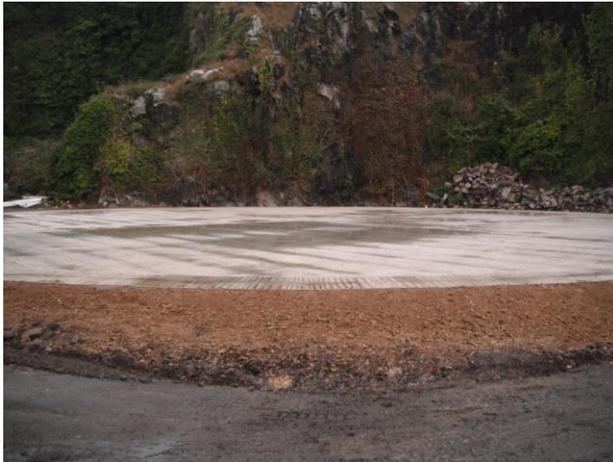
Figure 5 – Installed Concrete Slab (Capping Layer)

The remediated works were completed by the installation of a concrete slab as a capping layer – this was designed by JHBL with input from Envirotreat. The installed concrete slab is shown in Figure 5 below.
