Project Overview

This project related to the effective maintenance of a section of the Dutch River Flood Defence System near Goole. The Dutch River is a re-engineered section of the River Don between the River Went and River Ouse. The Dutch River has a significant tidal influence.

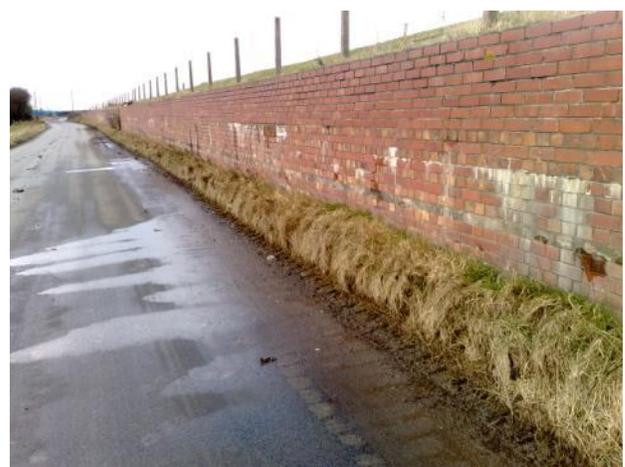
Figure 2 – Evidence of Seepage through Embankment Retaining Wall.

Seepage was occurring along an extended length of the embankment section requiring improvement. This seepage was clearly visible in a section supported by a retaining wall and in adjoining fields, where ponding was observed.

Seepage through or under an embankment constitutes a failure of a flood embankment to perform its main function of water retention. However, especially in early stage failure, the volume of water lost is often relatively small and this seepage is considered acceptable.

If seepage is not addressed in the longer term, finer particles of soil will probably be washed out of the embankment / foundation by the flow. Progressive deterioration is likely to occur. As the soil becomes more permeable, the flow rates will increase and consequently more particles of soil will be eroded, leading ultimately to catastrophic failure.

On the basis of this identified seepage the Environment Agency commissioned WYG Environmental to undertake an investigation into the material properties within the embankment and to assist in the selection of an appropriate remedial solution. WYG proposed three potential solutions:-

- *Sheet pile cut-off wall extending into the natural material below the embankment,*
- *Soil mix wall to improve the existing embankment materials in situ,*
- *Slurry cut-off wall to replace the embankment core with concrete and/or an impermeable membrane.*

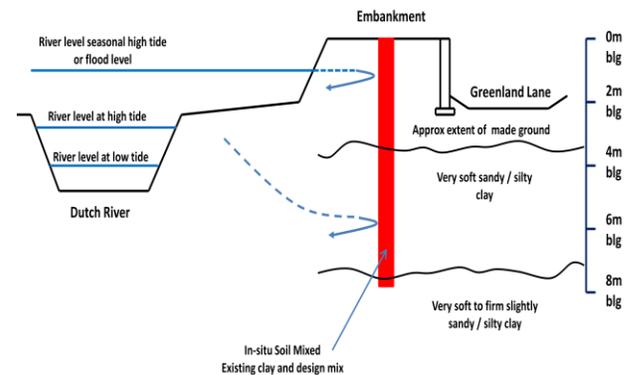
Figure 3 – Enviro-treat / Eco-Foundations Design.

In summary the design consisted of *in-situ* soil mixing of the embankment and underlying soils with a purpose designed cementitious / bentonite mix. The objective was to ‘toe’ into the underlying clay to create a continuous cut-off curtain which would minimise water ingress and egress through the embankment during high tides and flooding. The water ingress / egress was considered to be as a consequence of fissures within the embankment structure and permeation through the embankment under constant hydraulic pressure.

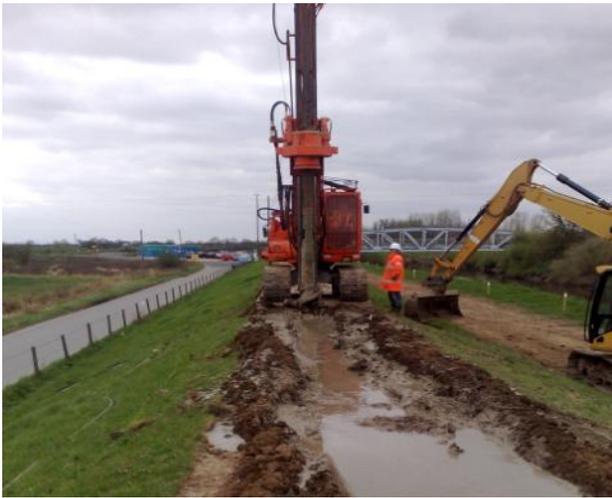
Figure 4 – Barrier Installation.

Prior to installation, Eco Foundations conducted a series of pilot trials to determine the correct auger drilling / mixing head, additive consistency and mode of implementation. Eco Foundations undertook the installation. A Continuous Flight Auger (CFA) rig was employed to soil mix the additive slurry with the embankment material. The order of column mixing was column No.1 followed by column No. 3 then No.2, No.5 and No.4. This sequence was repeated along the length of the barrier.

The column diameter was 700mm with a column overlap of 200mm.

The barrier was installed to a depth of 7.0 to 8.0m below ground level and keyed into underlying clay layer.

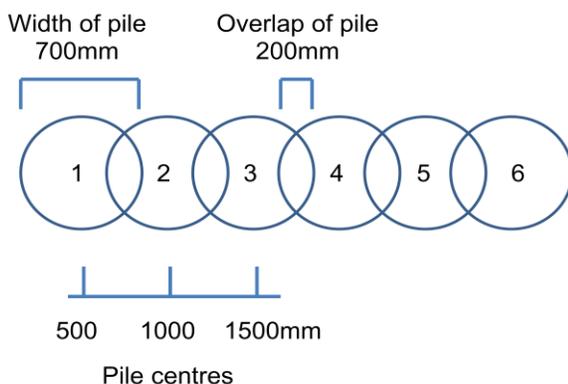
Figure 5 – Column Arrangement.

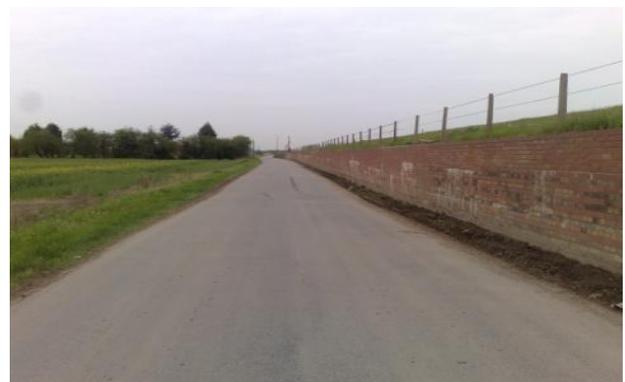
Several methods were utilised to demonstrate the efficacy of the process. Visual observations following installation demonstrated that the adjoining road and fields rapidly dried out. No water egress was observed through the embankment wall as shown in Figure 6. Borehole sample cores were taken along the barrier installation and analysed / evaluated to confirm compliance with target objectives (see Figure 7). All core samples demonstrated effective mixing with permeability values less than 10^{-9} m/s. WVG also installed a series of boreholes complete with data loggers which demonstrated that the barrier was functioning in accordance with the design. The complete barrier installation is shown in Figure 8.

Figure 6 – Adjacent road following installation – significant improvement compared with Figure 2.

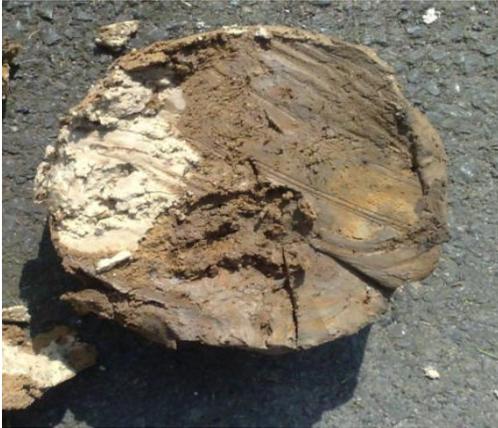
Figure 7 – Borehole Core - showing Bentonite Plugging.

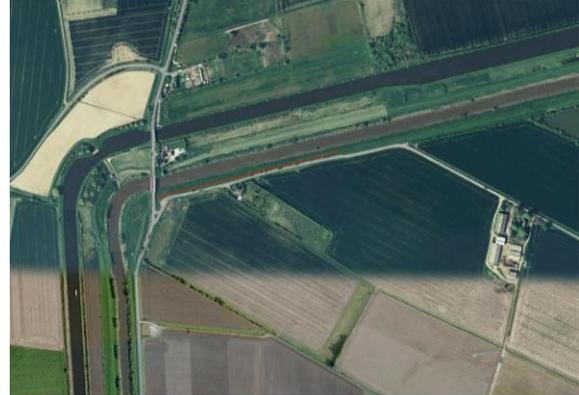
Final extent of barrier installation

Figure 8 – Location and Extent of Complete Embankment Barrier Installation.

The original proposal required the repair of a 270m stretch of embankment - this was later extended to 500m.
