COMPLETION DATE: MARCH 2005
 CONSULTANT: EG Pettit & Co
 DEVELOPMENT: SUPERMARKET

Site Overview

At the Cork Road project, the E-Clay Stabilisation Technology was applied using an *in-situ* approach to remediate contaminated soil and groundwater at a site.

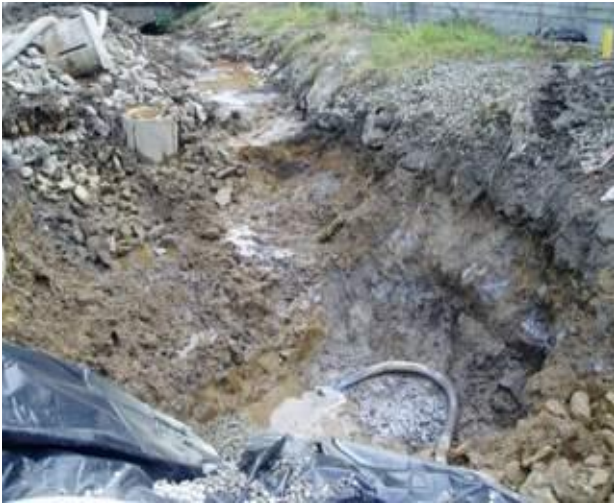
Plate 1 – Contaminated ground at Waterford.

The contamination at the site was attributed to the Petrol Station located next to the site. It was considered that leaking pipe work and storage tanks were responsible for the ongoing hydrocarbon contamination to soil and groundwater.

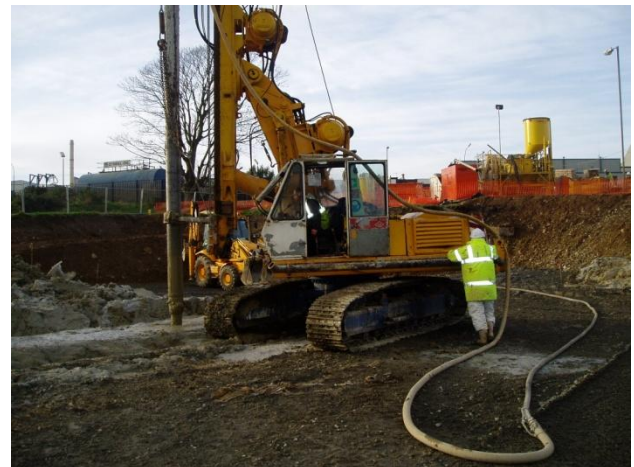
A slurry production unit was used to produce the E-clay slurry before being pumped through the hollow stem of the Auger (illustrated in Plate 2). The Auger is then drilled into the ground whilst continually injecting the treatment slurry until the desired depth of the column is reached, at which point the pumping is halted and the auger reversed.

Plate 2 – Continuous Flight Auger installing soil mixed column

The *in-situ* process allows for the remediation of contaminated soils to take place without the need for the contaminated soils to be excavated and stockpiled. The process involved the use of a Continuous Flight Auger to install soil mixed columns to depths ranging from 1m to 4.5m.

By reversing the auger, the column is effectively mixed again and the amount of spoil brought to the surface reduced to a minimum. The process was then repeated utilising the overlapping column design illustrated in Figure 1.

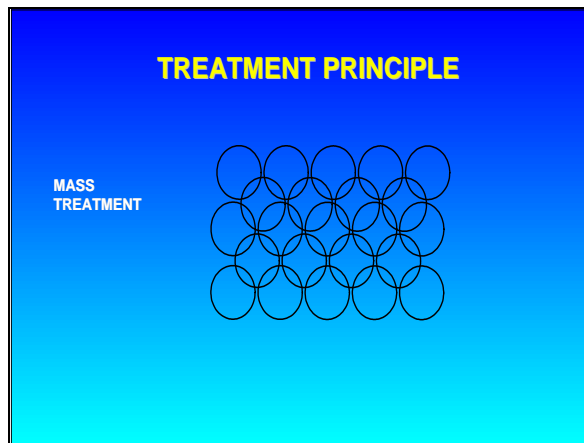
Figure 1 – Diagram showing overlapping column design.

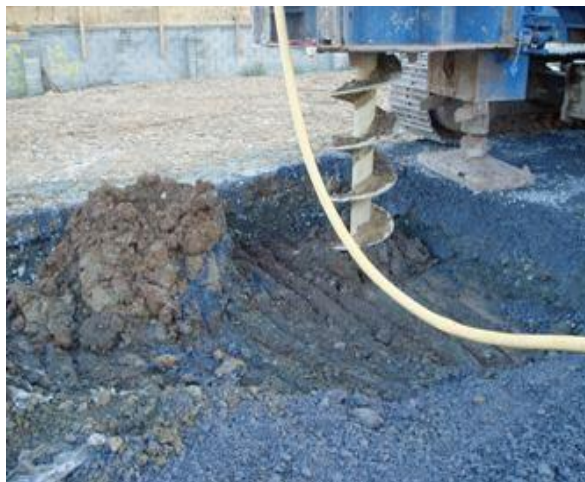
Plate 3- *In-situ* mass treatment at Cork Road, Waterford

Enviro-treat employed an *in-situ* soil mixing strategy to remediate approximately 9,200m³ of contaminated soils at the site.
