COMPLETION DATE: JANUARY 2005
CONSULTANT: RAW CONSULTING
MAIN CONTRACTOR: GEORGE WIMPEY

Site Overview

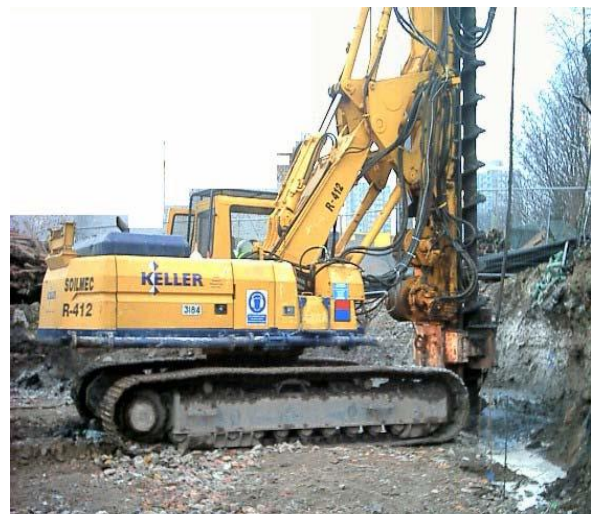
Figure 2 Barrier installation

The containment barrier was installed around the periphery of the site prior to the contaminated material on the site being excavated and replaced with clean infill material. This was undertaken prior to commencement of the major aspects of the remedial works. This ensured that contaminants which existed on adjacent areas to the site were unable to migrate onto the site. The barrier comprised of soil mixed columns containing E-clays® which were installed along the north western, western and south eastern boundaries of the site. The passive sections (interleaved between active sections) are designed to intercept and deflect some of the ground water flow around the site, whilst the active sections were designed to be permeable to allow some ground water to pass through the site, minimising the overall impact of the barrier system on the local hydraulic regime. The E-clays used in the active sections were specifically designed to chemically immobilise the contaminants of concern in the groundwater passing through the site. See figure 4 for a schematic diagram of the barrier system. The barrier was installed using conventional piling techniques incorporating advanced soil mixing technology. The barrier was up to 7m deep and about 1.5m wide.

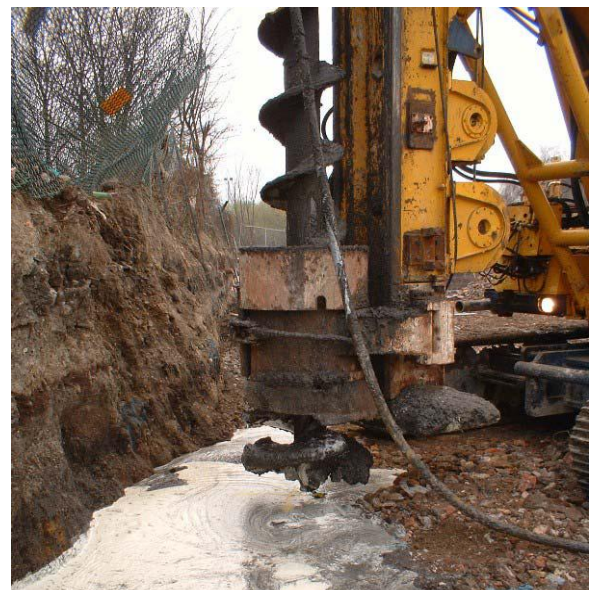
Figure 3 Piling equipment used to achieve advanced soil mixing.

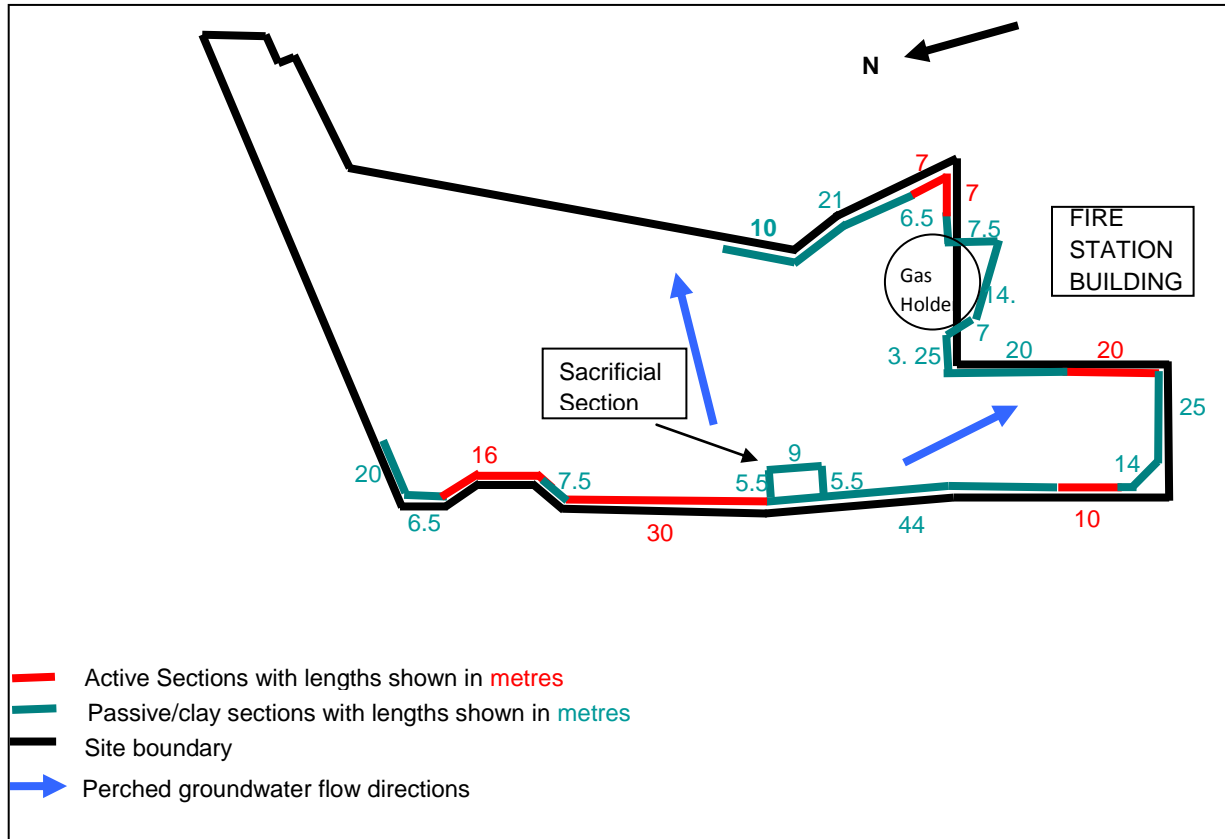
Figure 4 Schematic layout of barrier system relative to site
