**LODGE PARK**  
LIMITED

### Site Background & History

Following a site assessment carried out in December 2013, Envirotreat prepared a Knotweed Management Plan [KMP], including an action plan designed to fit the timeframes and requirements of the client.

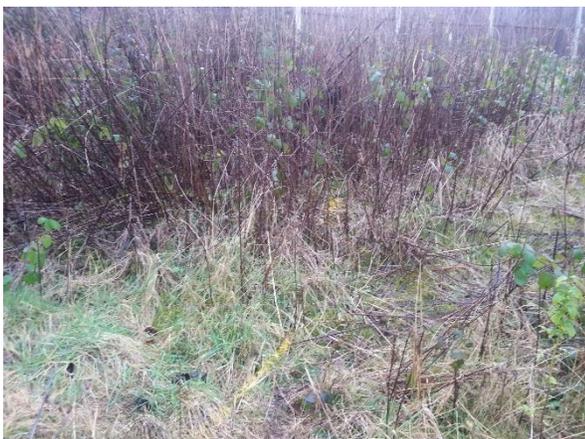
Figure 1 – Photograph showing extent of Japanese Knotweed infestation.

Envirotreat identified two distinct areas of JKW based on evidence of canes. One area being relatively small and possibly the result of a single plant and further, larger area approx. 20 m by 10 m with more established plants.

As part of the KMP an isolation area was agreed.

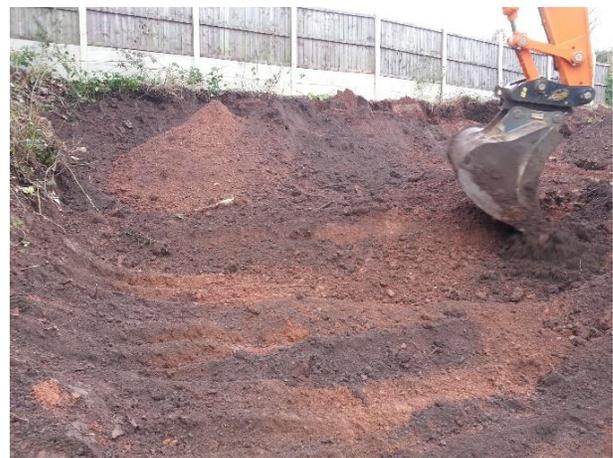
Figure 2 – Excavation of bulk JKW contamination.

In January 2014, based on the agreed KMP, Envirotreat undertook a managed dig operation to remove the bulk of the JKW offsite. In total approx. 50 tonnes of soil was removed offsite.

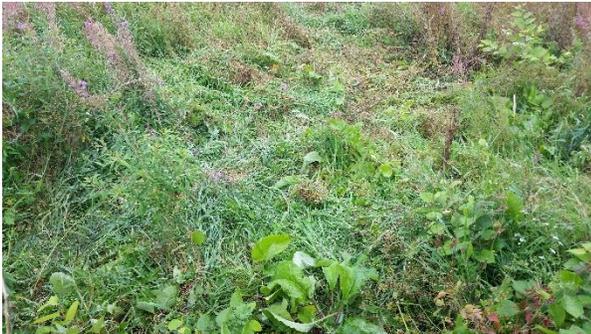
A review of the site indicated a significant reduction of the presence of Japanese Knotweed plants in those areas where the excavations had taken place. The plants that were present were small.

A small clump of more established plants remained beneath a large tree where excavations were not possible.

Figure 3 – Evidence of some regrowth.

In August 2014, Envirotreat attended site and treated the remaining JKW with a newly available herbicide, this was used on site to treat the identified, remaining plants.

The replacement herbicide – Icade was replacement for Picloram, which had been withdrawn early in 2014.
