Development:	Residential development.
Consultant:	Humberside Materials Laboratory Ltd
Developer:	MFM Developments

### Site Overview

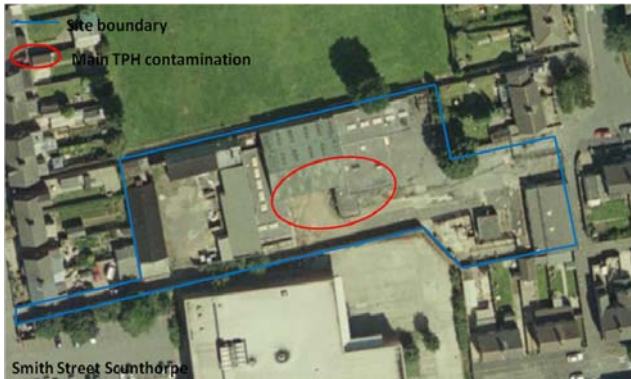
Plate 1 Site Layout

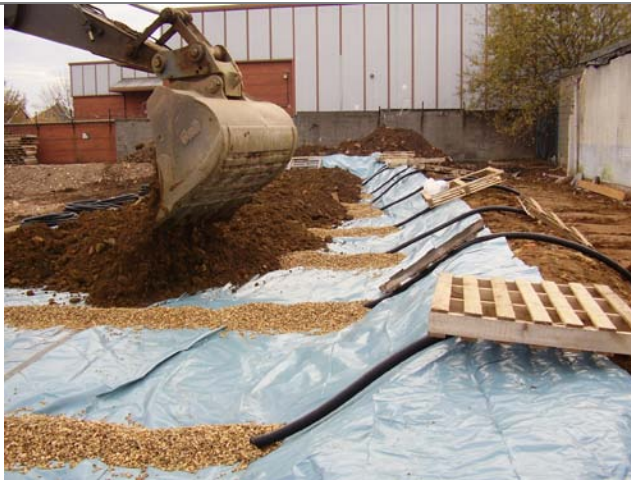
The biopile (Plate 2) was constructed on a network of pipes which initially drew air through the biopile (contaminated emissions being treated prior to release where necessary). Thereafter flow direction was changed and fresh air introduced to the biopile, this was monitored throughout to promote optimal performance.

Plate 2 Biopile construction

Other key parameters were monitored during the works and included temperature, oxygen & carbon dioxide levels, colony forming unit numbers, pH and nutrient levels. The biopile was covered during remediation with a breathable membrane to optimise the treatment process.

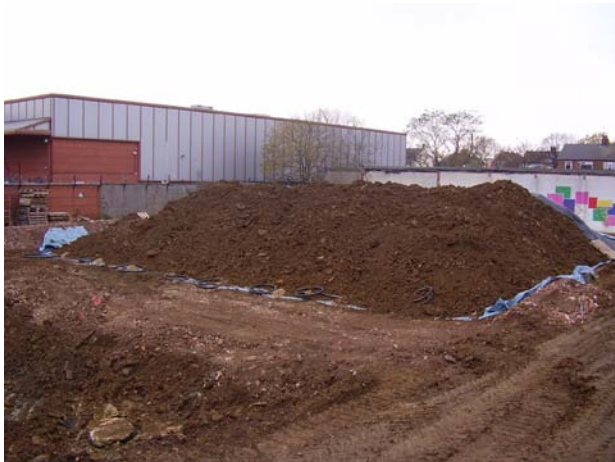
Plate 3 Complete biopile prior to covering

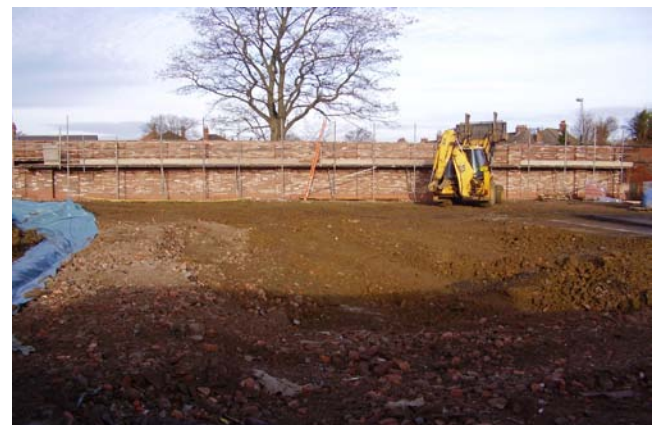
Plate 4 Redeposition of the treated material.

The treatment operation was designed to reduce the concentrations of the identified contaminants through their degradation by micro-organisms. The results presented in this report demonstrate that this was achieved, with the final contaminant concentrations being reduced by over 80%, to below the Site Specific Target Levels (SSTL). Achieving the SSTL's resulted in the project being signed off by the Environment Agency and the treated material being suitable for re-use on-site (Plate 4).
