### Site Background & History

The site is located in Sherwood Road, Bromsgrove and was formerly occupied by a manufacturing facility, primarily producing automotive components between 1964 and 2002. The site comprises of a slightly elongated, irregularly shaped plot of land occupying approximately 1.7 hectares. The site is split into two distinct areas by the Spadesbourne Brook - the main body of the site (eastern side of the brook) was previously occupied by the former factory building and the remainder of the site (western side of the brook) was utilised as a parking area.

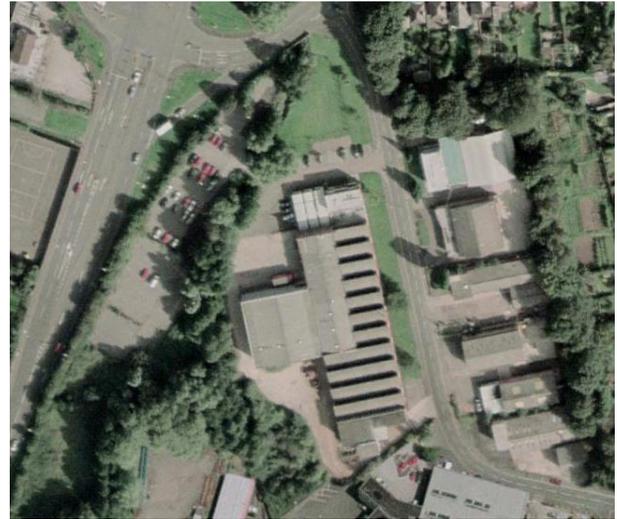
Figure 1 – Aerial View of the Site (circa 1999-2000)

The site is shown in Figure 1 below.

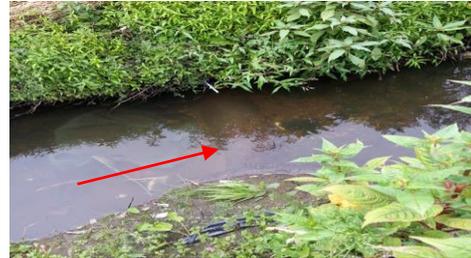
Figure 2 – Surface of Sewer Pipe Transversing the Spadesbourne Brook

The remediation works were complicated by the presence of a live foul sewer transversing the site from the south eastern corner to the western boundary. The presence of imported fill material surrounding the sewer was considered to be a preferential pathway for potentially contaminated groundwater (due to the relatively high permeability of the fill material). The top of the sewer was visible in the bed of the brook and henceforth the fill material was in direct continuity with the brook.

The surface of the sewer pipe can be seen in Figure 2 below.

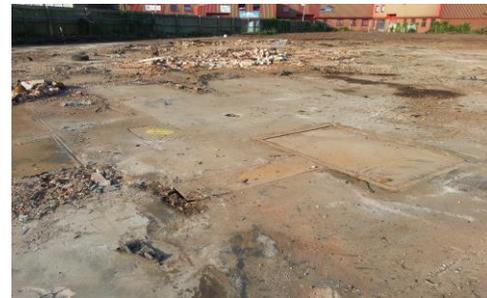
Figure 3 – Southern Area of the Site Following Demolition

The existing factory building was demolished prior to Enviro-treat commencing operations on-site. The southern area of the site following demolition is shown in Figure 3 below.

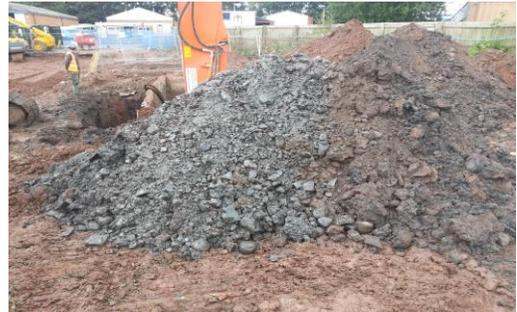
Figure 4 – Hydrocarbon Impacted Soils

The *ex-situ* remediation works involved the treatment of the stockpiled contaminated soils in batches of known volume. The treatment process involved mixing the contaminated soils with the designated E-Clay slurry and cement. In total approximately 1,500m<sup>3</sup> of hydrocarbon impacted soils were treated on-site.

The hydrocarbon impacted soils are shown in Figure 4 below.

The source treatment involved the excavation and subsequent *ex-situ* E-Clay stabilisation of contaminated soils (and associated groundwaters) from the south east corner of the site.

Contaminated soils were excavated and stockpiled pending treatment. The effective removal of contaminated soils was confirmed by validating the bases and sides of the excavations in accordance with pre-determined CLEA derived target criteria. The testing procedure involved a combination of visual / olfactory assessment and PID measurement to determine the extent of the initial excavations and sampling / analysis of the bases / sides of the full excavations to confirm compliance with the target criteria.

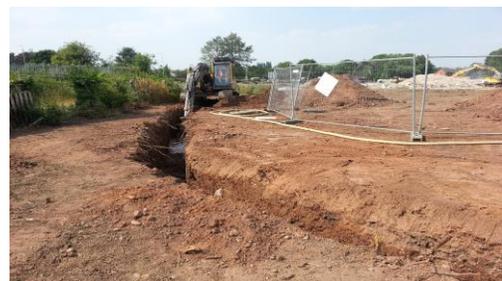
Figure 5 – *In-situ* Installation of E-Clay Permeable Reactive Barrier

The barrier installation involved a combination of *ex-situ* treatment of the shallower soils with the designated pillared E-Clay (the shallower soils were excavated and re-replaced following treatment) and *in-situ* [in place] treatment of the deeper soils with the pillared E-Clay to depths of 4.2m bgl - the *in-situ* installation is shown in Figure 5 below. The installed barrier length was circa 175m.

The permeable reactive barrier was installed along the southern and western boundaries of the main part of the site and along the eastern side of the Spadesbourne Brook. The barrier was designed to intercept and treat the natural flow of contaminated groundwater migrating from the site in a generally southerly direction and to address the potential pollution risks to the brook from the identified preferential pathway associated with the infill material surrounding the sewer and other potential groundwater pathways (including former river meanders underlying the factory building).

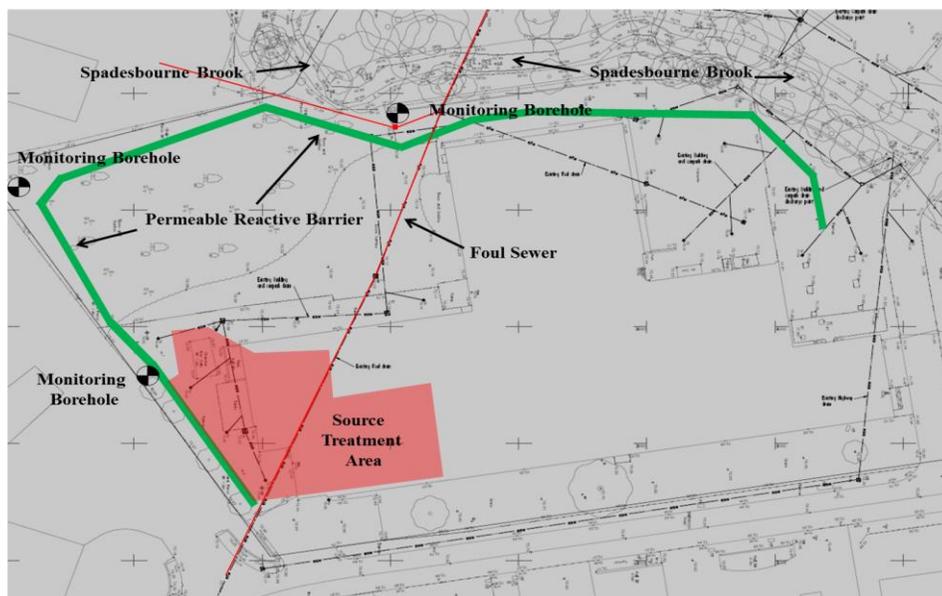
Figure 6 – Summary of Remediation Works

The remediation works are summarised in Figure 6 below.

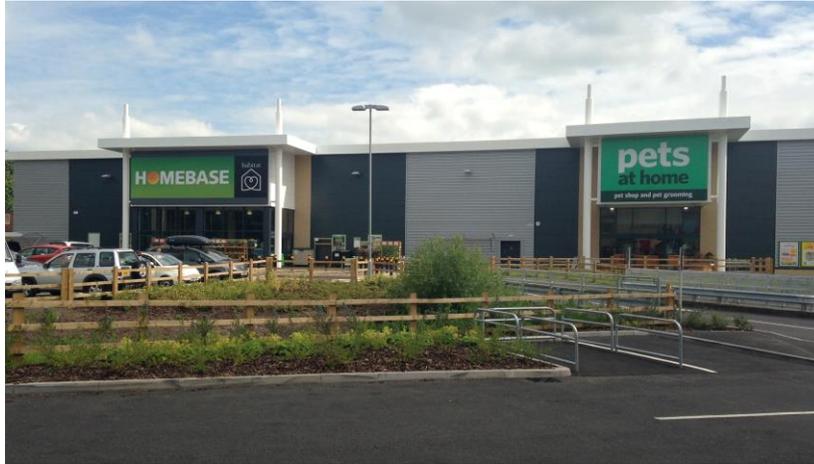
The retail development is shown in Figure 7 below. The service yard (overlying the treated source contamination area) is shown in Figure 8 below. The Spadesbourne Brook is shown in Figure 9 below.

Figure 8 – Service Yard
