Site Background & History

The site, located in the West Midlands, north west of Walsall near Brownhills, is a former engineering works, which occupies an area of circa 0.5 hectare. The site had been purchased by our client who was looking to develop the site for residential purposes.

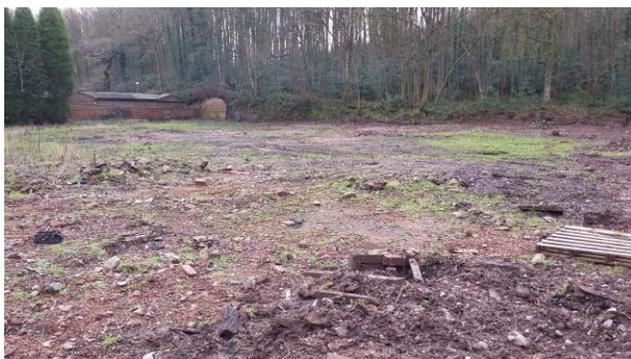
Figure 1 – Site prior to remediation.

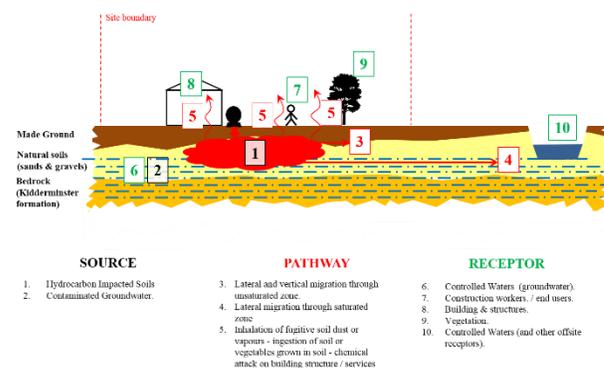
GIP reported ground conditions as made ground overlying sands & gravels over bedrock. The nearest watercourse was an unlabelled stream that flows through the site. A pond is located 50 m to the north east of the site. The site is situated upon a 'Principal Aquifer' as classified by the Environment Agency.

Figure 2- Conceptual Site Model.

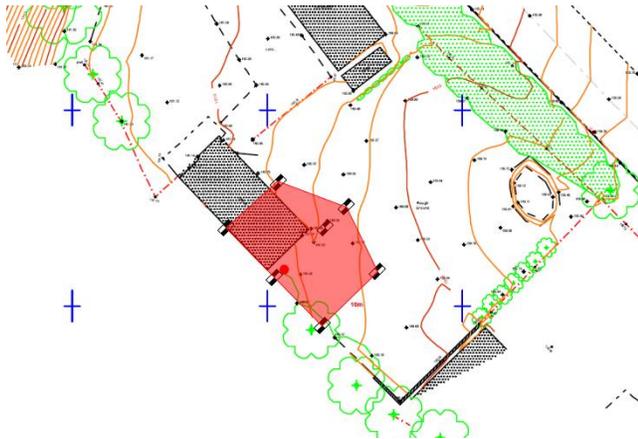
Based on visual and olfactory observations, an area of approximately 20 m x 10 m with an impacted depth of general down to 4.0 m bgl was confirmed.

Figure 3 – Lateral extent of hydrocarbon source contamination (indicated red).

The extent of hydrocarbon contamination within the vicinity of WS4 was fully delineated by Envirotreat through the excavation of a series of trial pits excavations around the periphery of the area to confirm the lateral / vertical extent of the contamination.

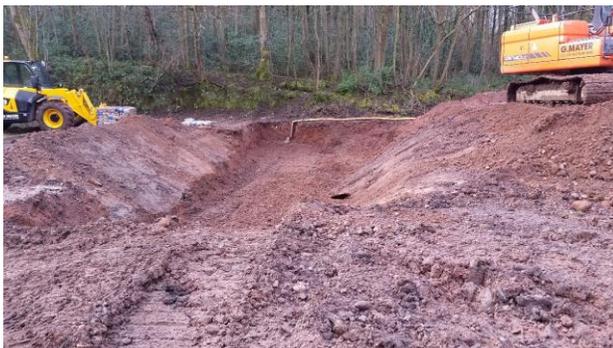
Figure 3 – Reduced Level Excavation and introduction of E-Clay Slurry.

The delineated area was reduced in depth to above the contamination, the area was subdivided into sections to enable assessment of required volumes. Within each section pre-determined volumes of E-Clay slurry were added and soil mixed to the required depth. Each section was treated in turn until the whole delineated area had been treated with E-Clay treatment slurry.

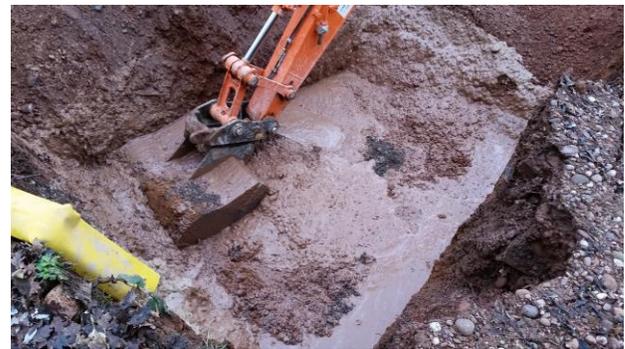
Figure 4 – Soil mixing within the Contaminated Area.
