### Site Background & History

The site is located in Nechells, Birmingham and occupies 0.49 hectares. The site was formerly occupied by ERA and was utilised for the manufacture of locks and ironmongery.

### Remediation Objectives

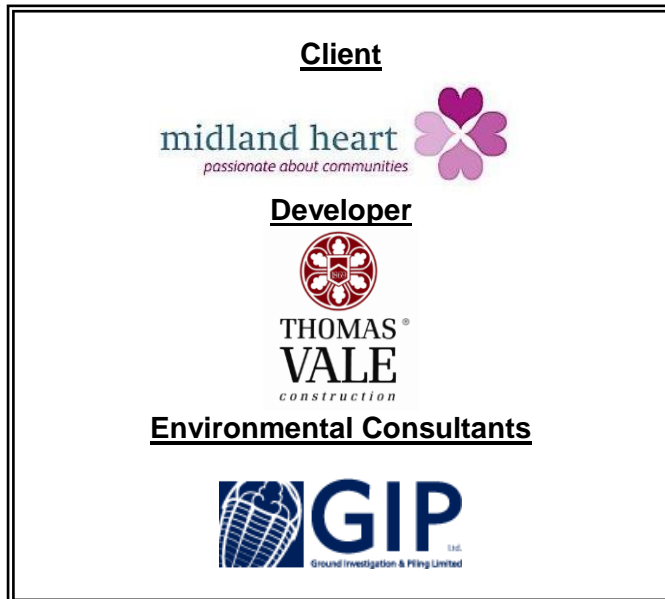
Figure 2 – Proposed Development

The proposed residential development on the site [by Midland Heart] comprises of 33 houses. The development is shown in Figures 1 and 2.

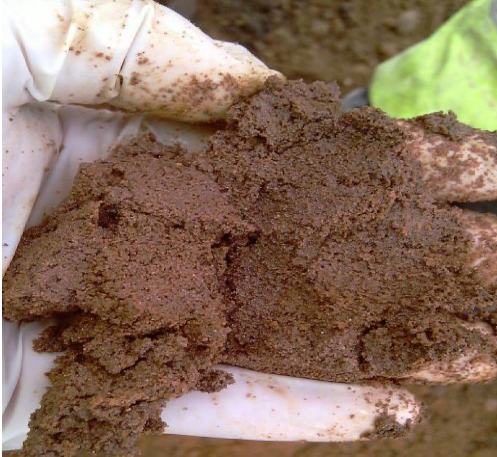
Figure 3 – Typical Site Contamination

Three distinct contamination areas were identified based on analytical data provided by GIP – these areas were delineated based on a TPH threshold value of 1,000mg/kg and coincided with the historical location of machine sumps, oil storage areas, drainage runs and likely spillage areas.

The source contamination extended to depths in excess of 3.5m bgl – this was primarily due to the sandy geology associated with the site. Significant TPH concentrations were recorded within these areas (↑30,000mg/kg).

The typical site contamination is shown in Figure 3.

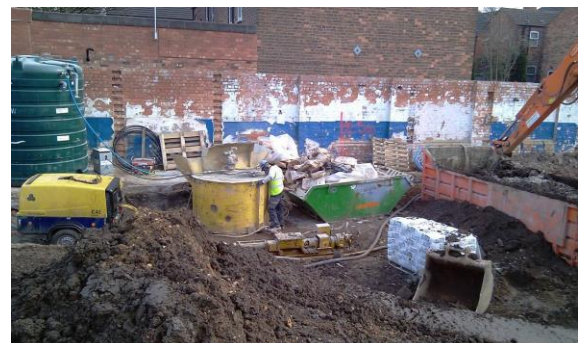
Figure 4 – Ex-Situ Stabilisation

The stabilisation process comprised of a designated mix formulation of E-Clay and cementitious materials.

The *ex-situ* treatment process is shown in Figure 4.

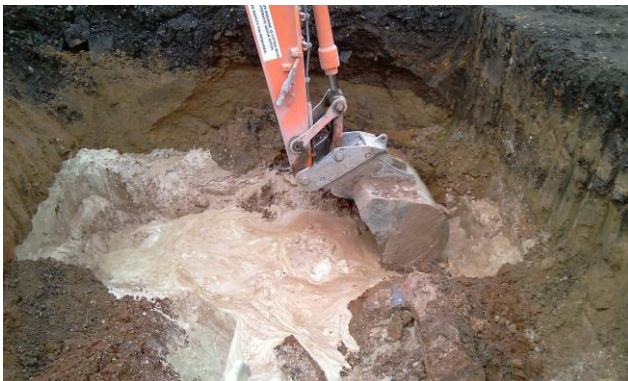
Figure 5 – In-Situ Stabilisation

Site constraints prevented the possibility of utilising soil mixing plant (soil cutters / augers) for the *in-situ* treatment [stabilisation]. It was therefore decided to carry out the *in-situ* treatment element utilising a conventional excavator bucket to the required depth.

The *in-situ* treatment process is shown in Figure 5.

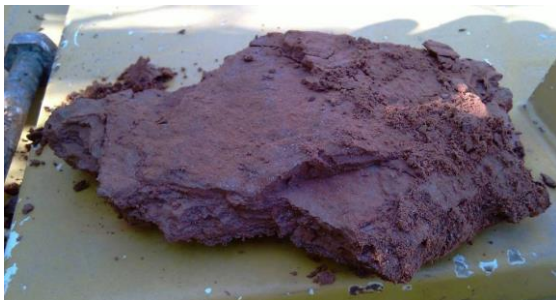
Figure 6 – Weathered Mudstone (at 3.2m bgl)

The reactive barrier was installed utilising a similar methodology to the source treatment (due to the site geology). The barrier was installed in 6m long sections to minimise the risk of collapse and most importantly to maintain the site access on the northern boundary of the site (which the barrier intercepted). The barrier sections were excavated to circa 2.5m bgl. In each case the excavation was extended to ascertain / confirm the depth of the weathered mudstone / bedrock. The mudstone is shown in Figure 6.

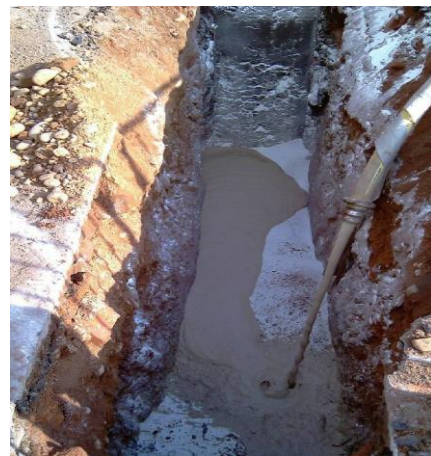
Figure 7 – Addition of E-Clay / Reductive Additive

The requisite volumes of E-Clay and reductive chemicals were mixed with the soils installing the reactive barrier to the required depth.

The addition of E-Clay and the reductive agent is shown in Figure 7.

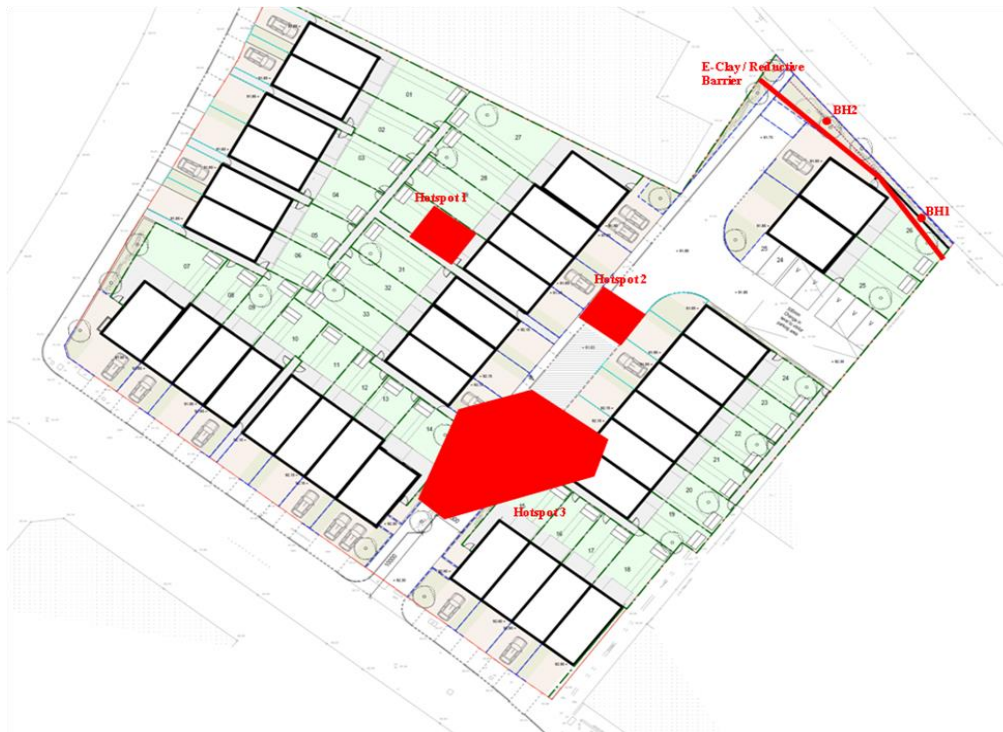
Figure 8 – Overall Remediation Strategy

Envirotrete developed an integrated remediation strategy to address the complex and uncertain contamination identified on site. The strategy comprised of E-Clay stabilisation to treat the identified TPH source contamination in the central area of the site in combination with an E-Clay / Reductive Permeable Reactive Barrier to address residual chlorinated hydrocarbon and residual TPH groundwater contamination. The reactive barrier was designed to be installed along the northern site boundary to intercept the natural flow of groundwater migrating from the site (in the direction of the Hockley Brook and the River Tame).

The source treatment involved the excavation and ex-situ treatment of 575m<sup>3</sup> of shallow contaminated soils and in-situ treatment of a further estimated 250m<sup>3</sup> of deeper contaminated soils. The barrier was 30m in length and installed along the full north eastern boundary of the site to a depth of 3 – 3.3m bgl.

The overall remediation strategy is shown in Figure 8.
