Clyde Gateway

I & H BROWN
LIMITED

Grontmij

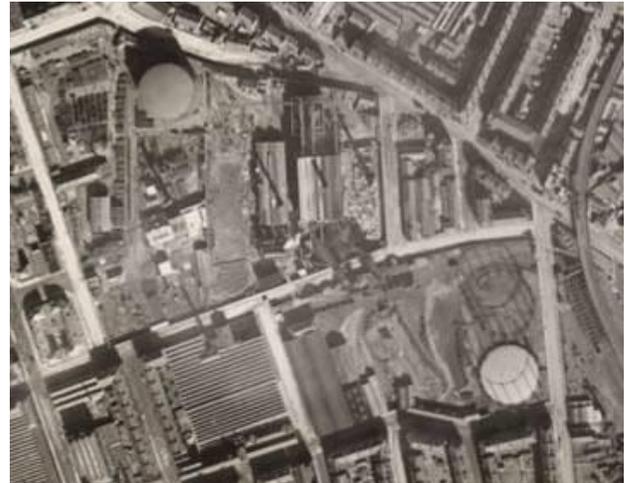
Figure 1 – Historical Aerial View of the Former Dalmarnock Gas Works

The Dalmarnock Gas Works was opened in 1843 and later extended in 1856 and 1871. The works closed in 1904 but later reopened again in 1911. The works were finally closed in 1956 and most of the above ground structures were demolished in the 1970's. The historical gas works in shown in Figure 1 below.

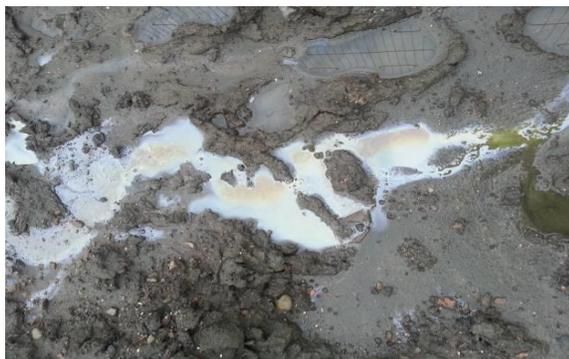
Figure 2 – Filter Cake Material (showing hydrocarbon contamination associated with the filter cake material)

- *Ex-Situ* E-Clay Stabilisation of Stockpiled Filter Cake (resulting from the on-site soil washing process – see Figure 2 below)
- *Ex-Situ* E-Clay Stabilisation of Excavated General Gas Works Waste
- *Ex-Situ* E-Clay Stabilisation of Spent Oxide Waste – see Figure 3 below
- *In-Situ* E-Clay Stabilisation of General Gas Works Waste (within an onsite gas holder)

The previously employed soil washing process produced a concentrated contaminated filter cake comprising of ‘fines’, typically less than 0.06mm in diameter – these contaminated fines are typically hazardous in nature with associated high disposal costs. It was therefore necessary to implement a cost-effective and technically acceptable on-site remediation stabilisation solution.

The soil washing process had been applied to a number of waste streams and henceforth the filter cake contained a wide range of CoCs which were concentrated in the filter cake material.

In addition to the concentrating effect of the soil washing process there was the additional concern that highly mobile and toxic free cyanides and unstable iron cyanide species (Fe(CN)₆) would have been liberated through dissociation of relatively stable ‘Prussian Blue’ complexed cyanide compounds. It was therefore essential to implement effective pH control in combination with the E-Clay Stabilisation Process – the objective was to drive the equilibrium towards the formation of low solubility and relatively immobile complexed ferri-ferrocyanides (which also necessitated the addition of iron compounds within the stabilisation media).

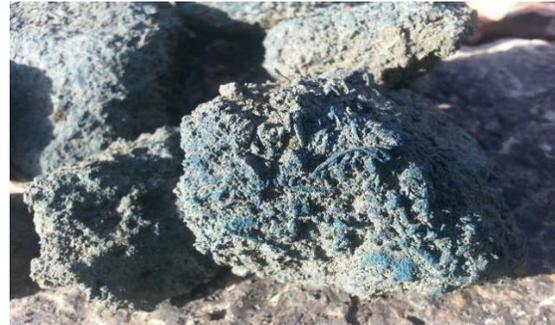
Figure 3 – Spent Oxide Material (showing complex cyanide [‘Prussian Blue’] contamination associated with the spent oxide material)

These waste streams were segregated by IHB on the basis that the material was clearly contaminated with spent oxide (cyanide bearing waste typically associated with the gas purification stage of the historical gas works operation). The spent oxide materials exhibited significantly elevated levels of total cyanides (circa 15,000mg/kg) in addition to other typical gas works pollutants.

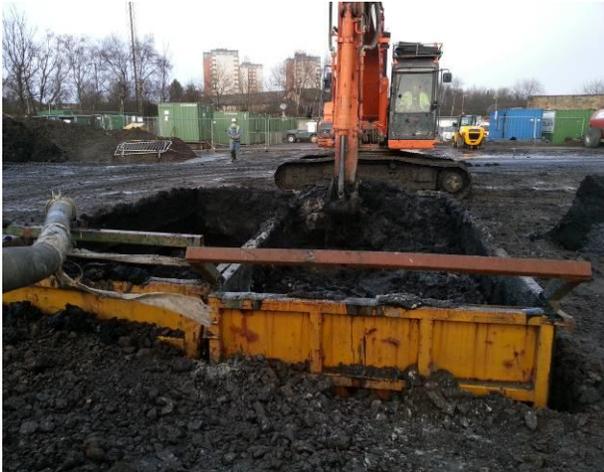
Figure 4 – Ex-Situ Stabilisation of Contaminated Materials

The *ex-situ* remediation works involved the treatment of contaminated materials in 15m³ batches utilising a mixing bin (see Figure 4 below). The treatment process involved mixing the wastes with the designated E-Clay in slurry form and cementitious materials in dry form. The wastes were mixed with the treatment materials to produce a homogeneous mass. Representative samples were taken throughout the treatment process – these samples were combined to produce composite samples for validation purposes.

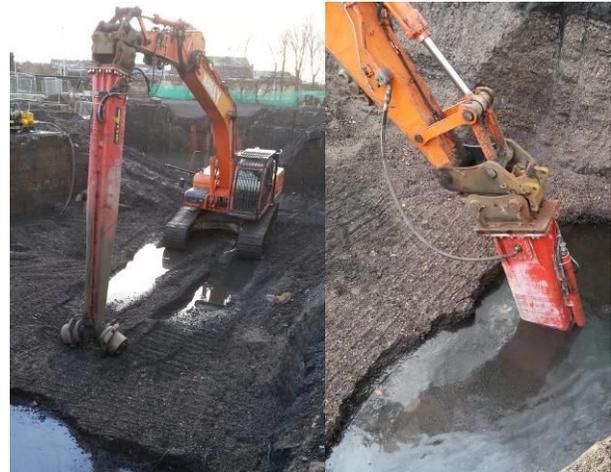
Figure 5 – In-Situ Remediation of Gas Holder A8

It was not feasible to excavate contaminated materials from Gas Holder A8 (as the gas holder was partially located under the adjoining roadway and there was a potential risk of structural collapse if the material was excavated). As a consequence it was decided to implement an *in-situ* remediation approach treating the contaminated gas works material 'in-place'.

The *in-situ* treatment (1,340m³) was carried out utilising an Allu soil cutter / mixer to achieve effective in place mixing of the treatment reagents with the gas holder materials.

The treatment process involved mixing the wastes with the designated E-Clay in slurry form and cementitious / bentonitic materials in dry form. The wastes were mixed with the treatment materials to produce a homogeneous mass. Representative samples were taken throughout the treatment process – these samples were combined to produce composite samples for validation purposes.

The *in-situ* treatment process is shown in Figure 5 below.

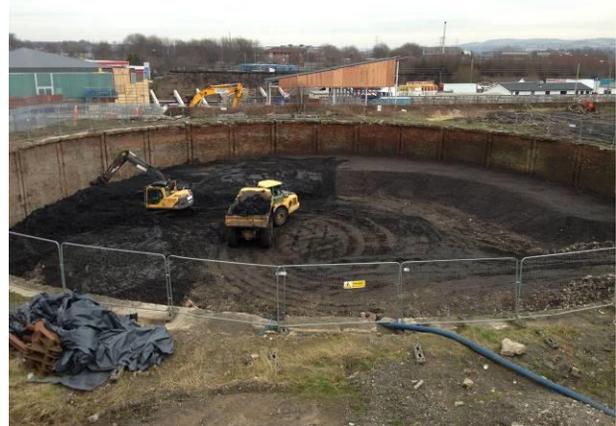
Figure 6 – Re-emplacement of Treated / Validated Material within the Former Poplin Street Gas Holder

The majority of the contaminated material was re-emplaced in the former Poplin Street Gas Holder as shown in Figure 6 below. The site prior to remediation showing the excavated Poplin Gas Holder and stockpiled material is shown in Figure 7 below.

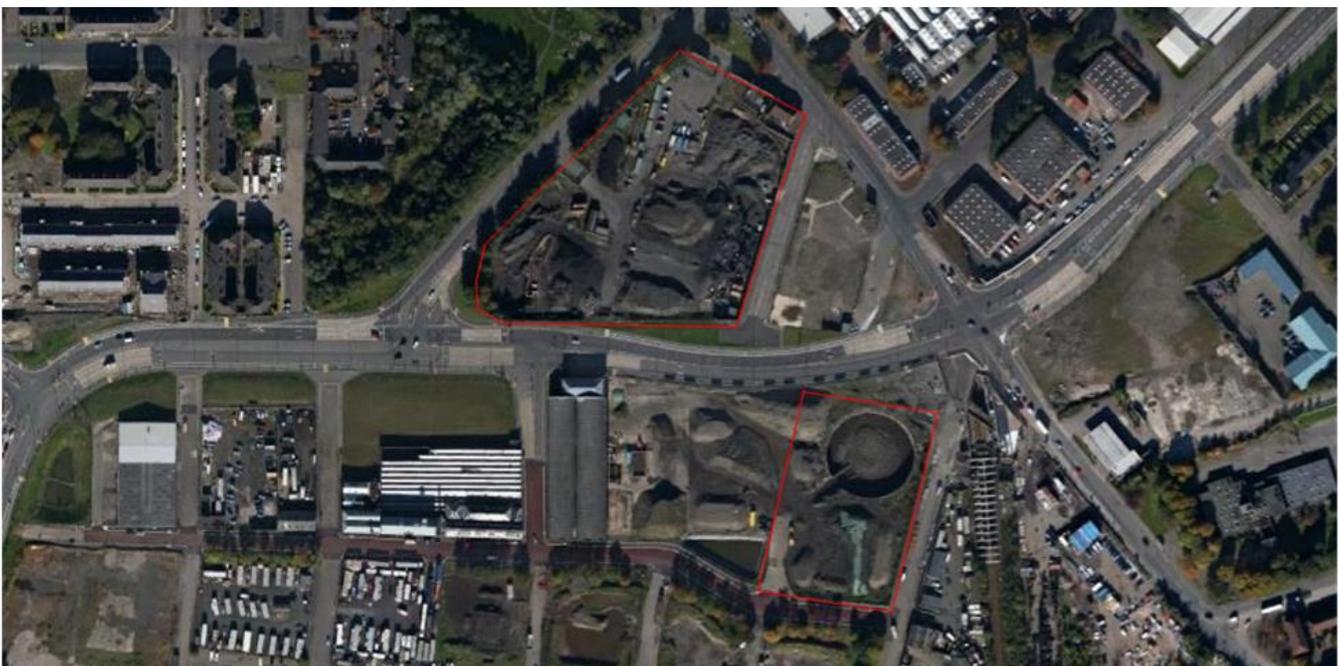
Figure 7 – Former Dalmarnock Gas Works – Aerial Photograph Showing the Excavation of the Former Gas Holder on the Poplin Street Site and the Stockpiling of Soils in Preparation for the Remediation Works
