Crown Crest (Leicester) Plc

Hallam

Site Background & History

Envirotreast worked closely with Hallam Contracts and the Environment Agency to develop the remediation solution for the site. The permeable reactive barrier system was designed to incorporate pillared E-Clay technology.

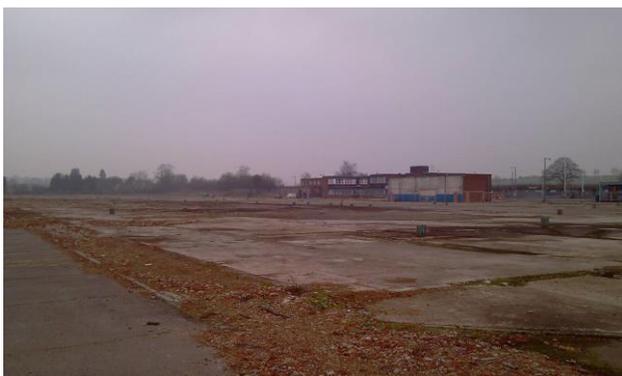
The site was dominated by a large concrete slab on which the (now demolished) steelworks building was constructed (see Figure 1). Some office buildings remain in the north of the site but are largely unused at present.

Figure 1 – Site Prior to Development

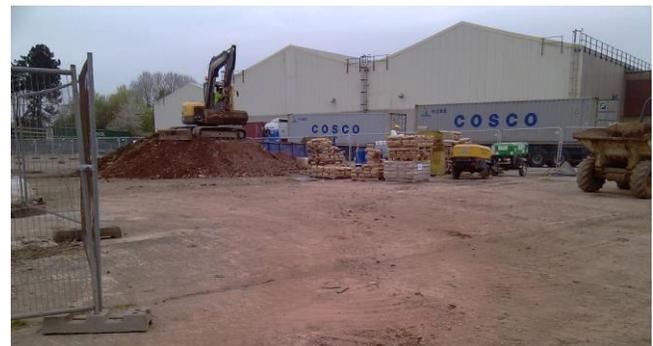
The *ex-situ* soil mixing process and E-Clay production area are shown in Figure 2 below.

Figure 2 – *Ex-Situ* Soil Mixing and E-Clay Production Area

As the barrier was relatively shallow it was decided to install a trench reactive barrier system whereby the soils within the barrier alignment were excavated and treated *ex-situ* with the E-Clay treatment media followed by reinstatement. The trench barrier methodology enabled visual confirmation of the soil mixing process and provided the opportunity for visual observation of changing geology along the line of the barrier and verification that the correct barrier depth had been achieved.

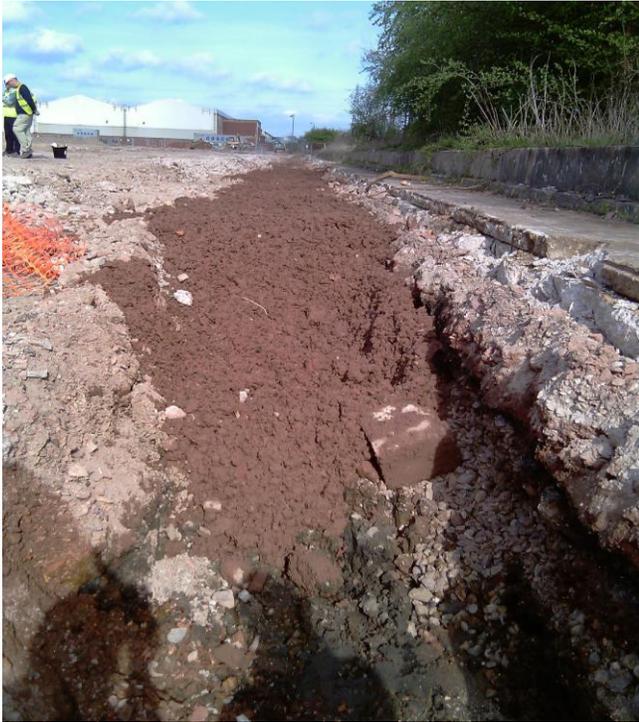
The re-replaced treated soils are shown in Figure 3.

Figure 3 – Re-replaced Treated Soils

In total a 650m length of barrier was installed using this methodology.

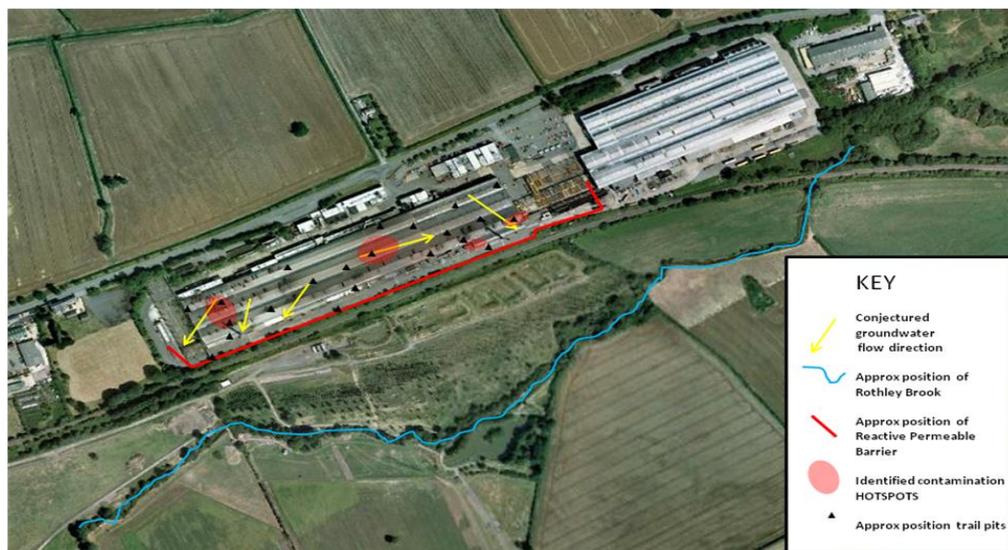
The barrier location is shown in Figure 4.

Figure 4 – Barrier Location in Relation to the Site [source Google Maps - predevelopment]

As part of the remediation strategy four boreholes were installed downstream of the barrier location for ongoing groundwater monitoring. The initial results are encouraging.
