LODGE PARK
LIMITED

Site Background & History

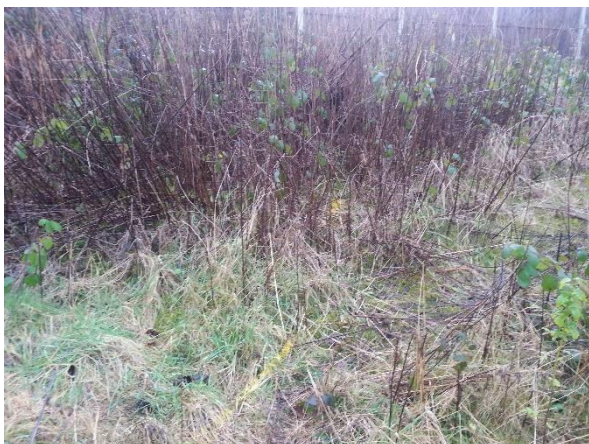
Figure 1 – Photograph showing extent of Japanese Knotweed infestation.

Envirotreat identified two distinct areas of JKW based on evidence of canes. One area being relatively small and possibly the result of a single plant and further, larger area approx. 20 m by 10 m with more established plants.

In January 2014, based on the agreed KMP, Envirotreat undertook a managed dig operation to remove the bulk of the JKW offsite. In total approx. 50 tonnes of soil was removed offsite.

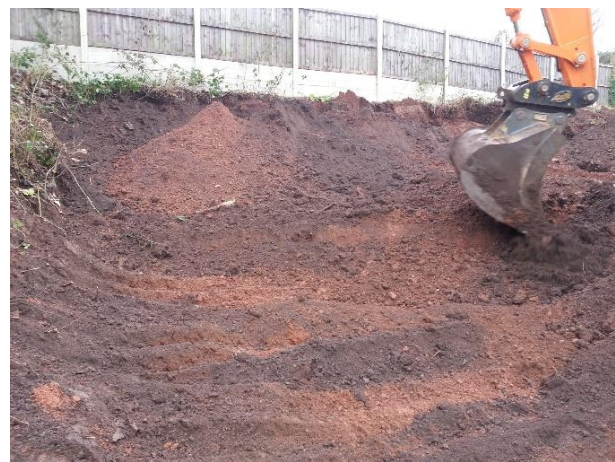
Figure 2 – Excavation of bulk JKW contamination.

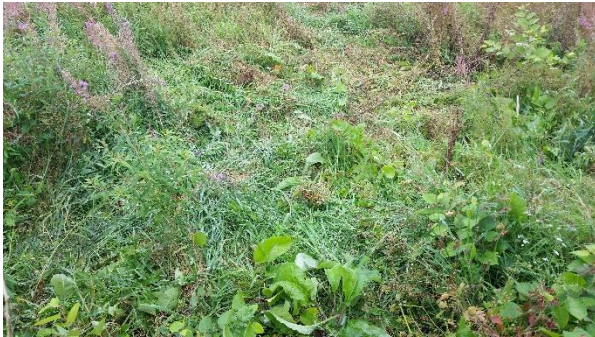
A review of the site indicated a significant reduction of the presence of Japanese Knotweed plants in those areas where the excavations had taken place. The plants that were present were small.

A small clump of more established plants remained beneath a large tree where excavations were not possible.

Figure 3 – Evidence of some regrowth.

In August 2014, Envirotreat attended site and treated the remaining JKW with a newly available herbicide, this was used on site to treat the identified, remaining plants.

The replacement herbicide – Icade was replacement for Picloram, which had been withdrawn early in 2014.
