THOMAS
VALE
construction

B A Y N H A M M E I K L E
partnership

Site Background & History

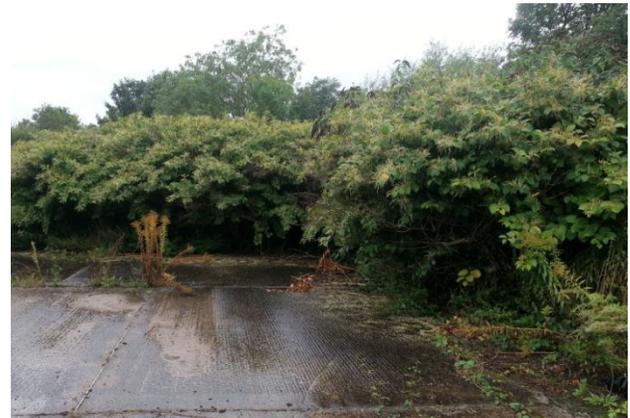
Figure 1 – Japanese Knotweed Infestation

Significant pockets of Japanese Knotweed [Knotweed] were identified on-site and along the banks of the River Stour. It is believed that the infestation has occurred as a consequence of Knotweed rhizomes being washed down the River Stour onto the site and becoming established in the banks over a number of years (and then spreading across the site).

The Knotweed infestation is shown in Figure 1 below.

The identified Knotweed plants were sprayed with a non-persistent glyphosate herbicide. The close proximity of the River Stour restricted the types of herbicides which could be applied – it was necessary to obtain Environment Agency approval in advance to use the designated herbicide. The plants were sprayed with the herbicide towards the end of the growing season – this minimised the potential risks to bees and other pollinating insects.

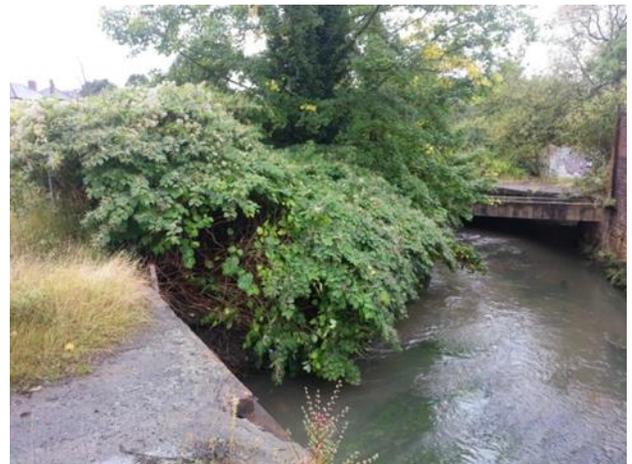
Figure 2 – Japanese Knotweed Infestation (Banks of River Stour)

The Knotweed infestation along the banks of the River Stour is shown in Figure 2 below.

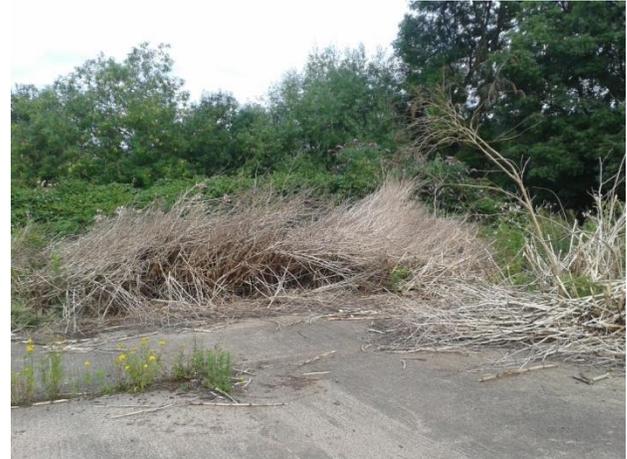
Figure 3 – Knotweed Infestation Following Treatment

The site was revisited during the following growing season to assess the efficacy of the herbicide treatment. It was observed that the treatment process had been very effective - there was a significant reduction in the number of Knotweed plants - the remaining Knotweed plants were also much smaller and less viable (and considered to be susceptible to further treatment in accordance with KMP).

The efficacy of the treatment process is shown in Figures 3 and 4 below – Figure 3 shows the same area of the site as shown in Figure 1 above and Figure 4 shows the Knotweed on the banks of the River Stour following treatment (in comparison with the untreated Knotweed as shown in Figure 2 above).

Knotweed control is ongoing in accordance with the KMP.
