### Objectives

The Kew Riverside Site is being redeveloped for housing and leisure facilities.

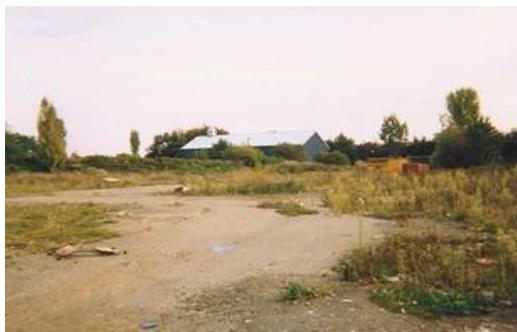
Figure 1 – Site Prior to Remediation

The site has been historically contaminated with waste materials from an adjacent domestic waste incinerator process. The identified contaminants include heavy metals, polycyclic aromatic hydrocarbons and other organic pollutants. The site prior to remediation is shown in Figure 1 below.

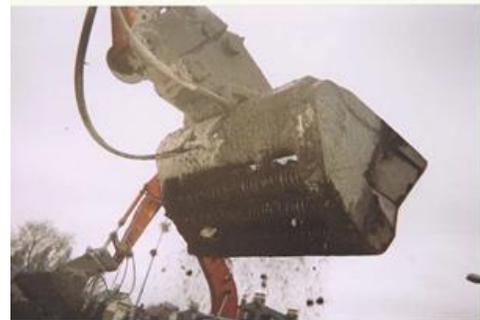
Figure 2 – Processing Bucket

The *ex-situ* remediation works involved the treatment of circa 6,500m<sup>3</sup> of contaminated soils and associated groundwater in 5m<sup>3</sup> batches utilising processing buckets (as the identified contaminated soils were clayey in nature). The processing buckets incorporate rotating blades at the bases facilitating a high degree of mixing. The treatment process involved mixing the contaminated materials with the designated E-Clay in slurry form and cementitious materials in dry form. The processing bucket is shown in Figure 2 below and the slurry production process is shown in Figure 3 below.
