Figure 1 – Proposed Royal Wharf Development

Site Background & History

Methodology

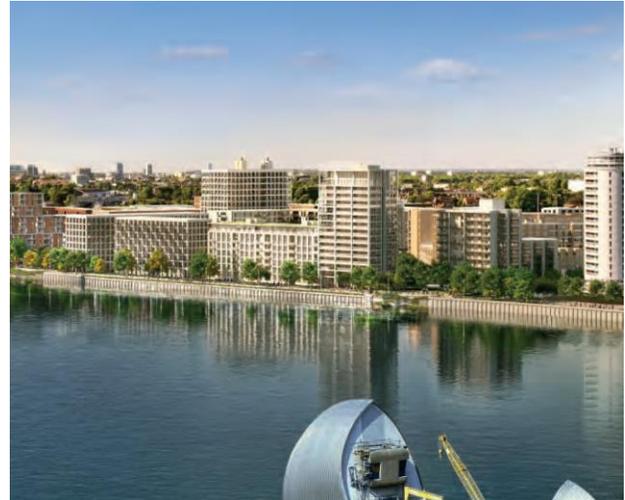
The proposed Royal Wharf Development is shown in Figure 1 below.

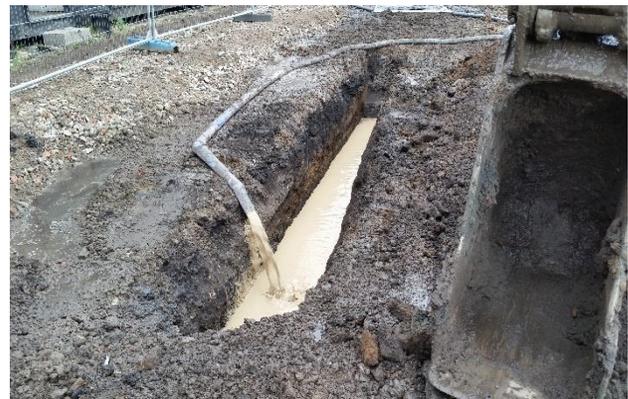
Figure 2 – E-Clay Slurry Addition to Excavated Trench

The barrier installation involved the excavation of a trench extending into the underlying (relatively impermeable) clay – the pillared E-clay treatment medium was then added in slurry form as shown in Figures 2 and 3 below. Previously excavated soils were added back to the trench and soil mixed using an excavator.

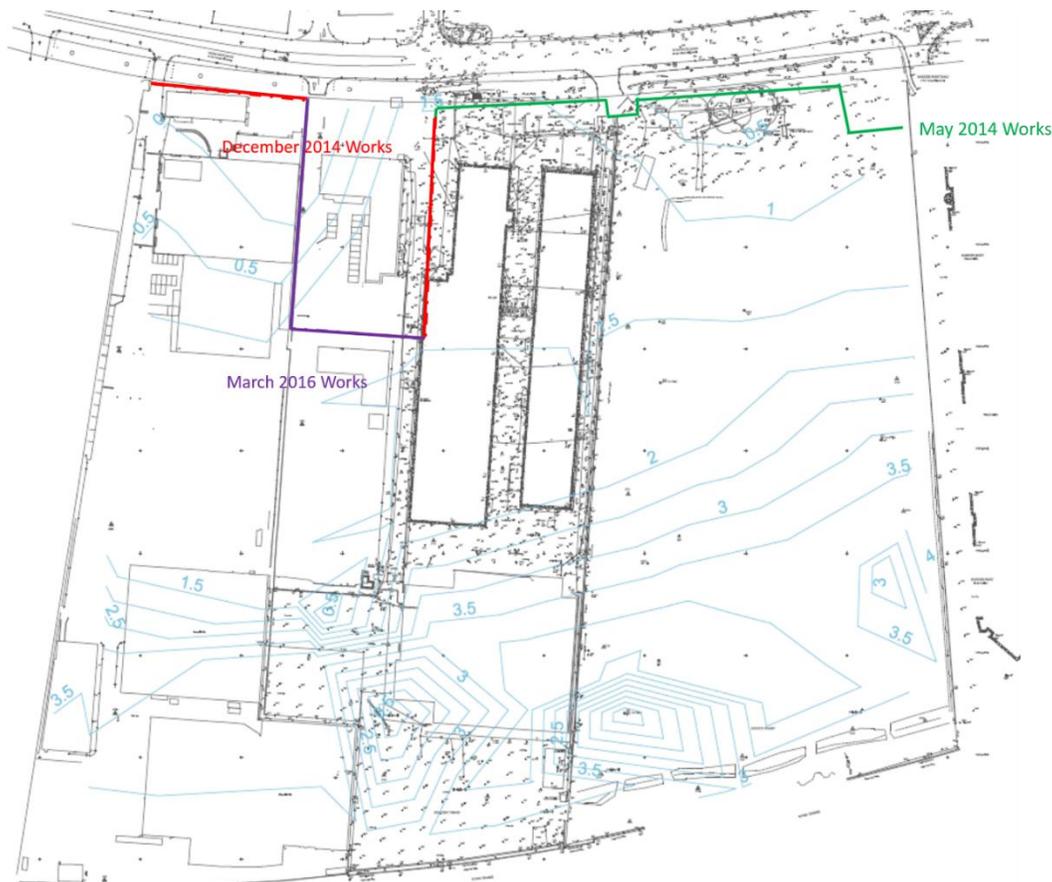
Figure 4 – Barrier Installation

The barrier installation is shown in Figure 4 below.
