### Site Background & History

The specific development site described in this case study is the former Renwick Road Landfill (referred to as Area 9 by Barking Riverside). In addition remediation works were carried out on a contamination hot-spot in Area 7 to the west of Area 9.

Following a remediation options appraisal by the appointed consultant Card Geotechnics Limited [CGL], it was agreed to implement an *integrated remediation approach* comprising the installation of a reactive barrier system and source treatment of contamination ‘hot-spots’.

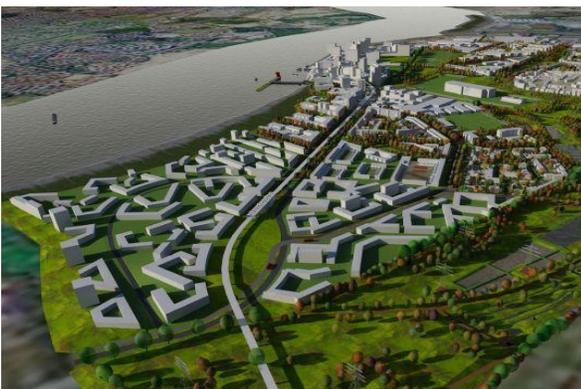
The vision is for Barking Riverside to provide a model for sustainable living in the 21st century. Over the next 20 years it is planned to build 10,800 new homes to house 26,000 people. The development will benefit from new transport links including the East London Transit and the Docklands Light Railway. New primary and secondary schools will also be constructed. The proposed site development is shown in Figure 1 below.

Figure 1 – Proposed Future Site Development

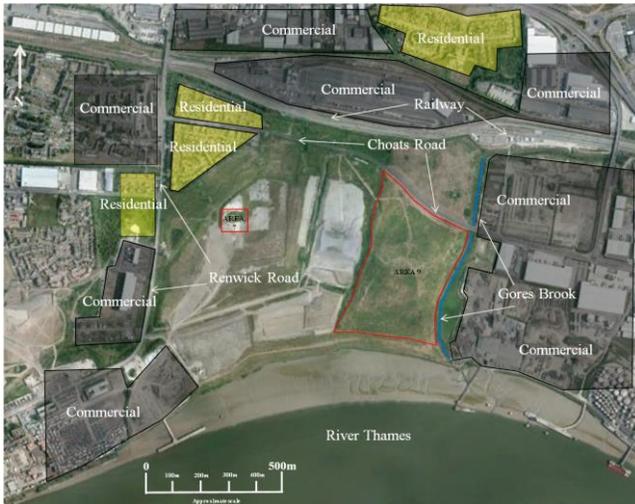
The contamination 'hot-spot' in Area 7 (to the west of Area 9) was identified as gasworks waste and specifically spent oxide waste. This material is assumed to have been tipped historically and is currently present within a hollow surrounded by surcharged material on Area 7 as a whole.

The site as a whole including Area 7 is shown in Figure 2 below.

Figure 2 – Site Overview

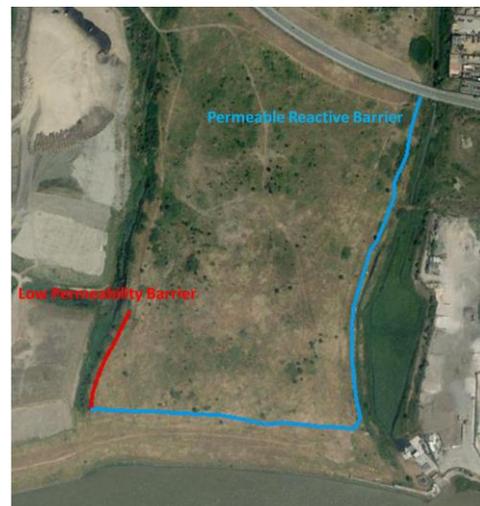
In general the barrier depth varied between 3.5m - 7.0m bgl. The barrier was keyed into the underlying low permeability layer.

The barrier installation is shown in Figures 3 and 4 below. The barrier system comprised of permeable reactive sections on the eastern and southern boundaries (designed to intercept and treat contaminated groundwater migrating from the site in the direction of the Gores Brook and the River Thames) and a low permeability section on the south-western boundary of the site designed to channel contaminated groundwater in the direction of the southern reactive barrier section.

Figure 3 – Barrier Installation

The overall barrier installation was 925m in length comprising 750m of permeable reactive barrier sections and 175m of a low permeability barrier as shown in Figure 3 above.

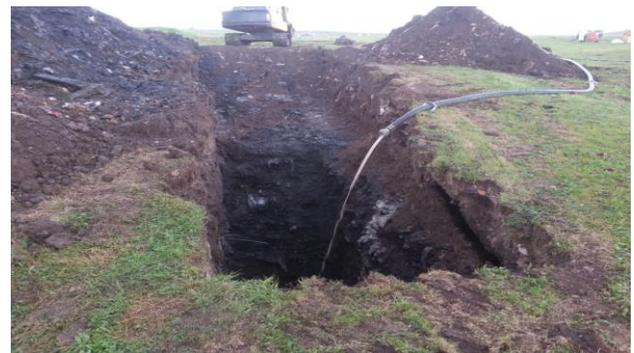
The Barrier was installed in accordance with the Barrier Design Statement. The actual barrier alignment was dictated by local conditions (flatness of ground, obstructions, etc.). The barrier was constructed by soil mixing techniques incorporating a purpose designed pillared E-Clay formulation reflecting to barrier design requirements.

Figure 4 – Barrier Installation – Soil Mixing Process

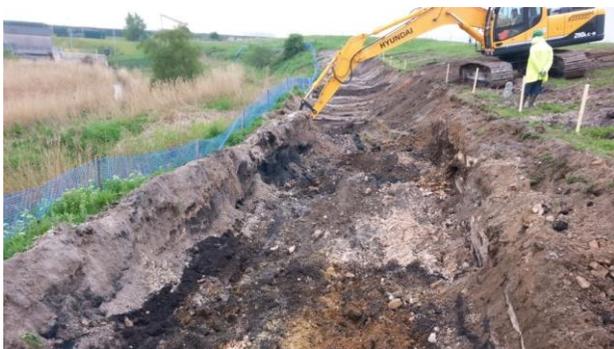
The gas works / spent oxide waste identified in the south-eastern corner of the landfill site (Area 9) was delineated and excavated as far as practically possible. The subsequent stockpiled spent oxide waste was treated *ex-situ* utilising the designated stabilisation medium incorporating cementitious materials, the appropriate E-Clay formulation and specialist additives. Following successful validation (by leachate testing) the treated material was reused as part of the surcharging material requirement in accordance with the material management plan [MMP] for the site.

Figure 5 – Excavation of Identified Gas Works / Spent Oxide Waste

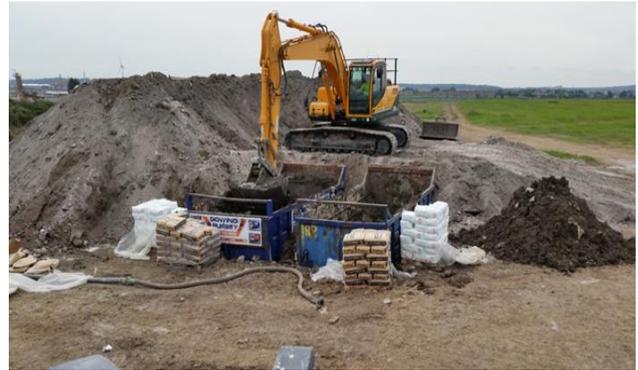
Figure 6 – *Ex-Situ* Treatment of Gas Works / Spent Oxide Waste in Area 9

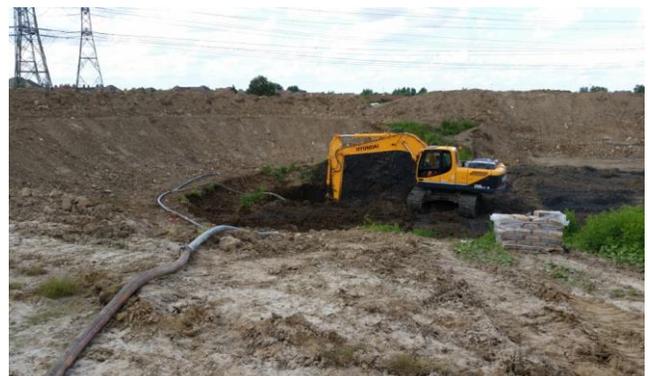
The spent oxide waste on the adjoining site (Area 7) was delineated by the excavation of a number of trial pits. The identified area was treated *in-situ* treatment utilising the designated stabilisation medium incorporating cementitious materials, the appropriate E-Clay formulation and specialist additives. The contaminated material in Area 7 was predominantly spent oxide waste with an associated very low pH necessitating a different stabilisation medium to that employed in Area 9.

Figure 7 – *In-Situ* Treatment of Spent Oxide Waste in Area 7

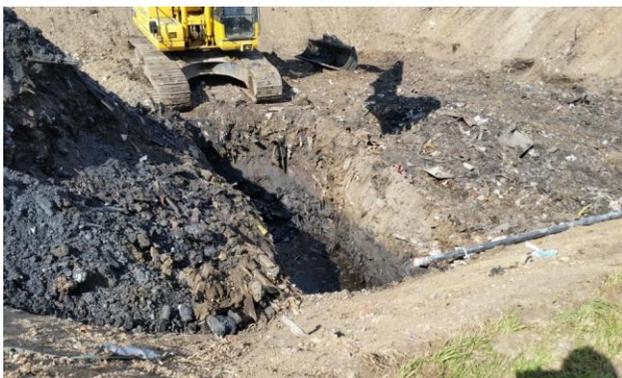
The ‘hot-spots’ were delineated by the excavation of a number of trial pits. The identified areas were treated *in-situ* utilising the designated stabilisation medium incorporating cementitious materials and the appropriate E-Clay formulation.

Figure 8 – *In-Situ* Treatment of Identified Hydrocarbon Contaminated ‘Hot-Spots’

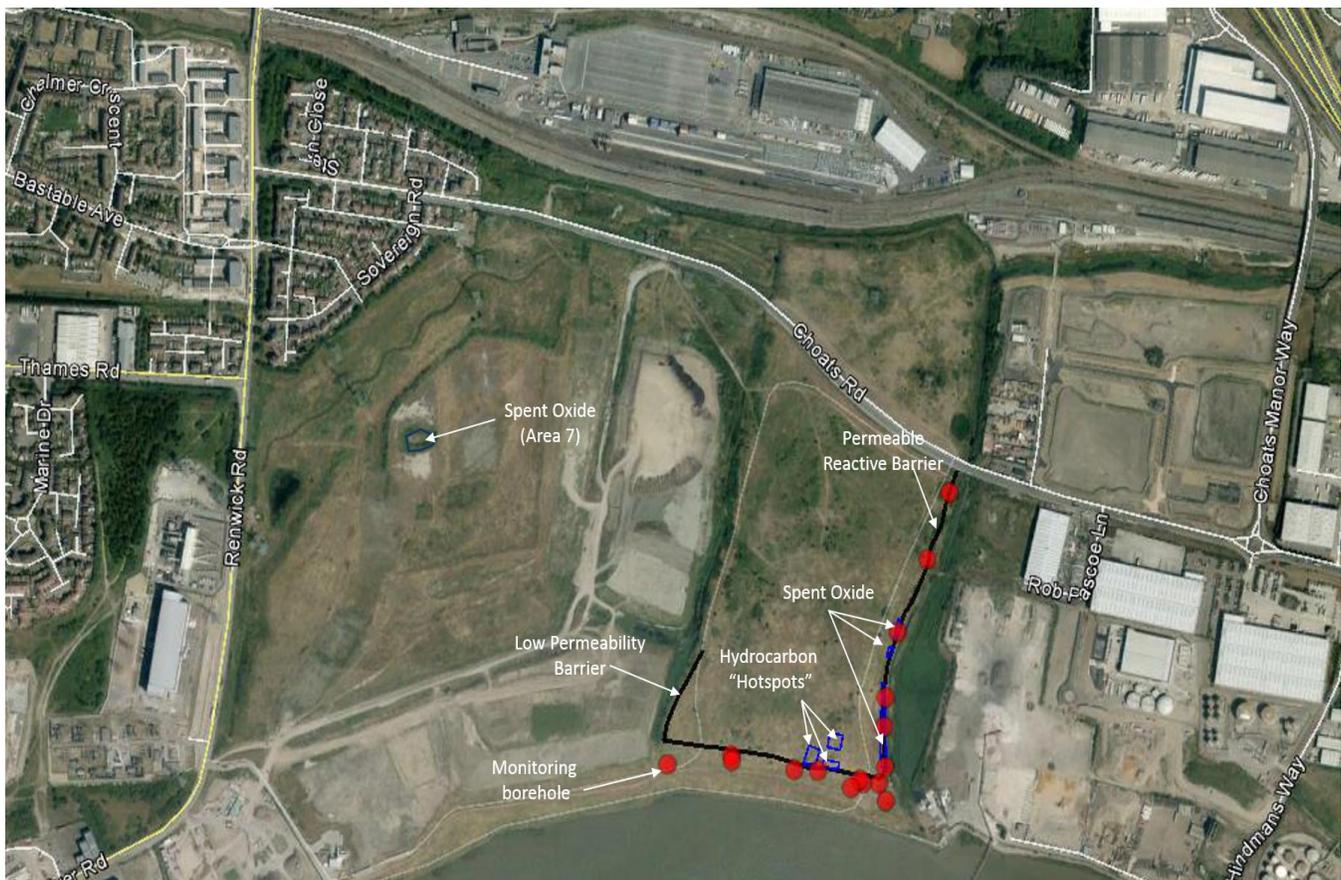
Figure 9 shows the location of the installed barrier system on the landfill site (Area 9) and the locations of the gas works / spent oxide and hydrocarbon contamination hotspots. The location of the 'hot-spot' in Area 7 is also shown.

Figure 9 – Barking Riverside - Integrated Remediation Scheme (Areas 7 and 9)
