Site Background & History

Remediation Strategy

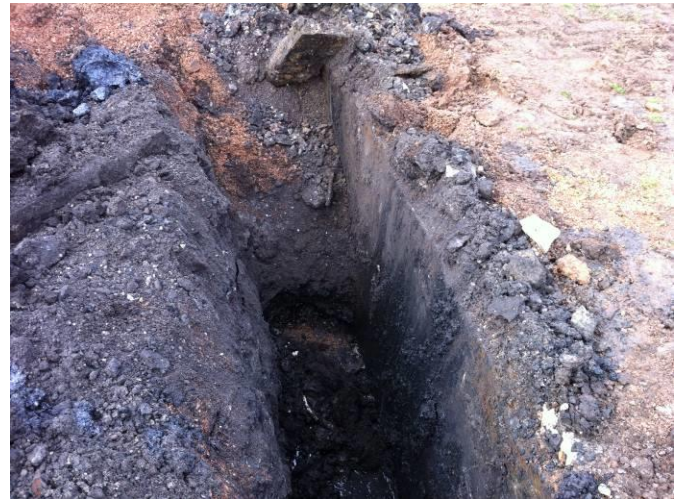
The typical contamination encountered on site is shown in Figure 1.

Figure 1 – Typical Gas Works Waste Encountered

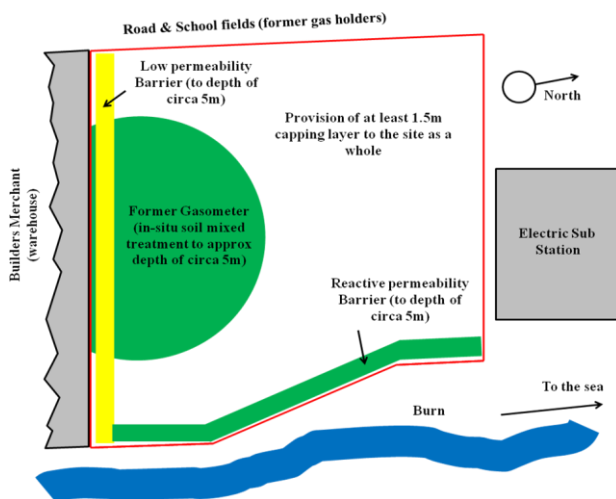
1. Installation of a low permeability barrier to prevent re-contamination of the site from the section of the gas holder located under the builder's merchant site.
2. In-situ E-Clay stabilisation of contaminated soils within the gas holder.
3. Installation of a E-Clay Permeable Reactive Barrier along the eastern boundary to protect the Kinness Burn from residual contamination on site.
4. Installation of a suitable capping layer to address human health risks.

The overall remediation strategy is shown in Figure 2.

Figure 2 – Schematic Representation of the Adopted Remediation Strategy

The works were undertaken by Envirotrear within a two week period. The low permeability wall was installed initially by in-situ soil mixing – this was necessary to protect the site from recontamination. The contaminated soils within the former gas holder were stabilised by in-situ soil mixing utilising a designated mix formulation of E-Clay and cementitious materials. The E-Clay Permeable Reactive Barrier was installed by in-situ soil mixing.

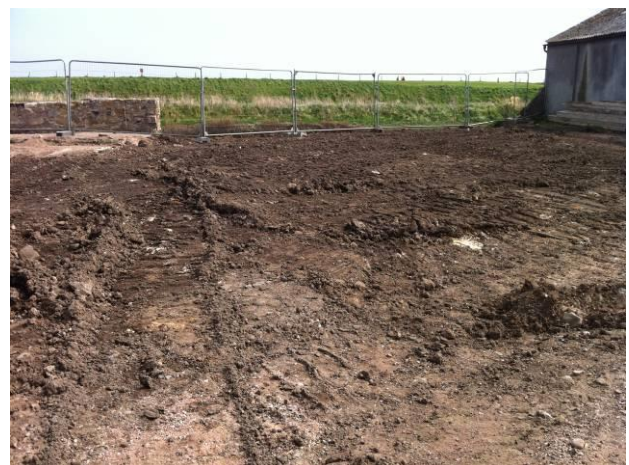
The site post remediation is shown in Figure 3. The installation of the capping layer was to be undertaken as part of the site development works (as part of the raised level requirements for flood protection).

Figure 3 – Site Post Remediation (looking east)

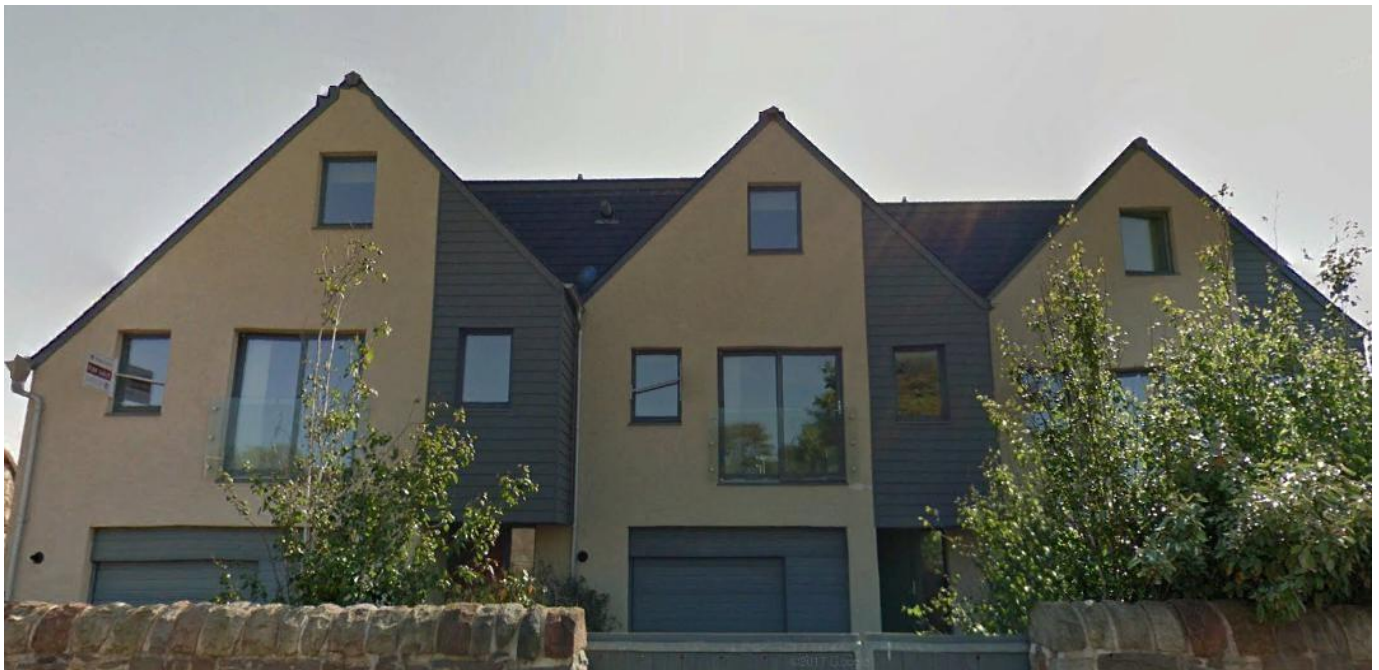
The site was subsequently redeveloped for residential use as shown in Figure 4 below.

Figure 4 – Residential Development
