Site Background

The site formed part of the historic former town gasworks and occupies an 'L' shaped area of approximately 0.35 hectares.

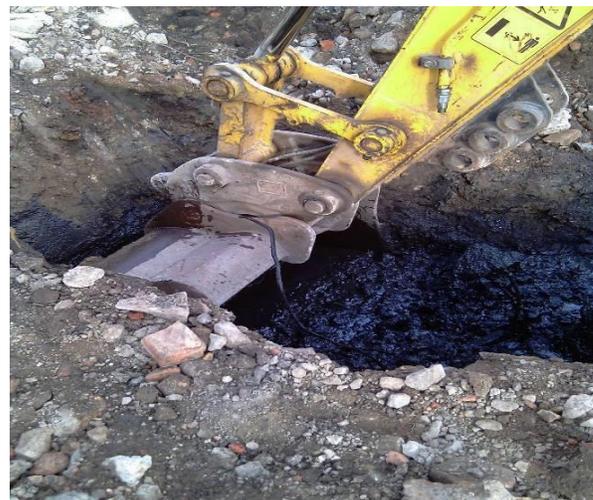
The contaminated soils associated with the former Gas Purifier were highly impacted with tarry waste. Excavations in this area were hampered by the remnants of the gas purifier structure which extended underneath the adjoining car park. This tarry contamination is shown in Figure 2 and the remains of the gas purifier are shown in Figure 3.

Figure 2 – Tarry Waste associated with the Gas Purifier

Approximately 650m³ of contaminated soils were excavated, treated and re-used on site.

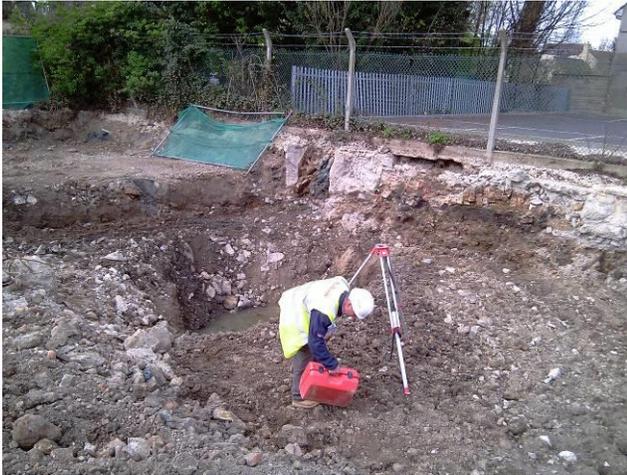
Figure 3 – Remains of Gas Purifier extending under SKDC Car Park

A low permeability cut-off wall was designed and installed along the south western boundary to address the potential risk of recontamination from the adjoining car park area.

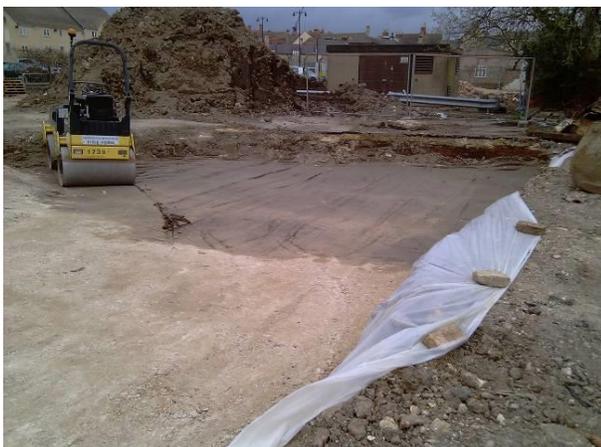
The treated soils were preferentially reused under hardstanding areas of the site (car parking and roads). The former Gas Holder was backfilled as shown in Figure 4.

Figure 4 – Backfilling of Former Gas Holder

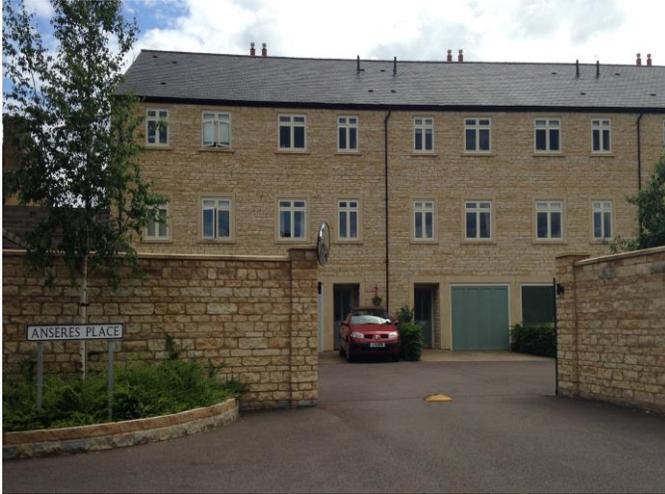
The completed housing development is shown in Figure 5 below.

Figure 5 – Housing Development
