Site Background & History

Stoke on Trent College commissioned Thomas Vale to deliver their new £10.5million Technology Hub at their Burslem College facility. The new build was completed in September 2015 – the facility focuses on construction and engineering courses.

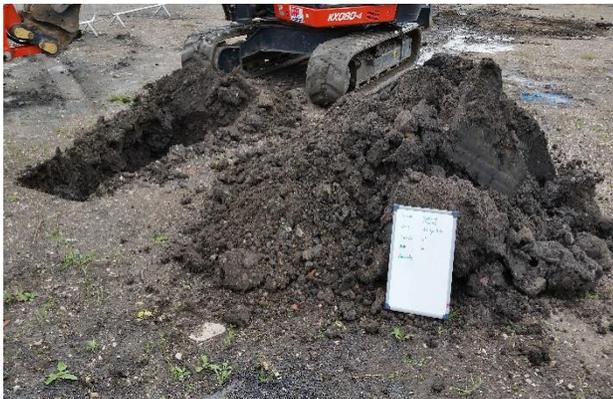
Figure 2 – Initial Investigations

Enviro-treat initially undertook a series of shallow trial pits across the site to gain a better understanding of the contamination concerns associated with the made ground. This included drilling boreholes within the existing building. The initial investigations are shown in Figure 2 below.

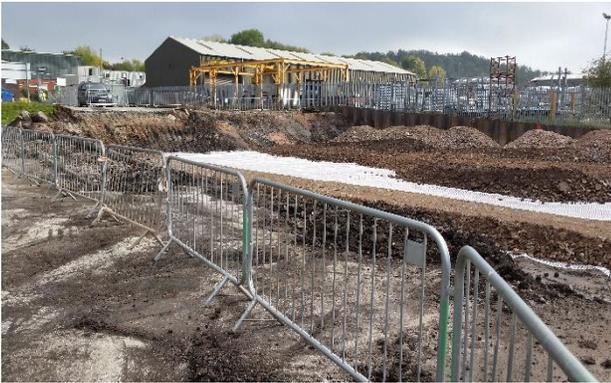
Figure 3 – Foundation Works

The foundation works and service installations are shown in Figures 3 and 4 below.

The proposed enabling works included the requirement for an extensive reduced level dig to accommodate foundations etc. Further excavations would be required for drainage runs etc. The excavated soils were effectively managed on-site by Enviro-treat through the ‘watching brief’.
