COMPLETION DATE: JANUARY 2005  
 CONSULTANT: RAW CONSULTING  
 MAIN CONTRACTOR: GEORGE WIMPEY

### Site Overview

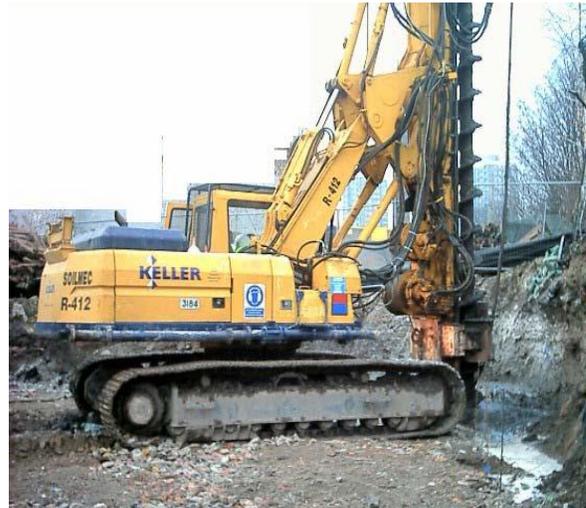
Figure 2 Barrier installation

The containment barrier was installed around the periphery of the site prior to the contaminated material on the site being excavated and replaced with clean infill material. This was undertaken prior to commencement of the major aspects of the remedial works. This ensured that contaminants which existed on adjacent areas to the site were unable to migrate onto the site. The barrier comprised of soil mixed columns containing E-clays® which were installed along the north western, western and south eastern boundaries of the site. The passive sections (interleaved between active sections) are designed to intercept and deflect some of the ground water flow around the site, whilst the active sections were designed to be permeable to allow some ground water to pass through the site, minimising the overall impact of the barrier system on the local hydraulic regime. The E-clays used in the active sections were specifically designed to chemically immobilise the contaminants of concern in the groundwater passing through the site. See figure 4 for a schematic diagram of the barrier system. The barrier was installed using conventional piling techniques incorporating advanced soil mixing technology. The barrier was up to 7m deep and about 1.5m wide.

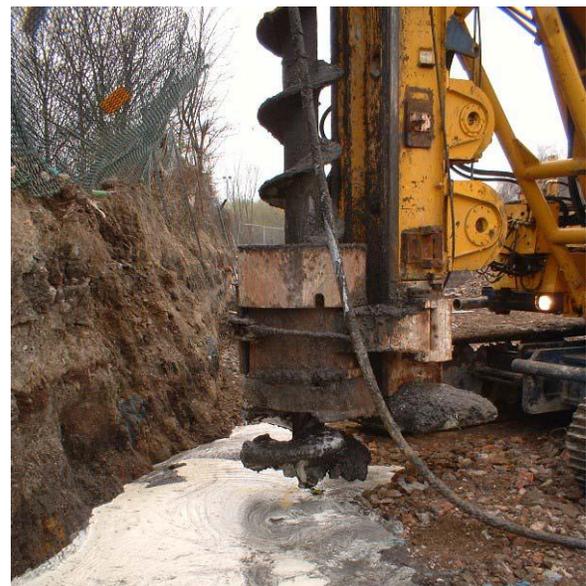
Figure 3 Piling equipment used to achieve advanced soil mixing.

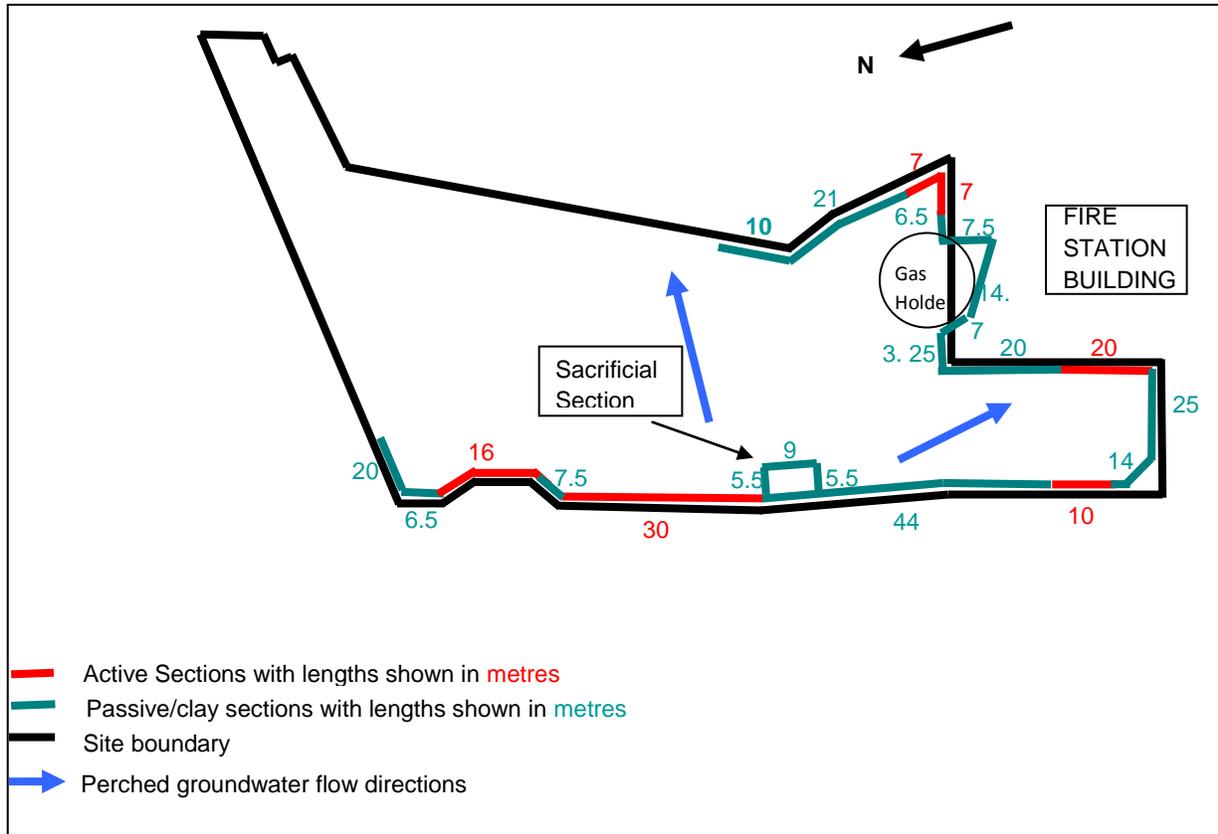
Figure 4 Schematic layout of barrier system relative to site
