### Site Background & History

The former JCB Heavy Products Manufacturing Site is located at the southern end of Uttoxeter town centre and covers an area approximately 700m long east to west by 200m north to south. The former manufacturing facility is shown in Figure 1 below [2005] and the current site prior to remediation is shown in Figure 2 below – the site was vacated by JCB in 2008 – the buildings were subsequently demolished and the site was cleared. The north-eastern area of the site was recently sold off by JCB and has subsequently been developed as a Waitrose Supermarket.

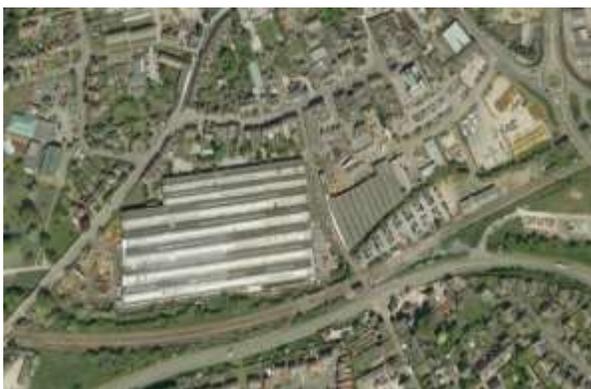
Figure 1 – Former JCB Manufacturing Site

The main manufacturing area of the site was located to the west of Pinfold Street as shown in Figure 1 above. This area of the site was previously occupied by the 'Leighton Iron Works' and a tannery.

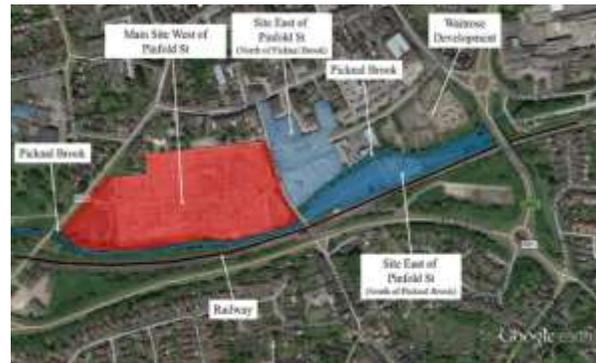
Figure 3 – Site Overview

The overall site can be split into areas as shown in Figure 3 below. The remediation works focused on the areas to the west and east of Pinfold Street (which bisects the site).

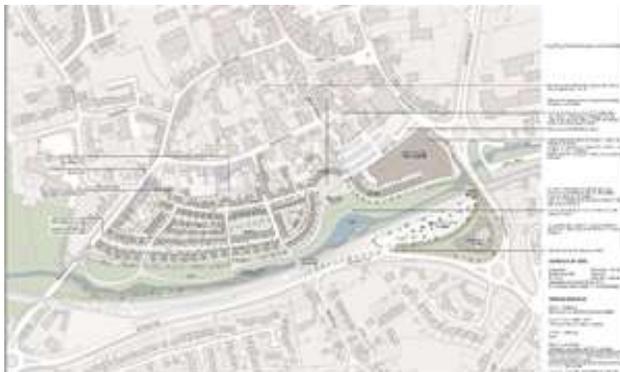
Figure 4 – Proposed Development [Bamford Park]

The proposed 'Bamford Park' development is shown in Figure 4 below – the realignment of the Picknal Brook and the design of the landscaping area and the pond is currently under review.

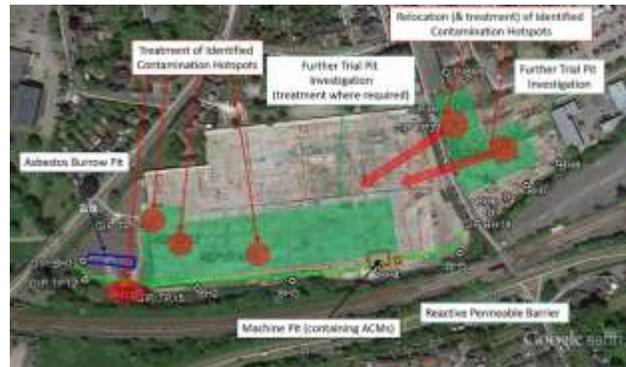
Figure 5 – Remediation Strategy

The Remediation Strategy is summarised in Figure 5 below (integrated treatment approach):

The remediation strategy comprised of the following key elements:

- Delineation and source treatment [E-Clay Stabilisation] of previously identified contamination 'hot-spot' areas on the 'Main Site' (west of Pinfold Street) – these were previously identified and assessed by GIP
- Source treatment [E-Clay Stabilisation] of contamination not previously identified – additional contaminated areas were identified during the remediation works - these areas were delineated and treated as required

- Delineation and removal of identified contamination 'hot-spots' in the identified contamination area on the site east of Pinfold Street. The contaminated soils / materials were relocated to the 'Main Site' (i.e. west of Pinfold Street) for subsequent treatment using E-Clay Stabilisation and deposition in designated areas following validation

- The installation of a PRB on the 'Main Site' (i.e. west of Pinfold Street) to address the identified potential pollution risks to controlled waters and to the Picknal Brook in particular. The PRB was installed in close proximity to the Picknal Brook

- Groundwater monitoring downstream of the PRB to confirm the efficacy of the PRB installation comprising of five equidistant boreholes installations
- Groundwater monitoring on the site east of Pinfold Street (four borehole installations) - these boreholes were utilised to monitor the levels of residual groundwater contamination following source removal undertaken in this area of the site – it was decided that there would be no requirement to install the PRB on the eastern side of the site providing that the groundwater contamination had been effectively addressed by the source removal

- Excavation of asbestos containing materials [ACM] from the machine pits followed by 'hand picking' of the ACM from the excavated materials followed by disposal at a suitably licensed facility. Treatment of residual materials by E-Clay Stabilisation and redeposition in a bespoke borrow pit outwith of the proposed residential redevelopment area

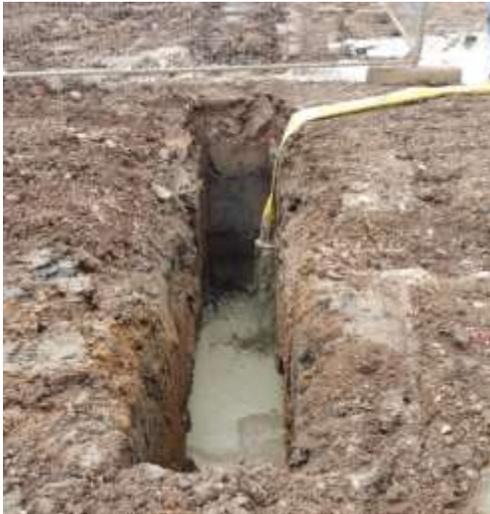
Figure 6 – PRB Installation – Addition of E-Clay Slurry

A site-specific pillared form of E-Clay was utilised for the barrier installation – the pillaring provided the necessary porosity and additional reactivity. The E-Clay was added in a slurry form.

The barrier was installed in nominal six metre long sections utilising a trenching methodology. Soils were excavated to a depth just above the groundwater depth - the excavated soils were set aside for later reinstatement. E-Clay slurry was then pumped into each open trench excavation followed by thorough mixing of the in-situ soils (sands & gravels) with the added slurry using the excavator bucket.

The PRB installation is shown in Figures 6,7 and 8 below.

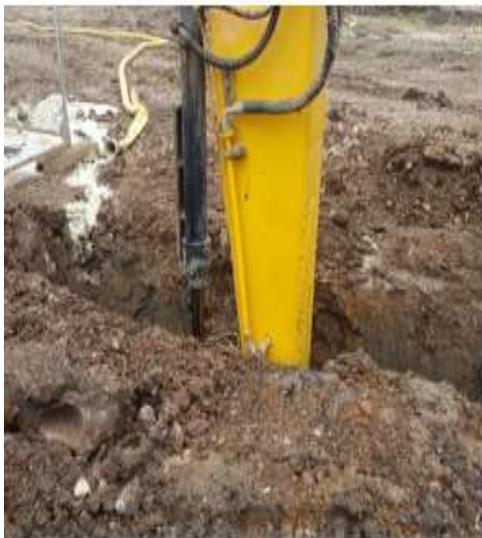
Figure 7 – PRB Installation - Soil Mixing

The mixing was extended to the required depth to key into the underlying impermeable Boulder Clay / Mercia Mudstone layer (circa 5m bgl) - the depth of the installation was confirmed by withdrawing the excavator bucket and assessing the nature of the soils on the bucket.

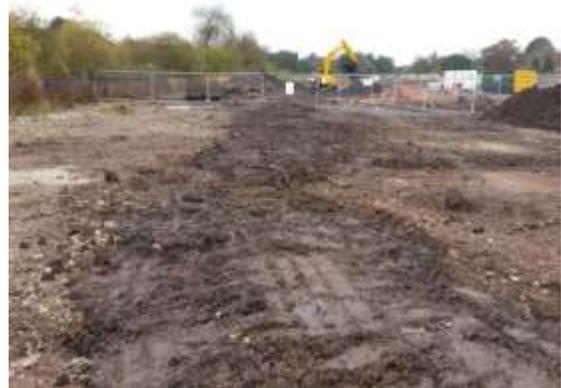
Figure 9 – Reinstated PRB Trench

On completion of each trench section the previously set aside soils were re-emplaced on top of the treated soils used to create the permeable reactive barrier. The reinstated PRB is shown in Figure 9 below.

Five boreholes were installed along the length of the barrier installation with the purpose of monitoring groundwater quality both during and after the remediation works. Monitoring was carried out on a regular basis for nine months following installation. All monitoring results were well below the agreed remediation target criteria.

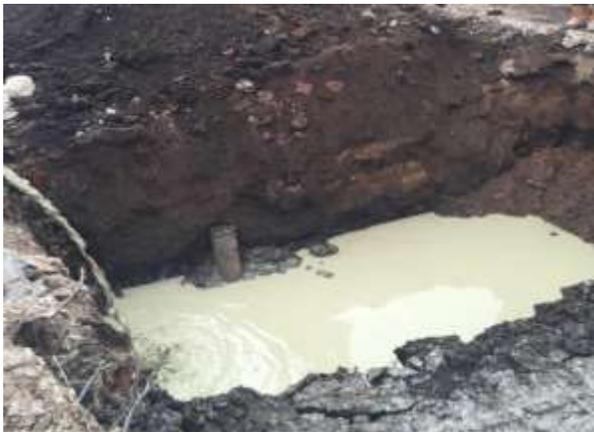
Figure 10 – Source Treatment – Addition of E-Clay Slurry

The soils were initially treated with E-Clay slurry and subsequently mixed with cementitious materials to provide the overall stabilisation process. The source treatment operation is shown in Figures 10, 11 and 12 below.

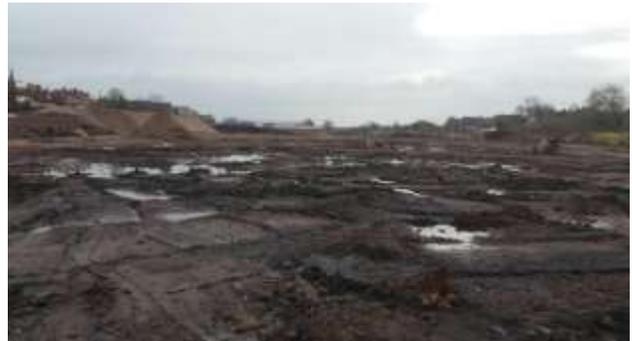
Figure 12 – ‘Main Site’ Following Source Treatment

Soils identified on the east side of Pinfold Street were removed and treated using E-Clay Stabilisation for subsequent reuse on the main site (west of Pinfold Street). In total seven hot spots areas were identified and subsequently treated. Following successful validation the treated soils were reused on the main site for infilling purposes.

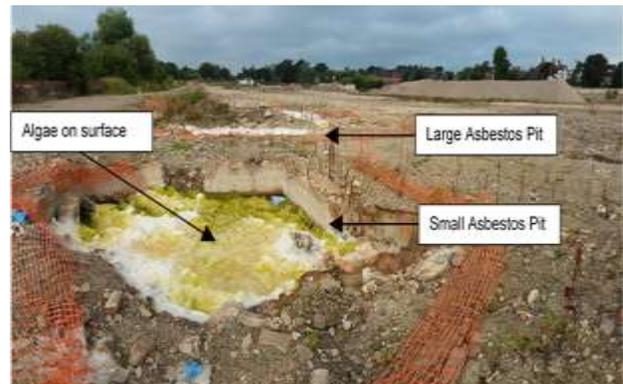
Figure 13 – Asbestos / ACM Contamination in Former Machine Pits

The former machine pits containing ACM are shown in Figure 13 below:

The demolition contractor had previously identified the presence of asbestos contaminated soils and ACM within the machine pits. The ACM contained within the machine pits comprised of cement bound sheeting fragments and insulation board (chrysotile and crocidolite forms of asbestos in the cement board sheeting and chrysotile and amosite forms of asbestos in the insulation board).

The area was therefore quarantined pending the adoption and implementation of a suitable remediation strategy to address the asbestos contaminated soils / ACM. The agreed strategy was to remove the ACM from the asbestos contaminated soils by 'hand picking' and then to remove the ACM from site for disposal at a suitably licensed facility; the residual soils would then be managed / retained on-site (subject to being acceptable for retention on-site) and deposited in a borrow pit located outwith of the proposed residential development area on the 'Main Site'.

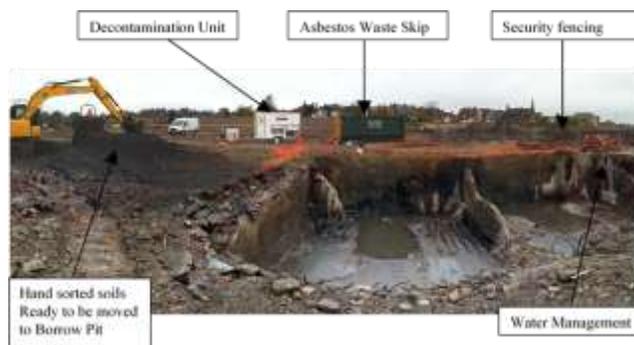
Figure 14 – Removal of Asbestos / ACM Contamination from the Machine Pits

The removal works are shown in Figure 14 below – the excavated ACM contaminated soils were stockpiled as shown for assessment / separation of visible ACM.

- excavation the contents of both machine pits
- sorting through the excavated material and hand-picking all ACM
- separating all wood, metal and soils accordingly
- physically inspecting the pits for any evidence of residual ACM
- signing off both machine pits as being 'clean' following removal
- confirmation that there was no residual ACM left on the surrounding ground

The ACM were successfully removed and disposed of at a suitable hazardous landfill facility. The remaining soils were analysed for residual asbestos fibres - all results were below the agreed <0.1% threshold enabling redeposition into the borrow pit.
