ROLTON GROUP
ENGINEERING THE FUTURE

Site Background & History

The former Pianoforte factory site is located to the south of the village of Roade in Northamptonshire.

Methodology

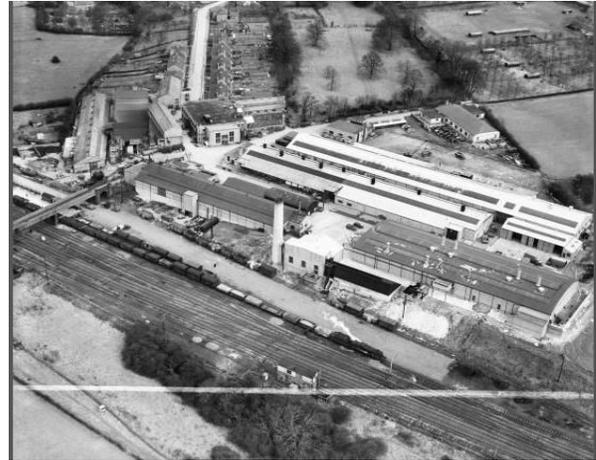
Figure 1 – Former Pianoforte site circa 1950's

The site in the 1950's is shown in Figure 1 below.

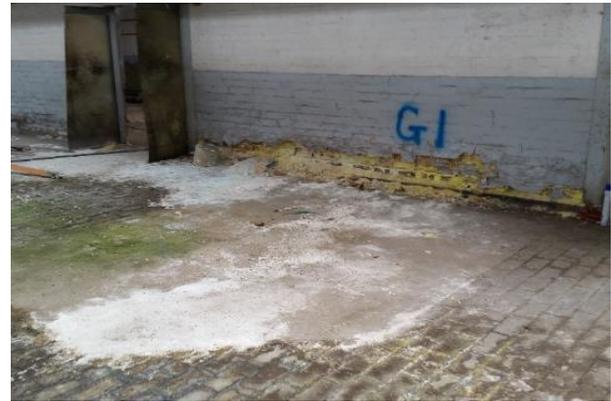
Figure 2 – Visual Evidence of Contamination Associated with former Plating Shop Activities

There was visual evidence of contamination of plating shop derived contamination (particularly Cr VI) on the plating shop floor and on the surfaces of the walls as shown in Figure 2 below.

To protect ground workers during the demolition process (undertaken by Cuddy) and to mitigate the risk of identified pollutants vertically migrating into the underlying groundwater during the demolition process (as a consequence of being exposed to rainfall) it was decided to treat the surface contamination on both the floors and the walls by applying ChromeSorb in slurry form to all the affected surfaces – see Figure 3 below. The treated surface contamination was controlled by utilising the existing floor drainage system (gullies) – this gully system terminated in a collection / reception pit where any treated slurry wash-off was collected and subsequently utilised in the treatment process – see below.

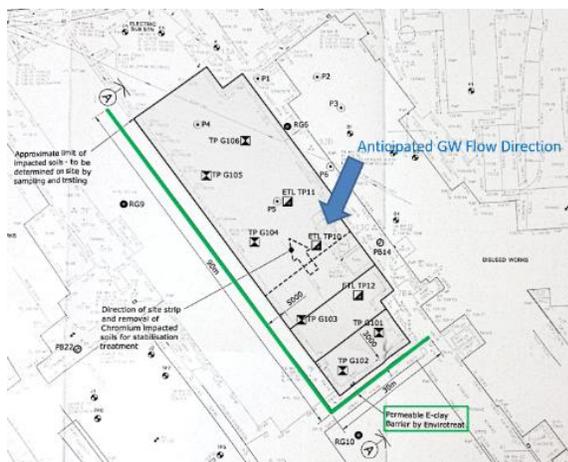
Figure 4 – Schematic Showing Alignment of the Installed PRB

The PRB was installed in December 2015 over a two-week period (along the southern and western boundaries of the Former Plating Shop Area). The PRB was installed by trenching and soil mixing techniques – the treatment medium was a highly pillared ChromeSorb formulation designed to chemically sorb and immobilise anionic Cr VI and cyanide in groundwater – the PRB installation was 100m in length and installed to the required depth to intercept migrating groundwater (toeing into the underlying Rutland Formation).

The alignment of the PRB is shown in Figure 4 below and the PRB installation is shown in Figure 5 below.

It was decided to install a permeable reactive barrier [PRB] directly downstream of the Former Plating Shop Area to address the potential risk of highly soluble and mobile Cr VI and cyanide pollutants migrating from the area in the underlying groundwater (once the plating shop structure was demolished and the associated floor slab was lifted exposing the area to potential rainfall).

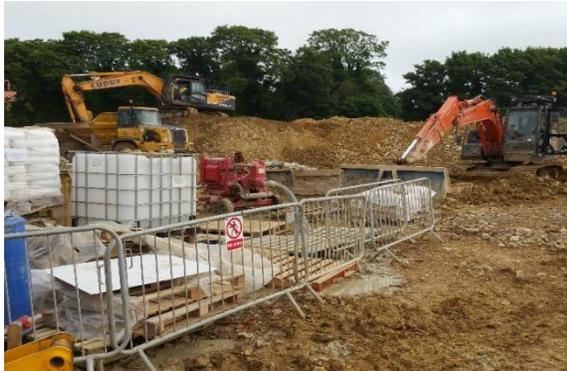
Figure 6 – *Ex-Situ* Treatment of Contaminated Soils

Enviro-treat utilised a stabilisation medium comprised of a suitable ChromeSorb formulation and cementitious materials (OPC) – the ChromeSorb formulation was designed to address the identified contamination loadings taking into account the high solubility and mobility of CrVI and cyanide.

Enviro-treat treated the contaminated materials in 10m³ batches over a seven-week period. In total 4,330m³ of contaminated materials were treated. The *ex-situ* treatment operation is shown in Figure 6 below (treatment of contaminated soils).

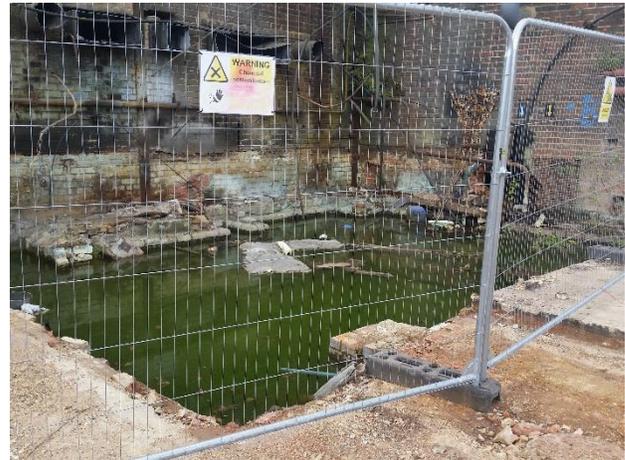
Figure 7 – Former Plating Shop Reception Pit (Contaminated Rinse Waters)

Enviro-treat were able to utilise contaminated water contained within a reception pit used to historically collect contaminated rinse water from the former plating shop (prior to treatment in the former effluent treatment plant). This water was incorporated into the treatment process and was utilised as an alternative water supply for the treatment process. Other contaminated water on the site was also incorporated into the treatment process. The reception pit is shown in Figure 7 below.
