Site Background & History

The site was formerly a petrol filling station situated in Four Oaks, Sutton Coldfield, Birmingham. The client, The Co-Operative (Coop) had previously obtained planning permission to develop the site for the construction of a new convenience store and associated parking.

Remediation Objectives

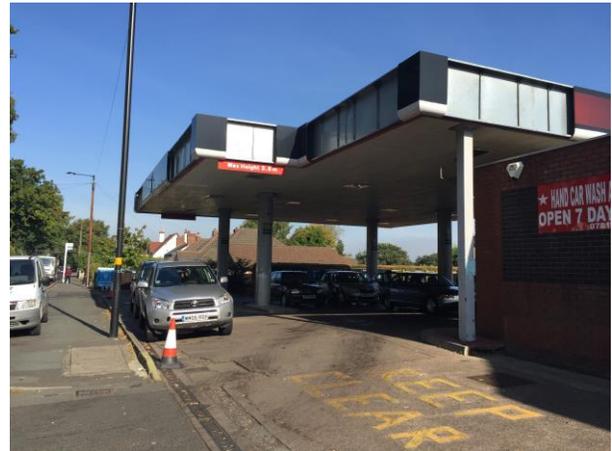
Figure 1 – Petrol Station Prior to Redevelopment

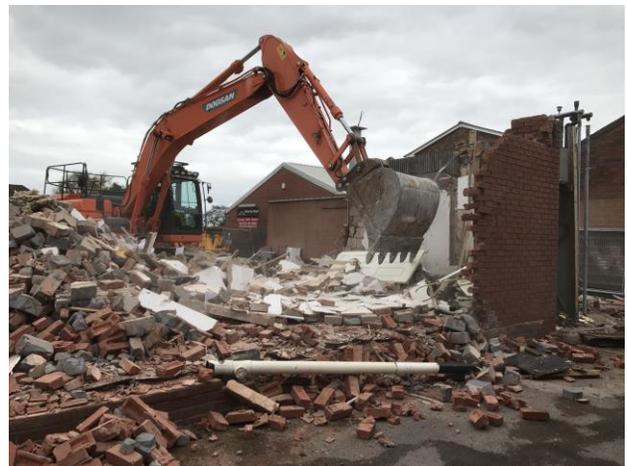
Figure 3 – Kiosk Demolition

The first phase of the works involved the demolition of the existing steel framed canopy and kiosk building together with the excavation of the concrete slabs. The demolition works were undertaken by Envirotreat.

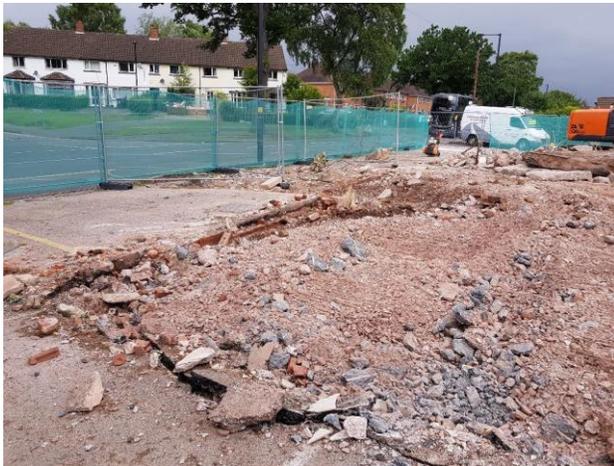
Figure 4 – Concrete Slab Removal

Once the above ground structures had been demolished and the arisings removed from site, the existing concrete slabs and foundations were broken out and removed from site. These were recycled to a further Enviro-treat remediation project to be crushed and reused there as part of the required sub-base.

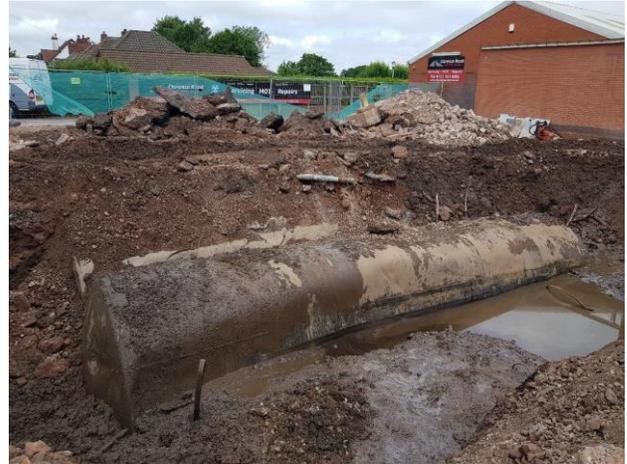
The tank excavation works are shown in figures 5 and 6 below

Figure 5 – Excavation of Underground Tanks

The underground storage tanks were then assessed and removed - this phase included the excavation of contaminated soils and subsequent validation of the excavations. The excavated soils were stockpiled pending treatment. It was necessary to carry out intensive environmental monitoring during this phase of the works due to close proximity of residential properties.

Enviro-treat pumped out the liquid tank contents (water) and incorporated into the treatment process. All the tanks were subsequently excavated, cleaned, tested and removed for offsite disposal.

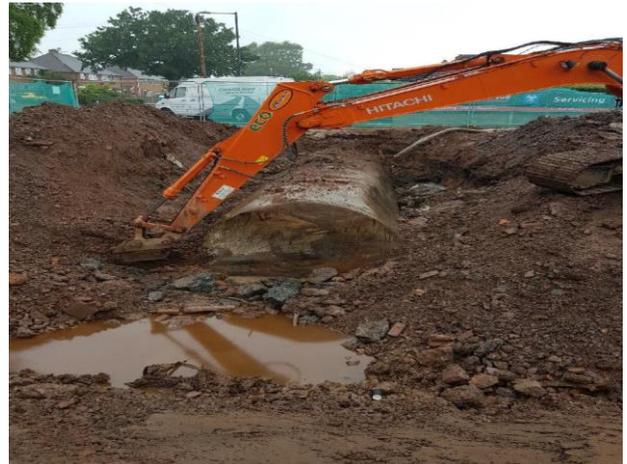
Figure 6 – Excavation of Underground Tanks

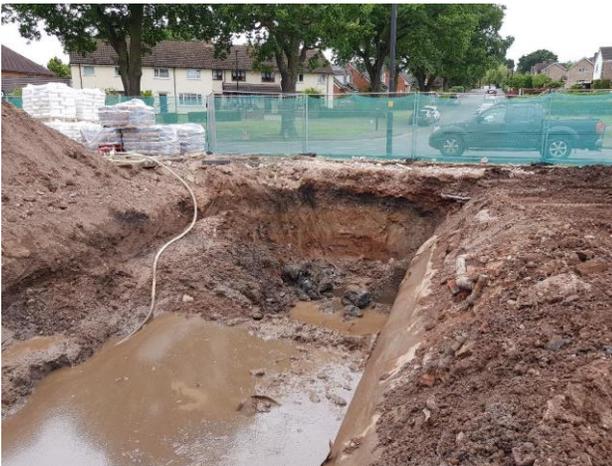
Contaminated soils and groundwater around the underground tanks were confirmed to be contaminated with fuel oils (TPH) consistent with the historical tank usages. These soils (and groundwater) were treated by E-Clay stabilisation. The soils remaining in the void from the tank excavation is shown in figure 7 below.

Figure 7 – Contaminated Soils Remaining in the Excavated Tank Void

Once complete, representative samples were collected from the stabilised soils for validation purposes.

Treated soils were backfilled into the excavations in layers and rolled.

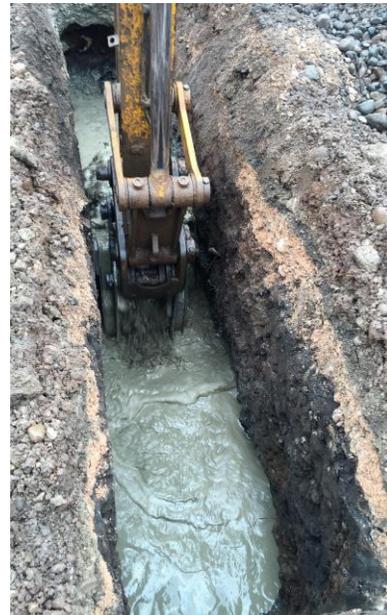
The installation of the permeable reactive barrier is shown in Figure 8 below.

Figure 8 – PRB installation (trench excavation)

The permeable reactive barrier was installed along the eastern and northern site boundaries to intercept and treat the natural flow of any residual contaminated groundwater migrating from the site toward the Mill Pond. The barrier was installed using a trenching technique – the soils were mixed with a slurry of the designated pillared E-Clay to produce the Permeable Reactive Barrier. The barrier was installed to a depth of approximately 4m to toe into the impermeable underlying strata.

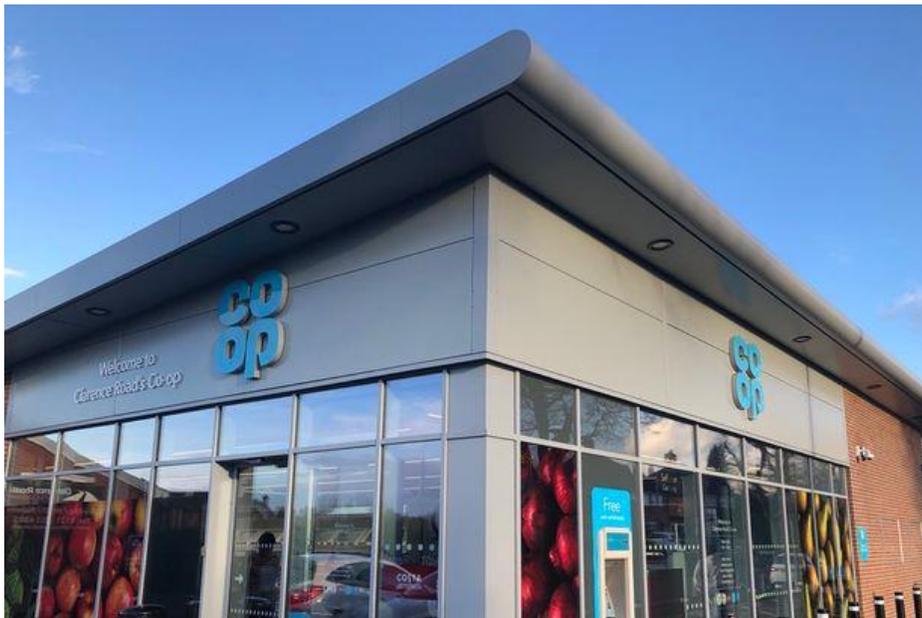
The Validation Report was approved by the NHBC, Birmingham City Council and the Environment Agency. The relevant planning conditions relating to contamination issues were discharged enabling the development to proceed. The completed development is shown in figure 9 below.

Figure 9 – The Completed Development
