Site Background & History

**Stabilisation of Dredged Harbour Sediments
Reuse as Restoration Material**

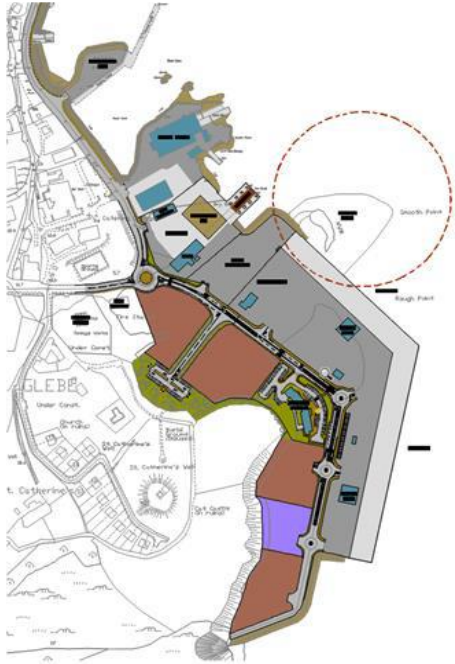
Figure 2 – Location of Dredging Works

The capital dredging works were undertaken under the auspices of DAFM at Smooth Point – the dredging was undertaken to facilitate harbour quay improvements. The location of the dredging works is shown in Figure 2 below.

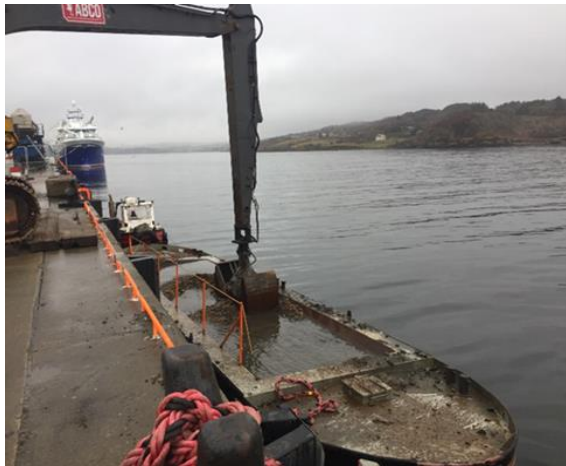
Figure 3 – Offloading of Dredged Sediment

The material was then offloaded from the barges using a sealed environmental bucket as shown in Figure 3 below.

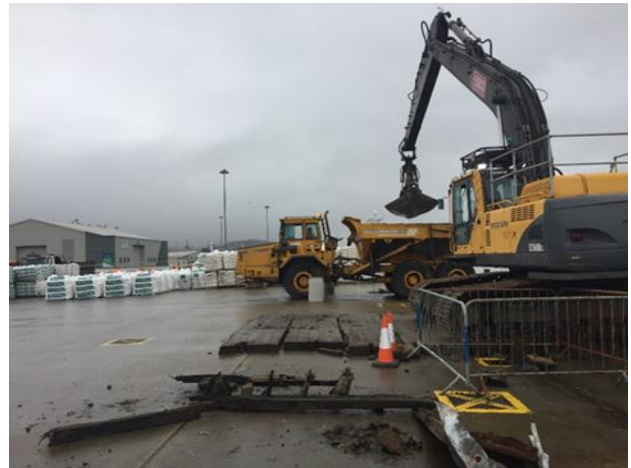
Figure 4 – Loading of Dredged Sediments

Dredged material was then placed in 25 tonne dump trucks at the quay side – see Figure 4 below. The material was then transported from the quay in the dumper trucks to the dredge storage area within the treatment site. A road sweeper was utilised to clean the surfaces between the quay and the treatment site.

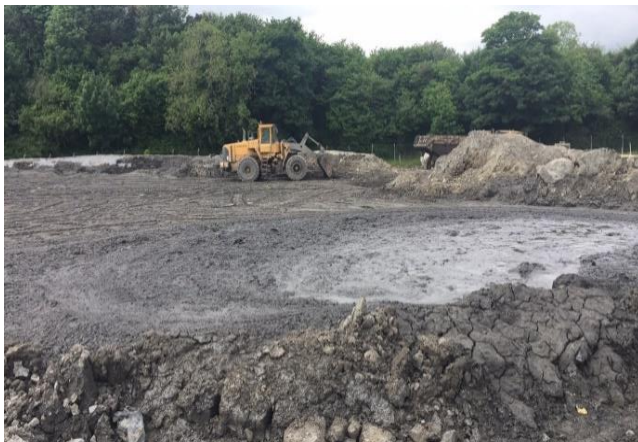
Figure 6 – Formation of Treatment Area

The formation of the treatment area is shown in Figure 6 below. The necessary protection to the environment was provided by the installation of polythene lining on the base of the area and on the perimeter bund as shown in Figure 7 below. The completed treatment area is shown in Figure 8 below.

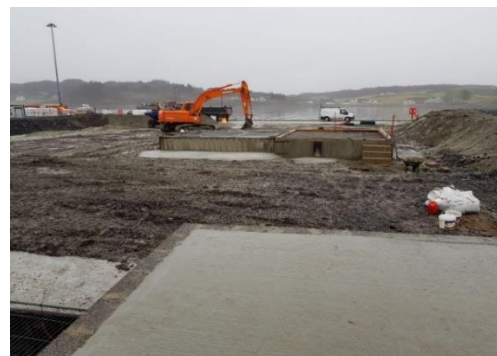
Figure 9 – Construction of Mixing Units

Two treatment platforms were constructed in the centre of the site. Mixing units were installed to mix the purpose designed E-clay formulation in slurry form with the dredged material and to physically stabilise the treated dredge material with cementitious materials as shown in Figure 9 below. A curing area was prepared (incorporating a truck loading area) - the curing area was designed to hold the treated dredge material whilst awaiting laboratory analysis confirming the success of the treatment process / compliance with target requirements. A loading area was constructed to load chemically and physically stabilised dredge material into trucks for transport to the designated repository site (for reuse as restoration material). A water collection sump was installed to collect run-off – this was removed from site as required.

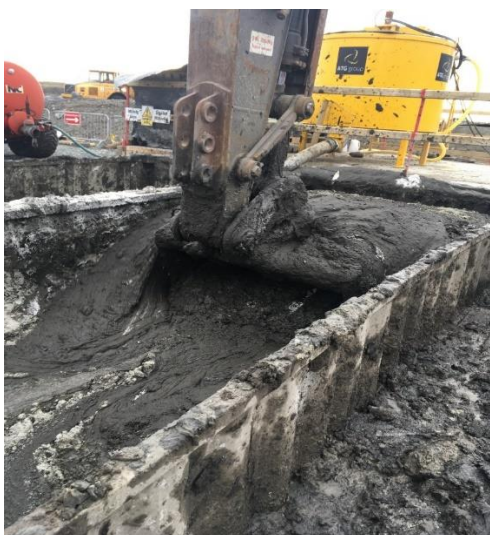
Figure 10 – Mixing [Treatment] Process

The E-Clay technology was utilised in combination with a cementitious binder to provide the physical stabilisation element. The treatment of the contaminated sediments was undertaken in the mixing units utilising a predetermined volume and concentration of treatment slurry (comprising of the designated E-Clay formulation produced on-site in the grout mixer) – the treatment slurry was pumped to the mixing units as required. The treatment process involved mixing the sediments with the slurry and cementitious materials (added in dry form) to produce a homogenous treated mass using an excavator bucket as shown in Figures 10 and 11 below.

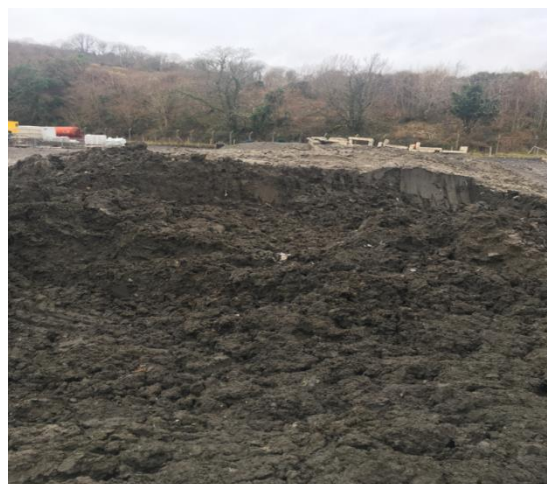
Figure 12 – Treated / Cured Sediments

The treated dredged material was removed from the mixing units and stored in the curing area awaiting off-site disposal as shown in Figure 12 below. A sample of the treated material was retrieved each day and sent for laboratory analysis at a UKAS accredited laboratory for TBT/DBT leachate analysis. As there is no actual regulatory leachate value for TBT/DBT, AAA implemented a highly conservative remedial target threshold of 200ng/l (0.2 ug/l) based on previous project requirements – this target requirement was agreed with Donegal County Council. Samples were also obtained for WAC analysis to ensure compliance with the acceptance requirements of the repository.

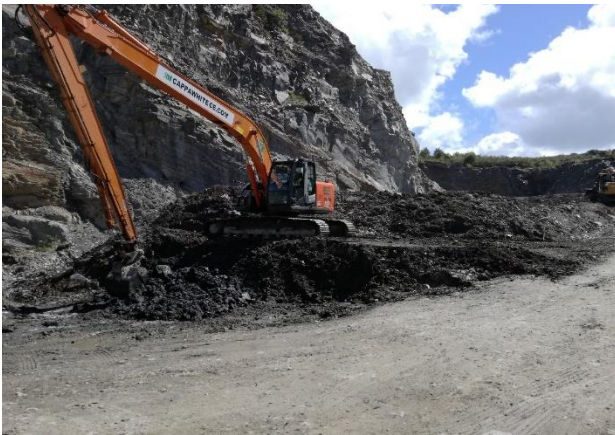
Figure 13 – Reuse of Treated Material for Restoration Purposes (Licensed Quarry Site)

On completion of the curing and validation process the treated material was loaded onto lorries and transported to a local licensed disposal site for infilling / restoration purposes. All lorries were wheel washed prior to leaving the treatment site and the road was regularly washed to ensure that muds and sediments did not pollute the surrounding environment.

The use of the treated material for restoration purposes is shown in Figure 13 below.
