Stagecoach

THE HUB™
THE TREATMENT HUB

Site Background & History

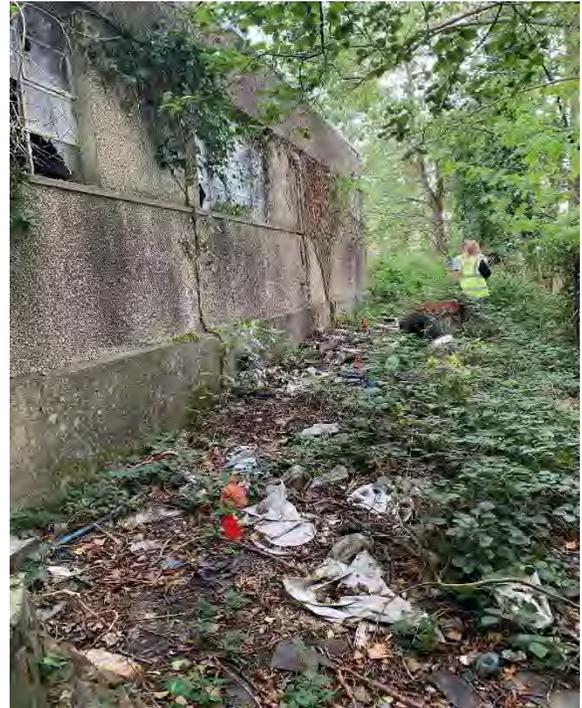
Figure 1 – Heating Oil Impacted Area

An accidental release of heating oil occurred in the west of the site immediately adjacent to the bank of the Afon Rhondda Fach in early 2019. The spillage incident was attributed to the overflowing of two internal heating oil / kerosene above ground bulk storage tanks (ASTs), situated in a single-storey part of the building adjacent to the Afon Rhondda Fach riverbank. The heating oil overtopped the ASTs and flowed onto the building's flat roof. The heating oil subsequently migrated down the vertical rainwater pipes and impacted the shallow soils at the base of the rainwater pipe outlet and then migrated through the shallow soils / surface drainage into the Afon Rhondda Fach.

The area impacted by the oil spillage is shown in Figure 1 below.

The findings from the investigation support the theory that heating oil appears to have migrated down the surface water downpipes to impact the soils within the river bank. Heating oil has likely further migrated through the porous soils and potentially along a concrete slab structure in a rapid pathway to impact the river. The only discreet preferential pathway observed was the clay pipe outlet, present in the river bank, though the majority of kerosene entering the river was observed to emanate from the soils over a length of approximately 6 to 8 metres.

A local oil spill response contractor was engaged immediately following the incident to carry out the requisite triage and to protect the adjacent river from any ongoing contamination impact. A series of trial pits were also excavated to provide an understanding and extent of the impacted area and any impacts to the River.

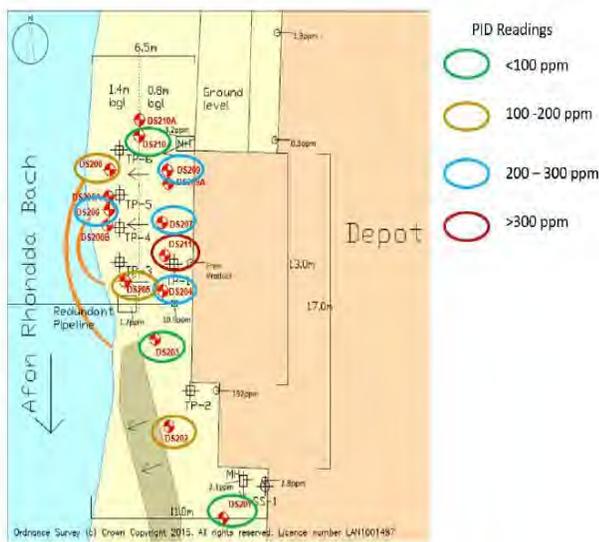
Figure 2 – BH/TP Locations

Delta Simons subsequently carried out a more detailed investigation of the area through the installation of 10 no boreholes and 15 no hand dug trial pits. The locations of the exploratory boreholes are as shown in Figure 2 below.

Free phase product was identified in three of the boreholes and TPH concentrations were identified at concentrations between 5,000 and 11,000 mg/kg immediately adjacent to the AST storage building.

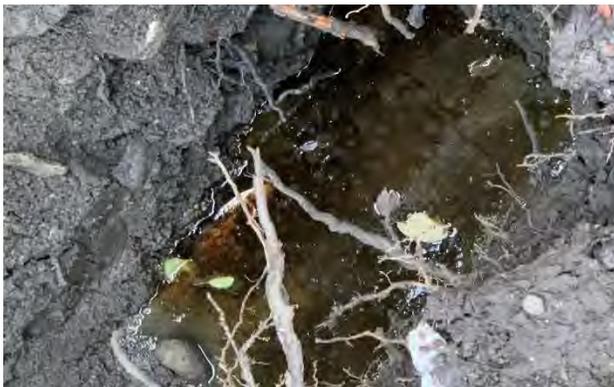
Figure 4 – Thin Layer of Free Product

Three slit trenches were excavated immediately adjacent to the AST building to enable the removal of any free phase product (LNAPL) present on the surface of the perched groundwater. Excavation of the trenches revealed only a very thin layer of product on the water surface. This is shown in Figure 4 below.

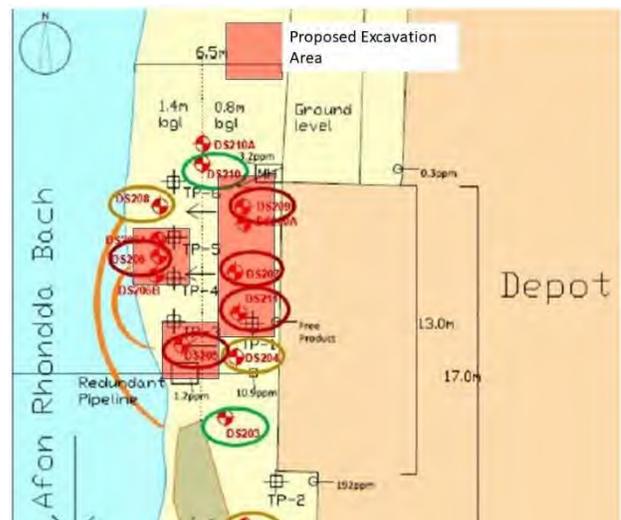
Figure 6 – Location of Grossly Impacted Soils

The grossly impacted soils were excavated as per the schematic plan shown in Figure 6 below.
