Figure 1 – New Cardiff Arena

Site Background & History

The site is referred to as Atlantic Wharf (located in Cardiff Bay) and the proposed development is the new Cardiff Arena, the associated hotel and necessary infrastructure. The proposed arena is shown in Figure 1.

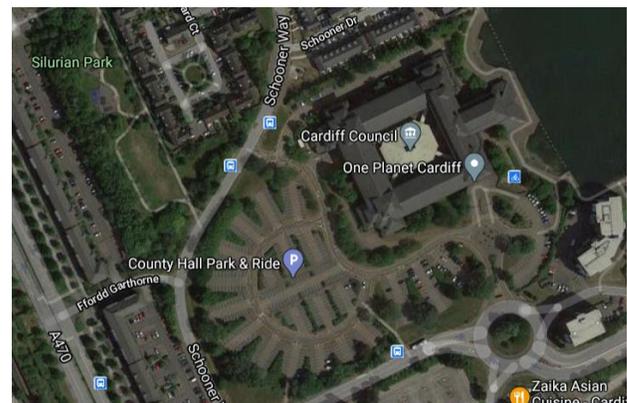
Figure 2 – Site Overview

The site overview is shown in Figure 2 below.

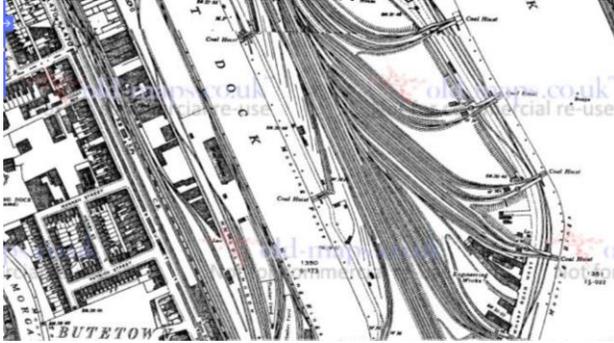
Figure 3 – Historic Mapping of Bute West Dock

A desk study was provided for the site. This study identified further potential ground hazards. These included the risk from UXO (unexploded ordnance) and radiological contamination from a historic gamma and X-ray laboratory. The historical mapping of Bute Dock is shown in Figure 3 below.

Ground conditions in this part of Cardiff Bay are known to be variable and challenging. The site is underlain by numerous infilled features, including the former Bute West Dock and timber ponds. Previous development in the area had uncovered highly variable and deep fill material generated through poorly controlled filling. The geological sequence is also complex, with very soft, organic Tidal Flat Deposits, deep cobbly granular soils overlying variable weathered Mercia Mudstone.

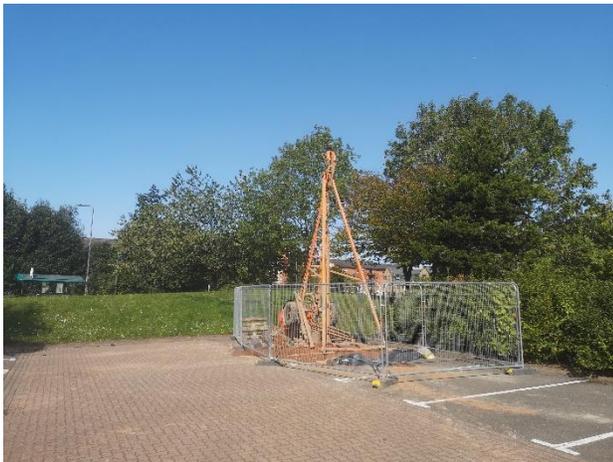
Figure 4 – Cable Percussion Set-Up

Drilling commenced using 10" casing with stainless steel lead length. Environmental bentonite seals were installed at the base of the Made Ground in each location.

The boreholes were then progressed using 8" casing until either the deep granular strata or bedrock was reached. Finally, the target depth was achieved in 6" casing. By starting with 10" casing, the drillers had the option to reduce casing size again at depth (if required) to control groundwater or to penetrate dense granular soils.

The cable percussion set-up is shown in Figure 4 below.

In-situ magnetometer UXO clearance was undertaken in the Made Ground and soft cohesive soils at each location. The provision of stainless-steel lead casing meant that the casing did not have to be adjusted to ensure no interference with the magnetometer.

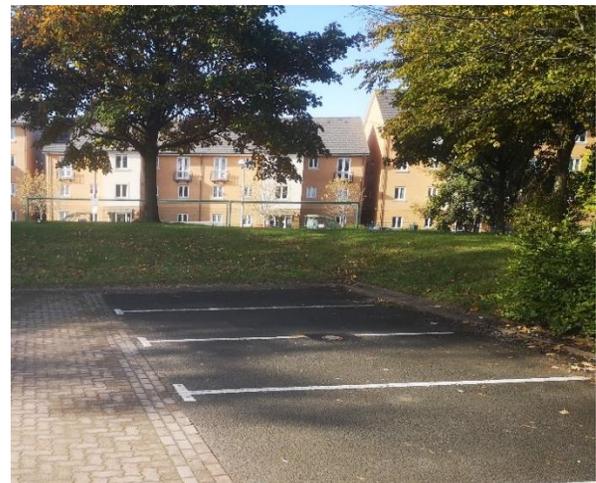
Figure 5 – Fully Reinstated and Washed Down Borehole Location

In the first phase, where there was no rotary drilling, boreholes were either backfilled with bentonite or monitoring wells were installed. Nested wells were installed in some locations. Headworks were set in tarmac and washed down. In the second phase, rotary casing was installed before the cable casing was removed. This allowed the rotary rigs to move and set up on available positions.

A fully reinstated and washed down borehole location from Phase 1 is shown in Figure 5 below.

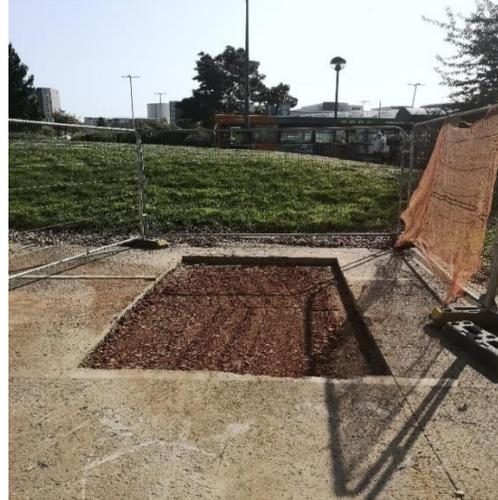
Figure 6 – Cut Out Trial Pit Awaiting Excavation

The outlines of the trial pits were cut out to provide a neat outline. Trial pits were then reinstated with arisings, plus additional compacted subbase materials. Hot-rolled tarmac was used to replace the pre-existing surfacing, with edges sealed with bitumen. White lines were re-painted, and the area cleaned down with a jet wash unit.

A cut-out trial pit is shown in Figure 6 below and the rotary borehole drilling set-up is shown in Figure 7 below. The trial pits were reinstated as shown in Figure 8 below.

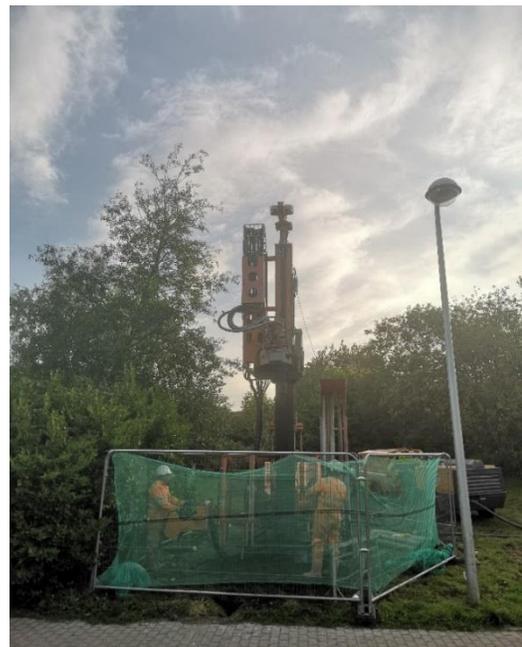
Figure 7 – Rotary Drilling Set-Up

Once suitable rock head was reached with the cable percussion rigs, rotary casing was installed ready to continue. A combination of water-air and air/water-flush drilling was used to maximise recovery of the extremely weak mudstone bedrock.

SPTs were completed every 1.5m, with rock core recovered in between. Rock core was placed into boxes, logged and subsampled as required.

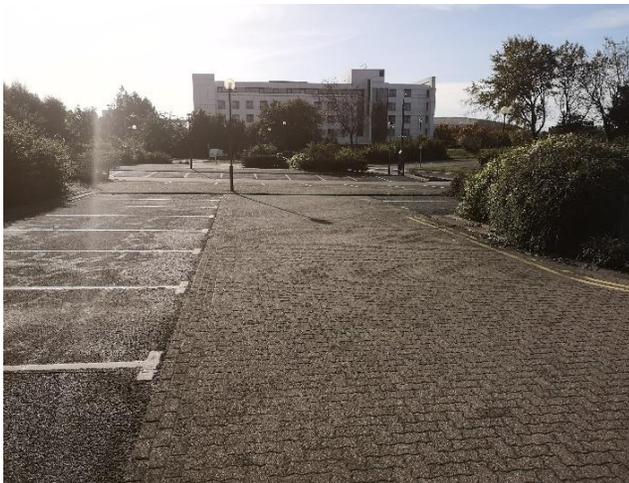
Figure 9 – Site Compound and Waste Storage Area
(Prior to Departure)

All work areas were cleaned down using a jet wash. The area used for the site compound and the waste storage area is shown in Figure 9 below (prior to departure).
