### Site Background & History

The site comprises of an approximately rectangular parcel of land 70m by 100m situated in the rural village of Stoke Ferry in Norfolk.

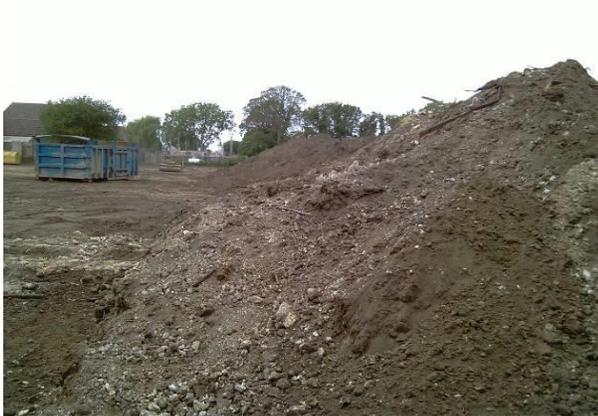
Chalcroft commissioned the bulk removal of the soil stockpiles to a dedicated landfill disposal site. The contaminated surface materials were then excavated across the whole site to a maximum depth of 300mm – the actual depth in each excavation was determined by visual observation / confirmation that all ACM had been effectively removed. The excavated materials were stockpiled pending treatment as shown in Figure 2.

Figure 2 – Stockpiled Soils Pending Treatment

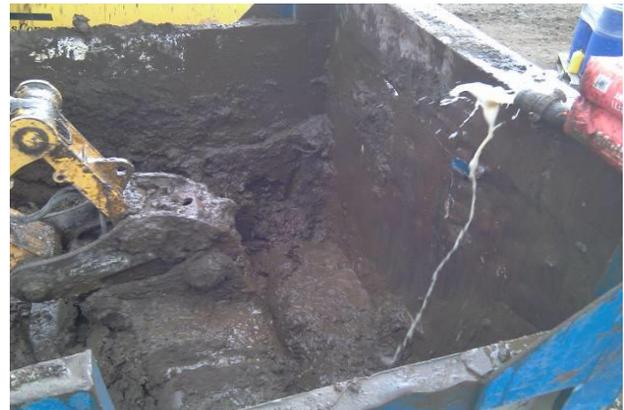
The treatment process was carried out utilising conventional *ex-situ* processing equipment. 10m<sup>3</sup> batches of ACM / contaminated soils were placed in a mixing bin (see Figure 3) – a designated volume of a combined E-Clay / additive slurry was added followed by the addition of cement in dry form. The ACM / soils were then mixed with the treatment materials to produce a homogeneous mass. Representative samples were taken throughout the treatment process – composite samples were produced for validation purposes – these samples were submitted to an independent laboratory for analysis. On successful validation, the treated soils were emplaced in a previously excavated pit and compacted in layers to ensure that the material was monolithic and posed no risks to human health (see Figure 4).

Figure 3 – Treating Stockpiled ACM / Contaminated Soils

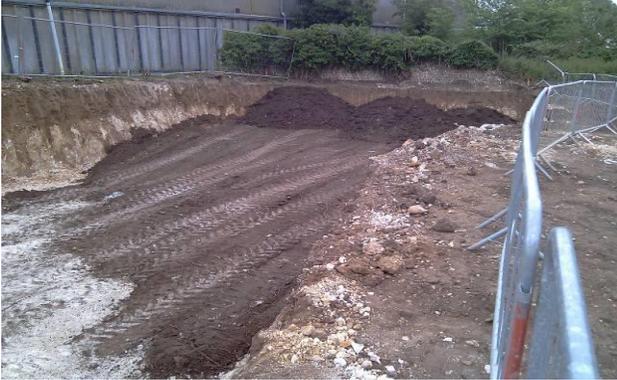
Figure 4 – Emplacing Treated Soils

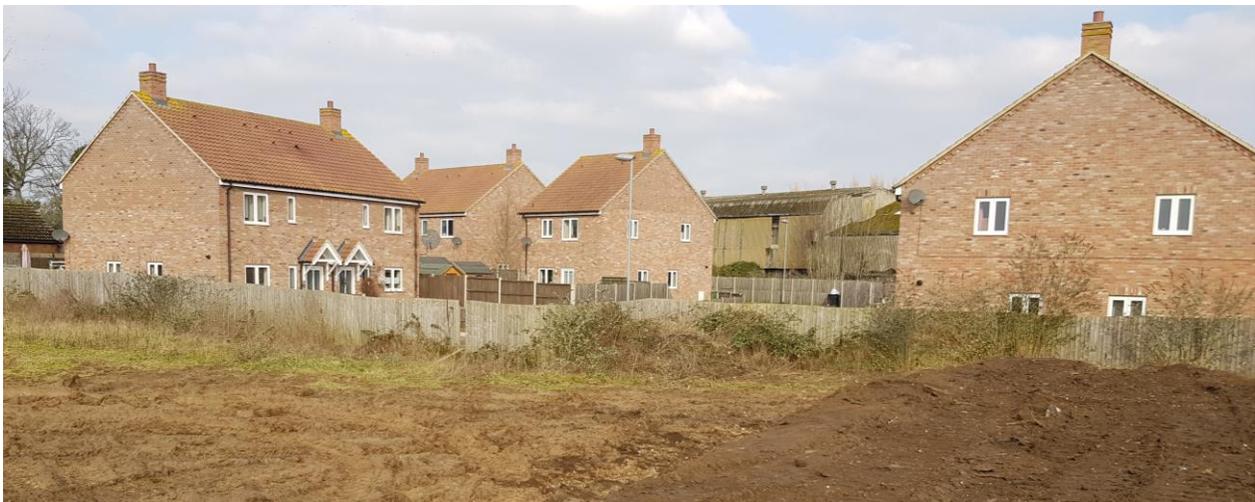
Figure 5 – Proposed and Actual Development.
