**Figure 1** – Flood Defence Embankment on Dutch River

**Client:** Environment Agency

**Consultants:** White Young Green

This project related to the effective maintenance of a section of the Dutch River Flood Defence System near Goole. The Dutch River is a re-engineered section of the River Don between the River Went and River Ouse. The Dutch River has a significant tidal influence.

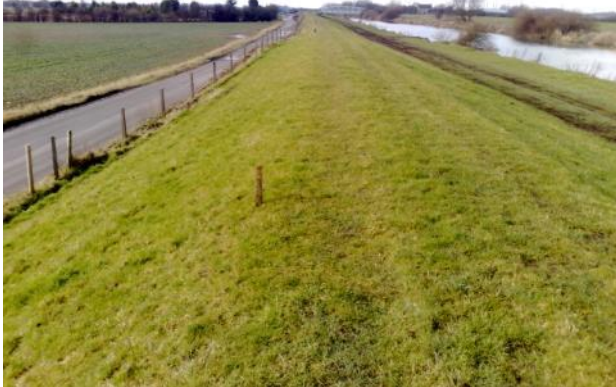
Seepage was occurring along an extended length of the embankment section requiring improvement. This seepage was clearly visible in a section supported by a retaining wall and in adjoining fields, where ponding was observed.
