Site Background & History

The site is located at 200, Cambuslang Road in Rutherglen, Glasgow. The site historically comprised of a laundry facility (including dry cleaning capabilities), a lorry yard and a timber treatment facility. The historical site is shown in Figure 1 below.

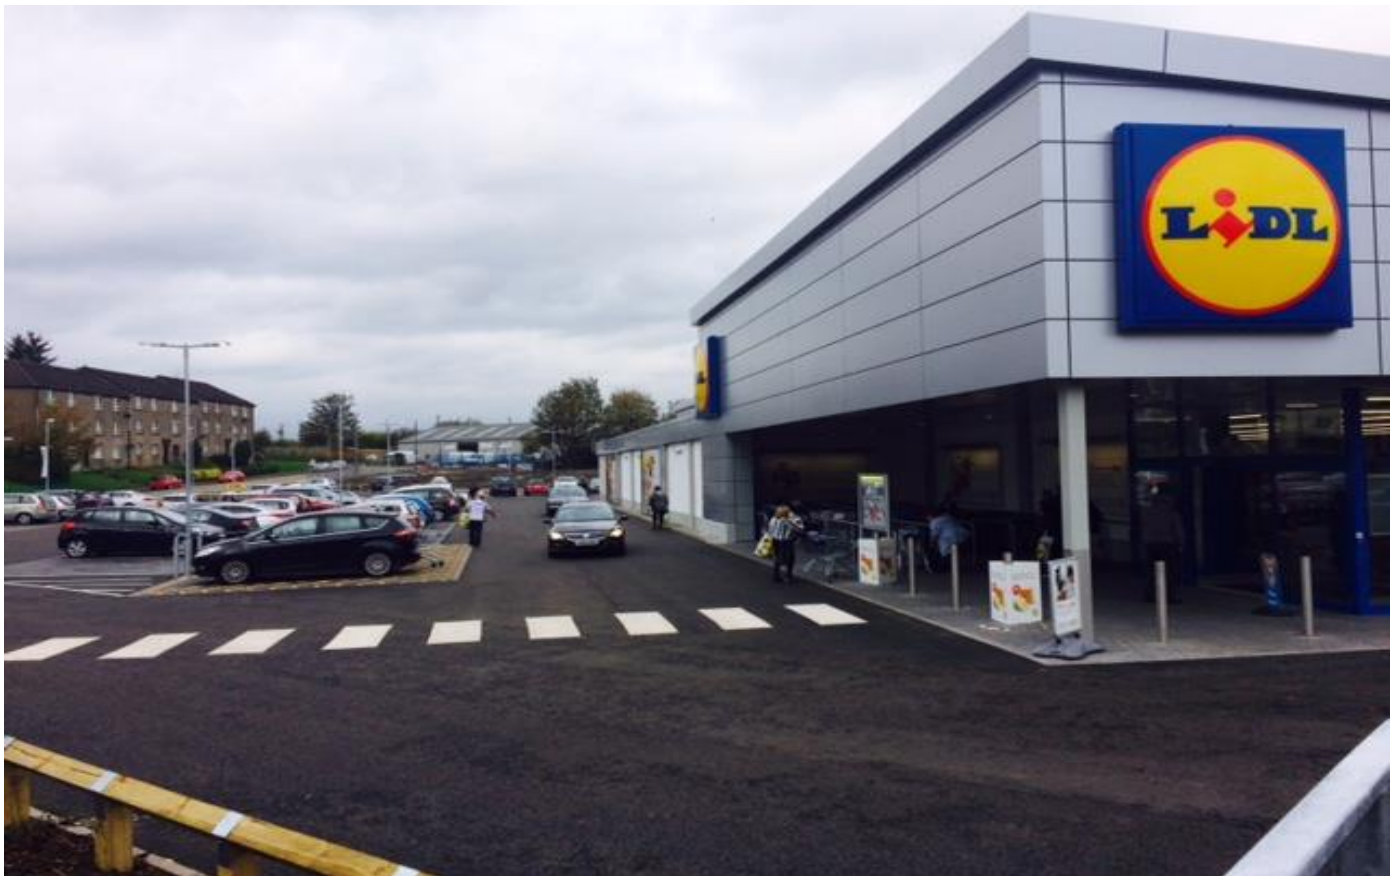
Figure 7 – Completed Lidl Store

The necessary approvals were obtained from South Lanarkshire Council and SEPA to enable the Lidl retail store to be developed. The completed retail store is shown in Figure 7 below.
