### Site Background & History

The site is located at Yarmouth on the Isle of Wight and is currently used as a boatyard. The site borders onto the River Yar Estuary and occupies 0.64 hectares. The high tide line bounds the site to the north and east. The Freshwater Gas Company was established on the site in 1899. The Gas Works was expanded in the 1940's with the addition of two further gas holders. It is believed that the gasworks closed in the 1960's.

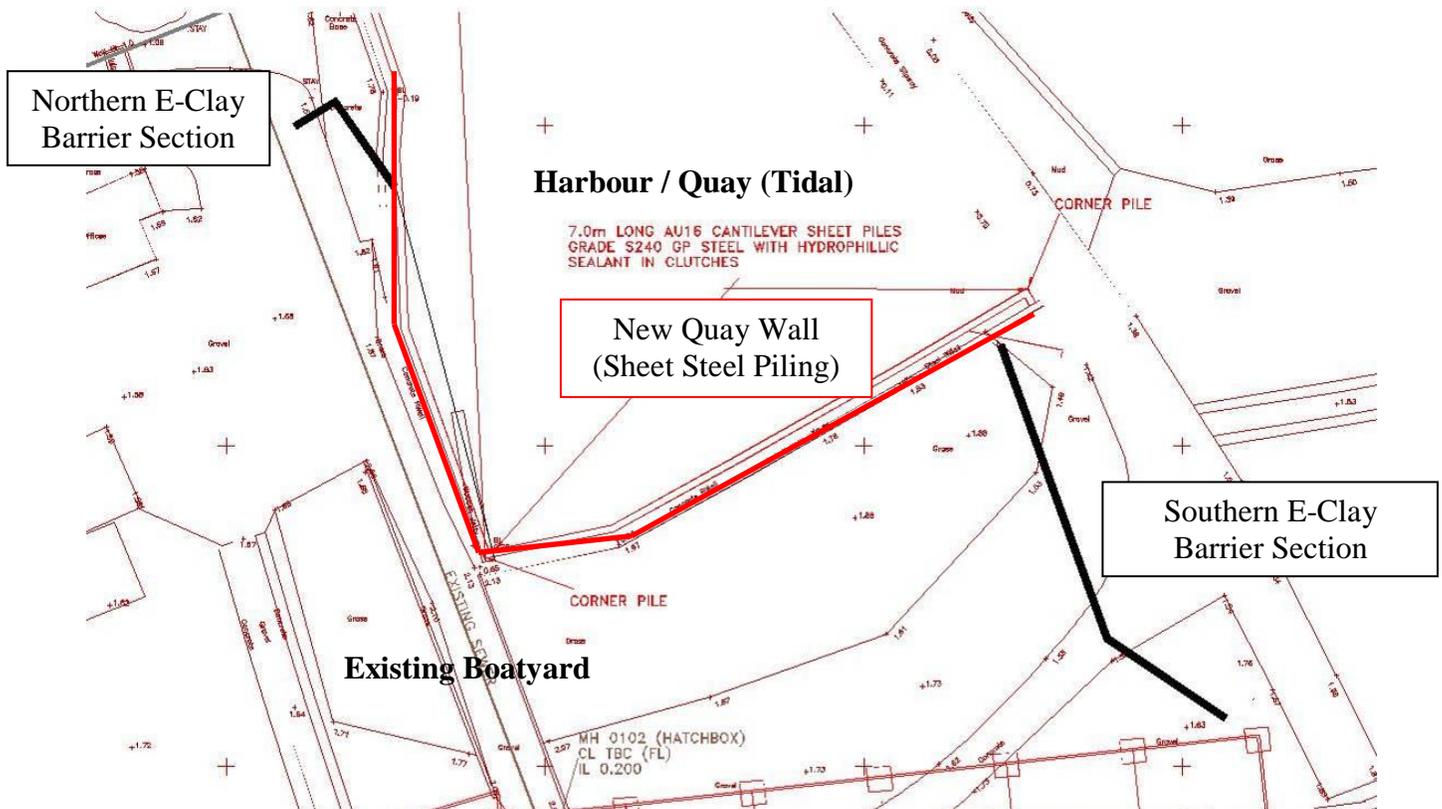
The barrier system was designed by Envirotreat including ConSim modelling, hydraulic gradient / directional flow determination and contaminant flux calculations. The final positioning of the two permeable reactive barrier wings (and the barrier scheme as a whole incorporating the sheet steel piled wall) is shown in Figure 5.

Figure 5 – Schematic Showing Barrier System (Low Permeability Section Shown in Red Colouration and Permeable Reactive ‘Wing’ Sections in Black Colouration)

**“Barrier System”** – this was the preferred option as the impact on the local environment and groundwater regime was considered to be minimal. The proposed barrier system was designed to incorporate the recently installed sheet steel piling ‘wall’ - it was considered that the newly installed wall would effectively restore the groundwater regime to the former hydrogeological flow pattern (as previously exhibited by the former quay wall when integral). However there was a clear risk of migrating contaminated groundwater ‘backing up’ behind the impermeable wall ultimately resulting in lateral flow around the wall and / or overtopping. It was therefore considered necessary to incorporate E-Clay permeable reactive barrier ‘wing’ sections at the southern and northern ends of the wall.
