Development: Residential Development

Developer: Persimmon Homes

Main Contractor: Envirotreat Limited

Site Overview

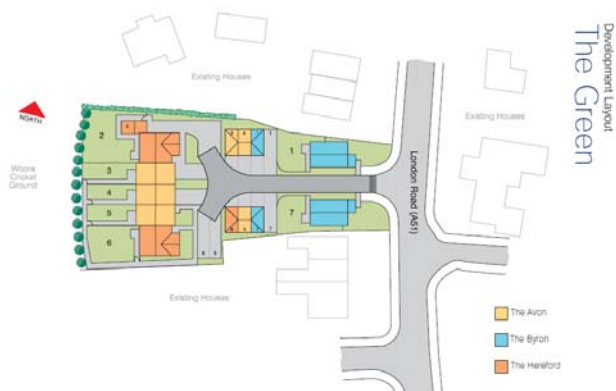
Plate 1 - The housing development at the site (Persimmon 2005)

Ultimately, the site was to be developed into a housing estate (Plate 1.) comprising of a mixture of two storey houses with associated gardens, landscaping, car parking and an access road.

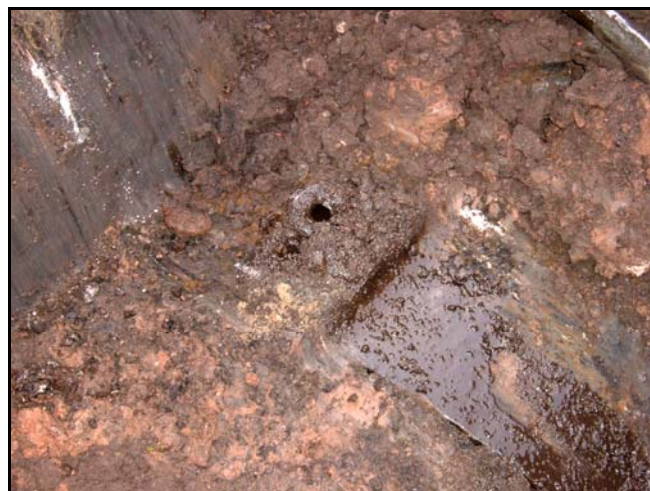
The intrusive investigations revealed the main contamination source to be an area previously occupied by underground storage tanks where elevated concentrations of Total Petroleum Hydrocarbon (TPH) and BTEX were identified.

Plate 2 - Contaminated soils with free phase hydrocarbon – typical of the contamination throughout the site.

The remediation strategy for the site was designed to address the on-site source contamination (Figure 2.) and indirectly, the pathway contamination issues with the intention of protecting the end user and the locally important underlying aquifer located in sands and gravels beneath the site.

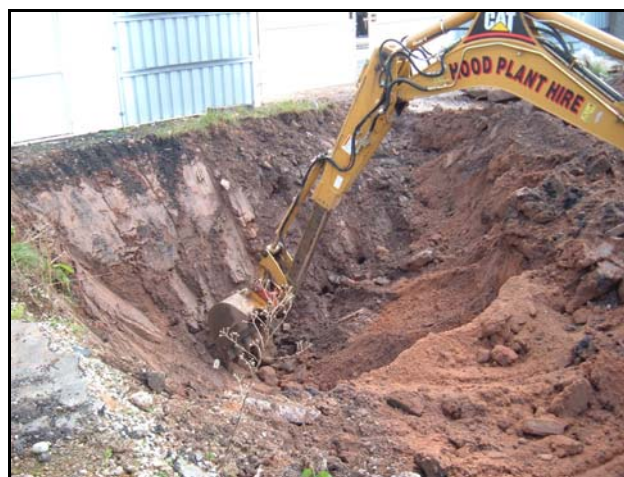
Plate 3 - Excavation of contaminated soils.

The identified contamination was excavated (Plate 3.), stockpiled and treated on-site using the Envirotreat E-clay® technology. The treatment operation utilised a slurry production unit with a mixing zone.

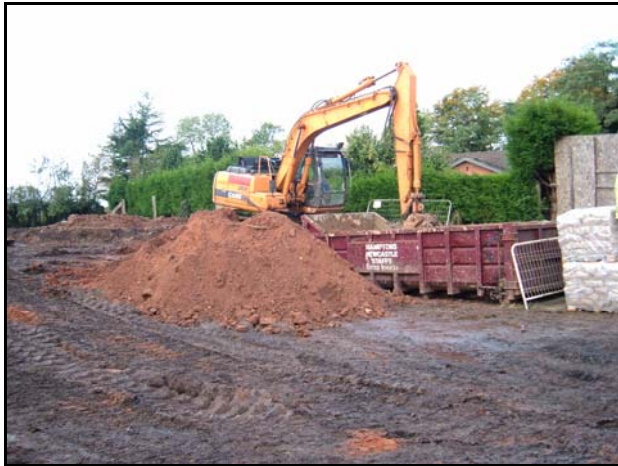
Plate 4 - Set-up of the excavator and skip to mix the contaminated soils with the E-clay[®] slurry.

An excavator mounted with a conventional bucket then mixed the E-clay[®] slurry and contaminated soils (Plate 4).

The soils were mixed in 5m³ batches to allow known quantities of contaminated soils to be combined with known quantities of the E-clay[®] slurry. The treated soils were then temporarily stockpiled before being reused on-site as a substitute for imported clean fill, thus preventing the need for off site disposal.

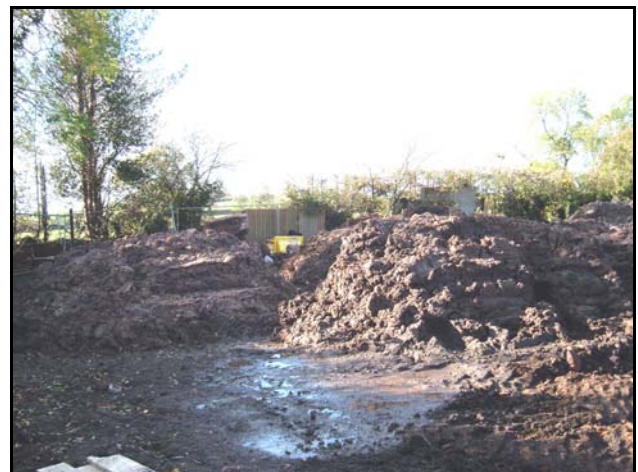
Plate 5 – Treated soils redeposited on-site awaiting site levelling.

The remediation project was successfully completed, with the results illustrating that the objective of protecting the underlying aquifer and site end users have been achieved. The contaminants of concern have been fully addressed with leachate levels falling below the agreed SSTL's, thus allowing the material to be re-deposited on-site (Plate 5).
