Photo 1 - Housing development at the Former Gas Works site.

Completion Date:	September 2004
Development:	Residential Housing & Hotel Development
Developer:	Barratt Eastern Counties & Robert Leonard Group
Remediation Contractor:	Knight Environmental Limited
End Value:	£40m

### Site Overview

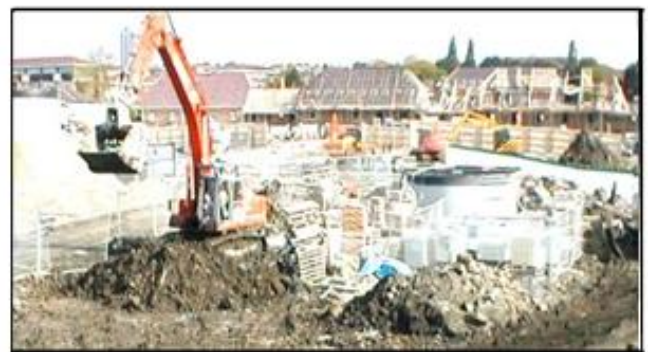
Photo 2 - Treatment of contaminated soils running parallel with Phase 1 of the building program.

The identified contamination was excavated, stockpiled and treated on-site using the Envirotreat E-clay® technology. The treatment operation utilised 2 No. slurry production units and mixing zones, which were relocated around the site as the job progressed, allowing the build to begin, prior to the completion of the remediation works (Photo 2).

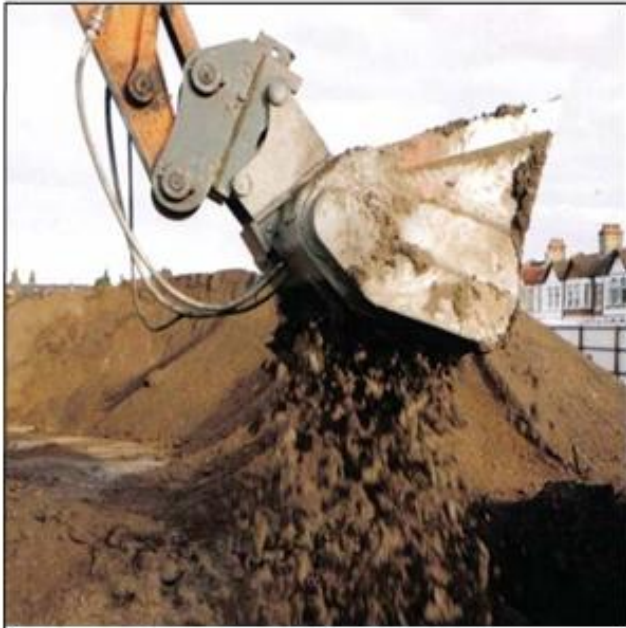
Photo 3 - Mixing of clayey soils with E-clay® slurry using the processing bucket attachment on a conventional 30T excavator.

Each set up comprised of a 1000L paddle mixer where the E-clay® reagents were combined together before being pumped across to the mixing zone. An excavator mounted with a specialist processing bucket attachment then mixed the E-clay® slurry and contaminated soils.

The processing bucket is a specialist attachment with rotating blade at the base of the bucket, which facilitate a high degree of mixing. This approach was utilised due to the clayey nature of material requiring treatment.

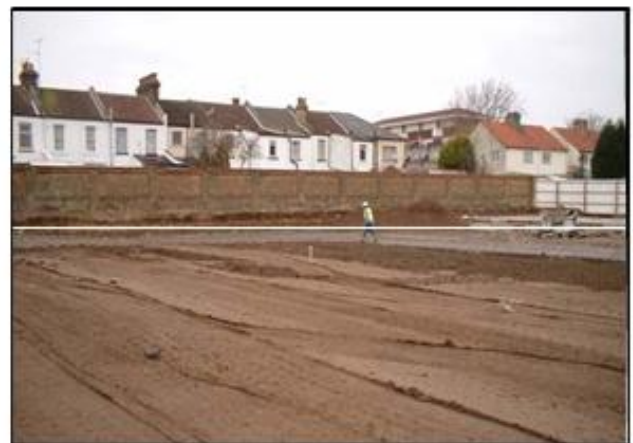
Photo 4 - Treated soils redeposited ready for the construction phase to begin.

The remediation project was successfully completed under the auspices of the MPL, with the results illustrating that the objective of protecting the groundwater receptor, the Thames Estuary, has been achieved. The contaminants of concern have been fully addressed with levels below the agreed Site Specific Target Levels for each contaminant, thus allowing the material to be reused on-site for a beneficial purpose (Photo 4).
