Completion Date:	June 2004
Development:	Residential Development
Developer:	Barratt Homes
Remediation Contractor:	Knight Environmental
Consultant:	Knight Environmental
End Value:	£30M

### Site Overview

The 3 hectare site, in Chelmsford, Essex is a former gravel quarry. The contamination originated from infilling with a variety of wastes as well as use by TXU Energy for storage, workshops and vehicle maintenance.

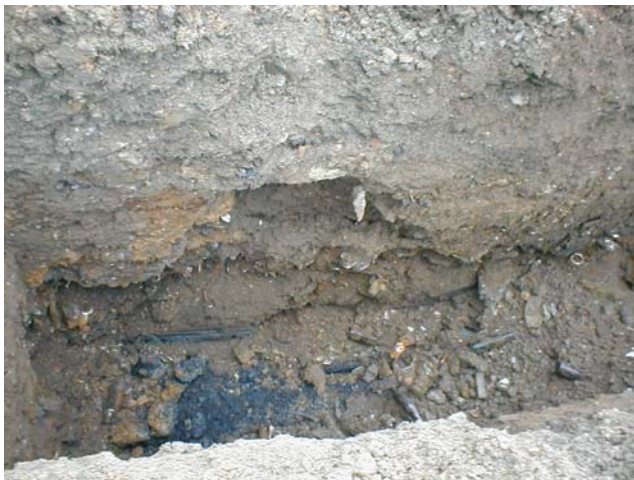
These historical uses have resulted in soil contamination hotspots across the site (plate 1). The identified contamination includes; Arsenic, Cadmium, Chromium, Copper, Lead, Nickel, Zinc, Phenols, PAH's and TPH.

Plate 1: Contaminated soils observed on-site

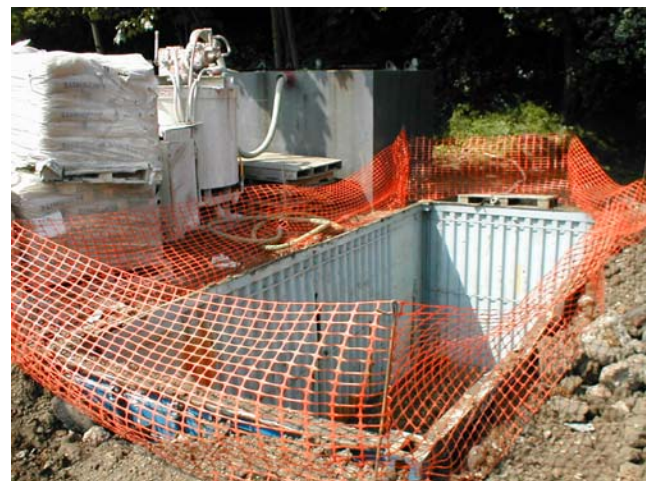
The contaminated soils were excavated, stockpiled and treated on-site using the Envirotreat E-clay<sup>®</sup> technology. The Envirotreat treatment plant comprised a slurry production unit and a mixing zone (plate 2).

Plate 2: The mixing zone (foreground) and slurry production unit (background)

The slurry production set up comprised 1 No. 1000L paddle mixer (where the E-clay<sup>®</sup> reagents were combined before being pumped across to the mixing zone) and 1 No. excavator fitted with a specialist processing bucket. The processing bucket has rotating blades at its base which facilitates a high degree of mixing. This bucket was required as the contaminated soils were clay based.

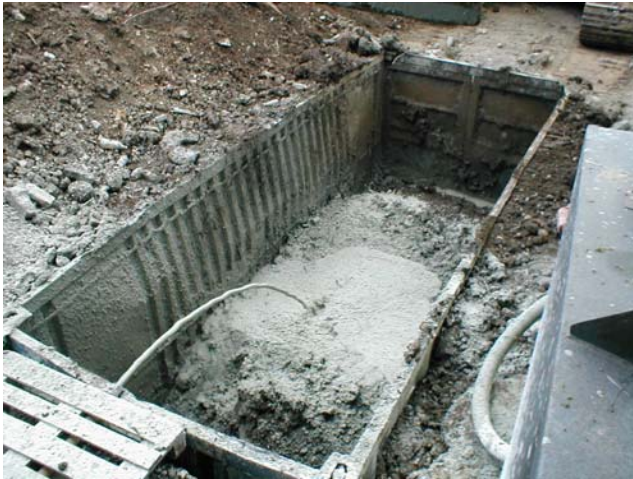
Plate 3: Combining the E-clay<sup>®</sup> slurry with the contaminated soils

The soils were mixed in 10m<sup>3</sup> batches to allow known quantities of contaminated soils to be combined with known quantities of the E-clay<sup>®</sup> slurry (plate 3). Following treatment, the material was temporarily stockpiled (plate 4).

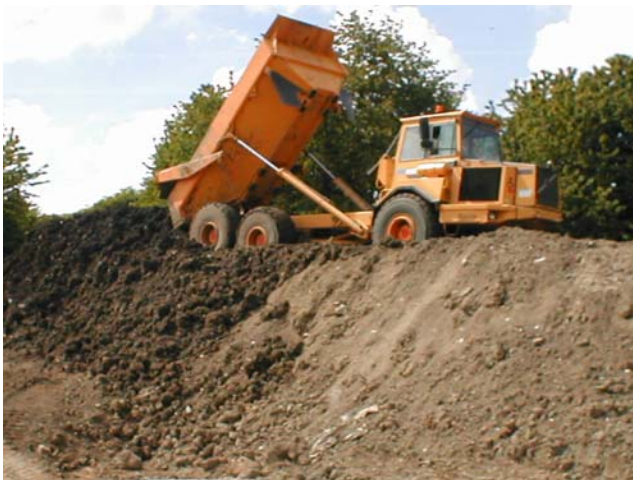
Plate 4 – Temporary stockpiling of the treated material

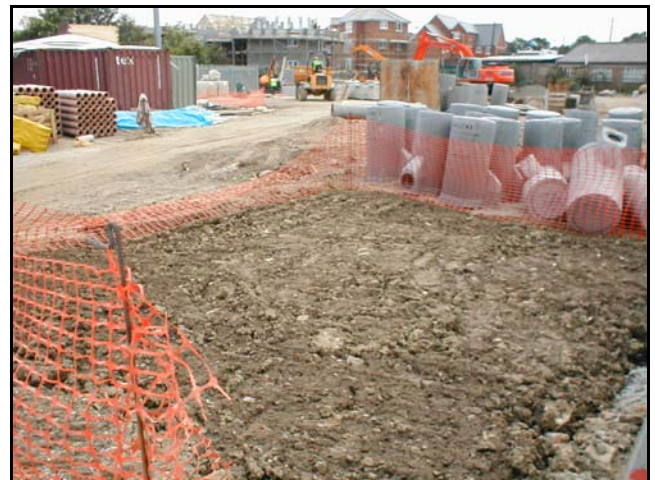
Successful validation enabled the treated material to be reused on-site as a substitute for imported clean fill (plate 5).

Plate 5: Contaminated hotspot backfilled with treated material.
