CASE STUDY

Ex-situ Bioremediation

Former Industrial Site, Hampshire

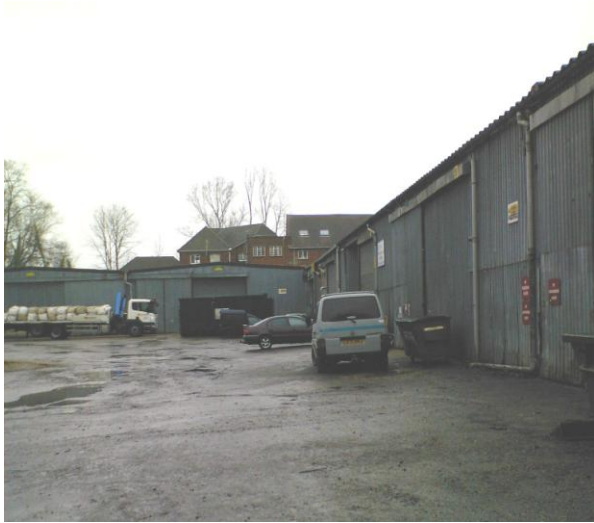
Figure 1 - Site Prior to Remediation

The site was irregularly shaped with an area of approximately 4 Ha. The site was divided by the public highway, the north of the site being mostly occupied by a pond. The southern part of the site consisted of undergrowth to the east and a former industrial area to the west; it is in this area that the main development area is proposed.

Significant hydrocarbon contamination was identified at this site consistent with its previous industrial usage as a haulage and transport centre, incorporating mechanics garages and various industrial units. A number of underground fuel storage tanks are known to have been present on this site. It was considered that soil and shallow groundwater remediation would be likely to ensure the protection of groundwater, surface waters and end users of the proposed development.

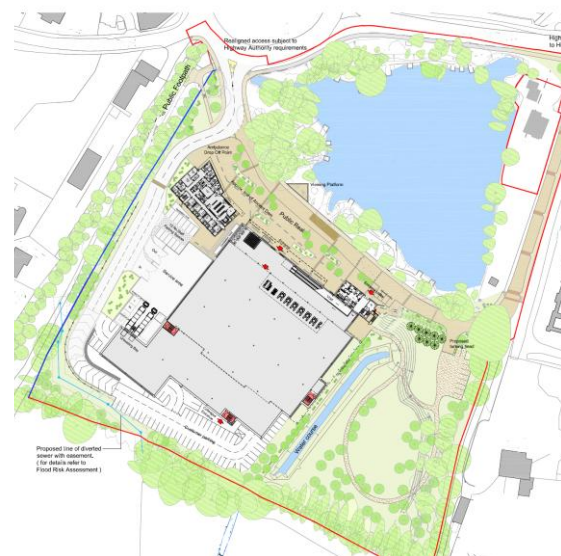
Figure 2 - Proposed Development.

A planning application has been submitted (2010) for the erection of a retail store and doctors surgery with undercroft car parking, refurbishment of existing mill building for residential flats and ancillary store uses /associated landscaping, access works and linkage improvements.
