Completion Date:	November 2008
Consultant:	Envirocentre
Main Contractor:	RJT

### Site Overview

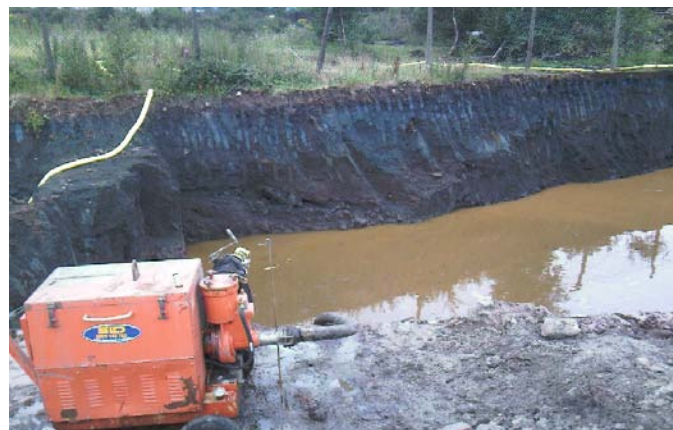
Figure 2 Evidence of contamination associated with a former gas holder.

The gasworks were established on the island of Inchgreen in October 1873 and by 1896 the plant included three in ground tank gasholders and gas manufacturing facilities. A fourth gasholder was constructed between 1913 and 1920 to the North West of the site

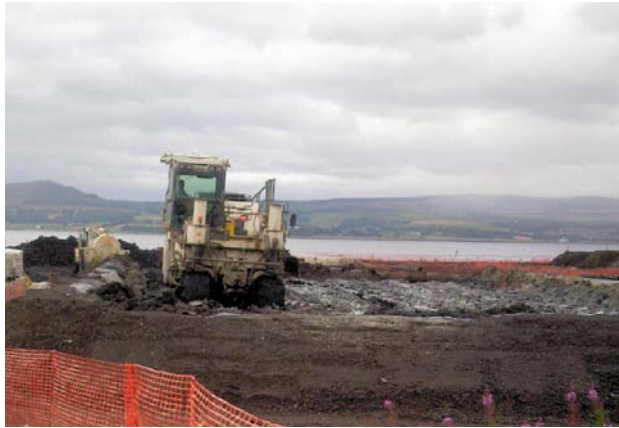
Figure 3 WIRTGEN blending E-Clay and contaminated material.

The strategy involved producing 150m<sup>3</sup> treatment pads of contaminated soils. These pads were sprayed with E-Clay slurry (by means of a slurry spreader), prior to mixing with a Wirtgen which also incorporated the addition of the cement at the same time.
