Completion Date:	June 2004
Development:	Residential Development
Developer:	Barratt Homes
Remediation Contractor:	Knight Environmental
Consultant:	Knight Environmental
End Value:	£30M

Site Overview

The remediation strategy for the TXU site was

designed to address the source and indirectly pathway contamination issues, with the intention of protecting both human and groundwater receptors.

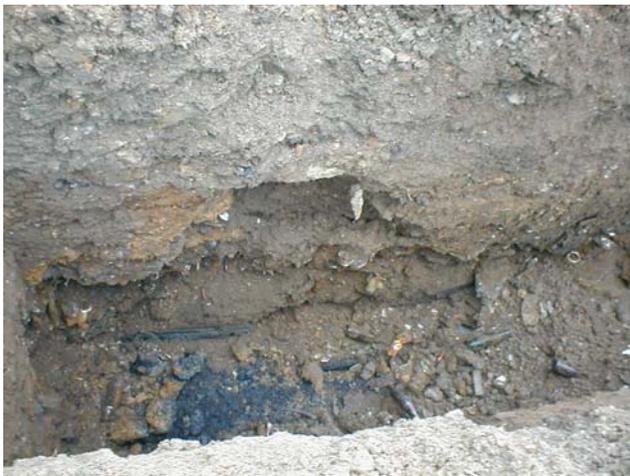
These historical uses have resulted in soil contamination hotspots across the site (plate 1). The identified contamination includes; Arsenic, Cadmium, Chromium, Copper, Lead, Nickel, Zinc, Phenols, PAH's and TPH.

Plate 1: Contaminated soils observed on-site

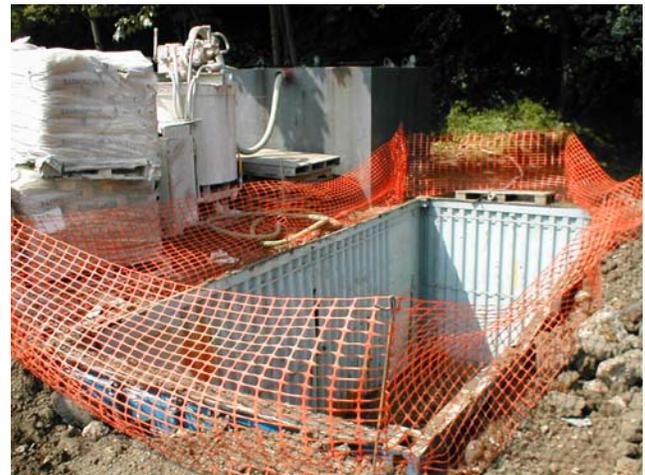
The contaminated soils were excavated, stockpiled and treated on-site using the Envirotreat E-clay[®] technology. The Envirotreat treatment plant comprised a slurry production unit and a mixing zone (plate 2).

Plate 2: The mixing zone (foreground) and slurry production unit (background)

The slurry production set up comprised 1 No. 1000L paddle mixer (where the E-clay[®] reagents were combined before being pumped across to the mixing zone) and 1 No. excavator fitted with a specialist processing bucket. The processing bucket has rotating blades at its base which facilitates a high degree of mixing. This bucket was required as the contaminated soils were clay based.

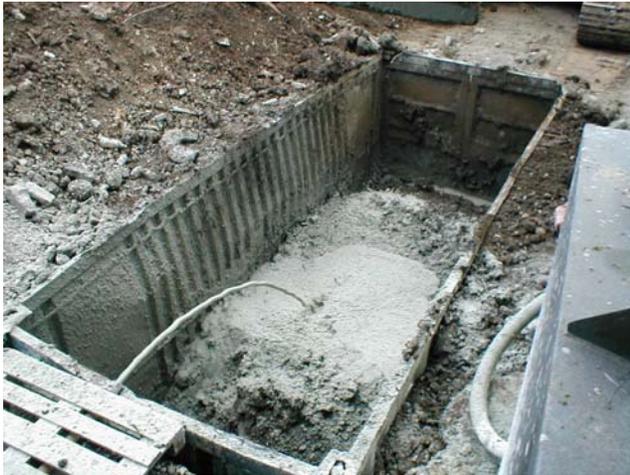
Plate 3: Combining the E-clay[®] slurry with the contaminated soils

The soils were mixed in 10m³ batches to allow known quantities of contaminated soils to be combined with known quantities of the E-clay[®] slurry (plate 3). Following treatment, the material was temporarily stockpiled (plate 4).

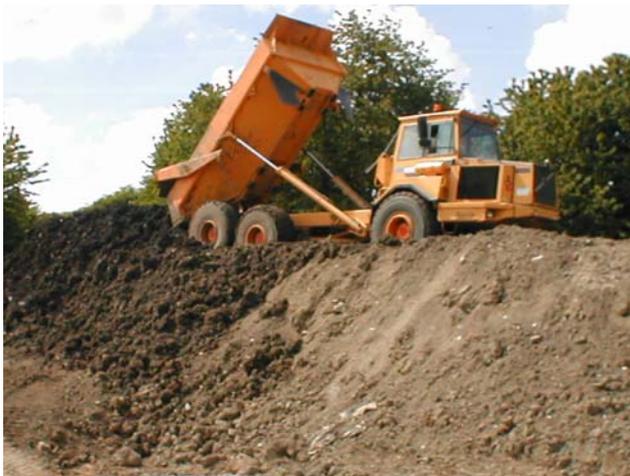
Plate 4 – Temporary stockpiling of the treated material

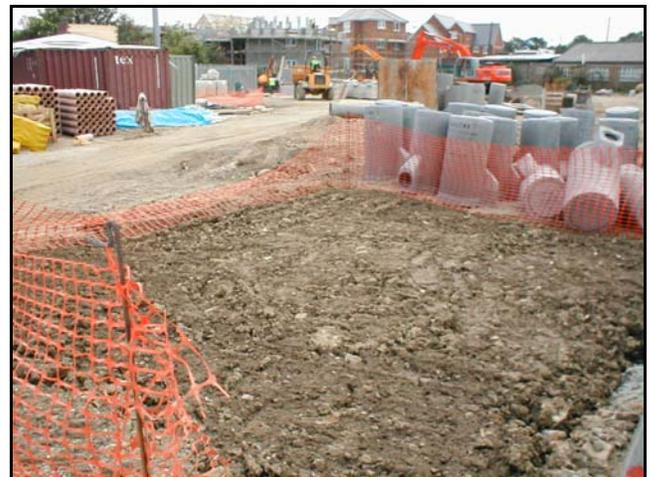
Successful validation enabled the treated material to be reused on-site as a substitute for imported clean fill (plate 5).

Plate 5: Contaminated hotspot backfilled with treated material.
