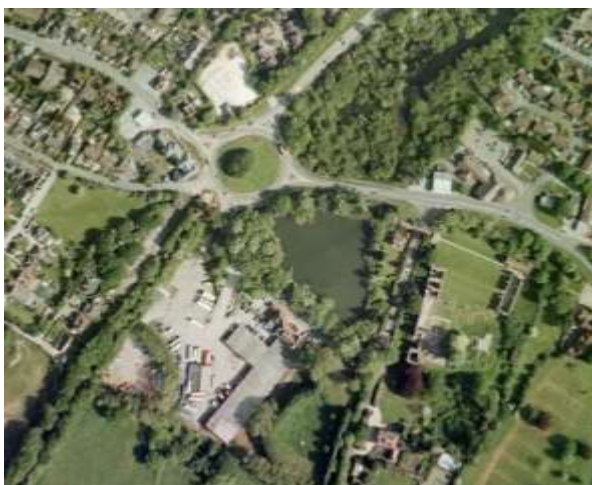
Figure 1 – Abbey Mills Site

The site was located in Bishop's Waltham in Hampshire and was irregular in shape covering an area of approximately 4 hectares in total, bisected by a public highway. The northern area of the site was mostly occupied by a pond. The southern area of the site consisted of undergrowth to the east and a former industrial area to the west - the proposed main development of the site was on this area of the site.

The site is shown in Figure 1 below.

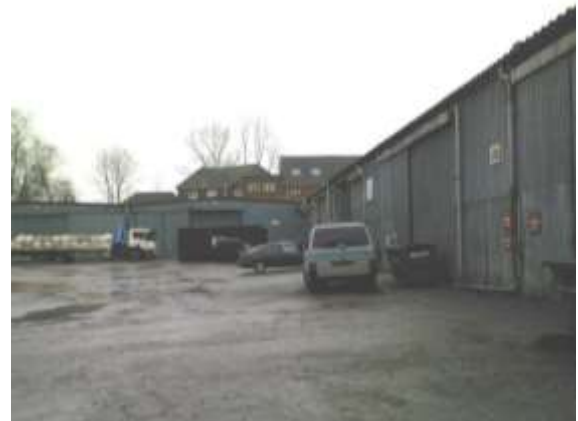
Figure 2 - Industrial Area

The location of the industrial area is shown in Figure 2 below. Significant hydrocarbon contamination was identified on this area of site consistent with its previous industrial usage as a haulage and transport centre which included mechanic's garages and various industrial units.

Detailed speciation of the hydrocarbons indicated the presence of a mixture of weathered petrol and diesel species. Several underground fuel storage tanks were known to have been present which are assumed to be the prime contamination sources.

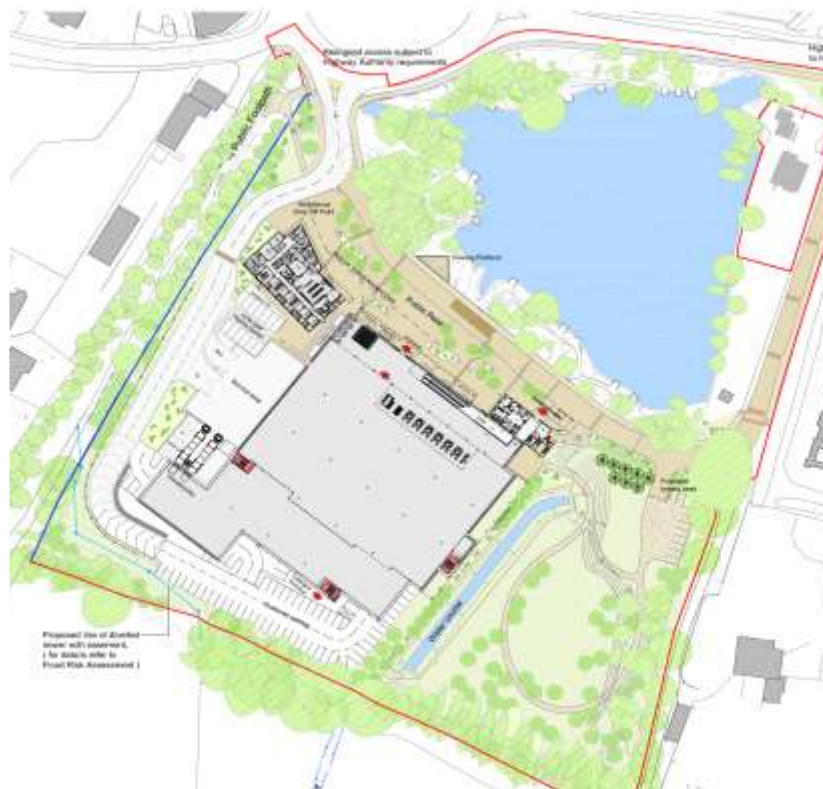
Figure 3 - Proposed Development

The proposed development is shown in Figure 3 below.

A planning application had been submitted [2010] for the erection of a retail store and doctor's surgery with undercroft car parking, refurbishment of an existing mill building for residential flats and ancillary store uses. In addition, the planning application included associated landscaping and road access improvements to the site.
