CASE STUDY

E-Clay Stabilisation

Cook's Shipyard, Wivenhoe
Essex

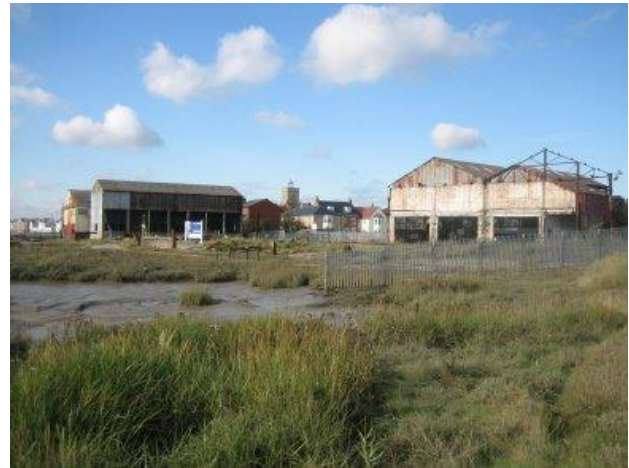
central section of the Cook's Shipyard site and the land of owned by the Environment Agency. The waste disposal license held for the site expired in 1988. The site prior to remediation is shown in figure 1 below:

Figure 1 – The site prior to Remediation

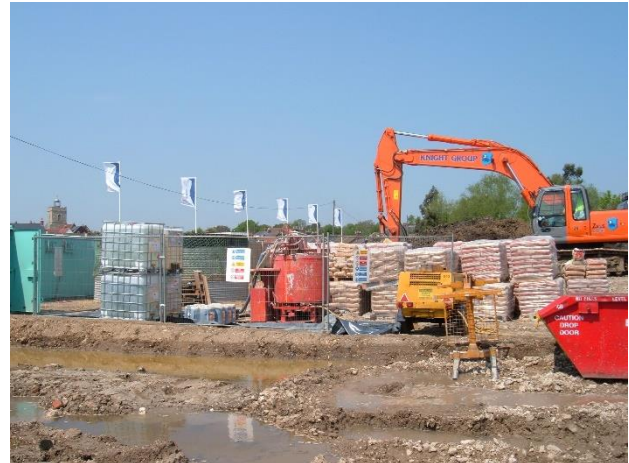
Figure 2 – Treatment Area Set Up

E-Clay slurry was prepared in the treatment area (see figure 2 below). The E-Clay slurry produced was mixed thoroughly with excavated soils from the identified hot spot areas using an Allu bucket attached to a conventional excavator to ensure optimum homogeneity of the mixture (figures 3, 4 and 5 below):

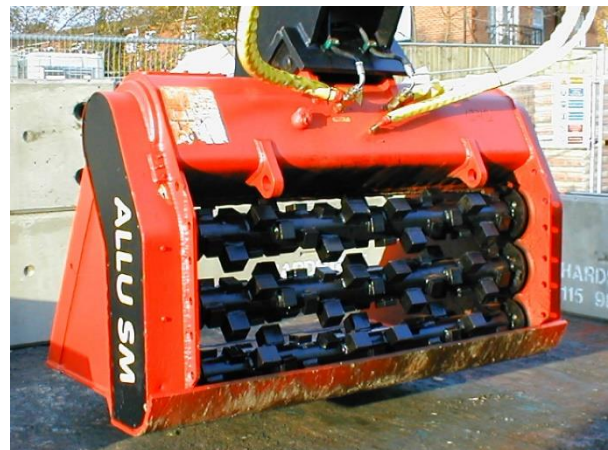
Figure 3 – Allu bucket used for mixing operations

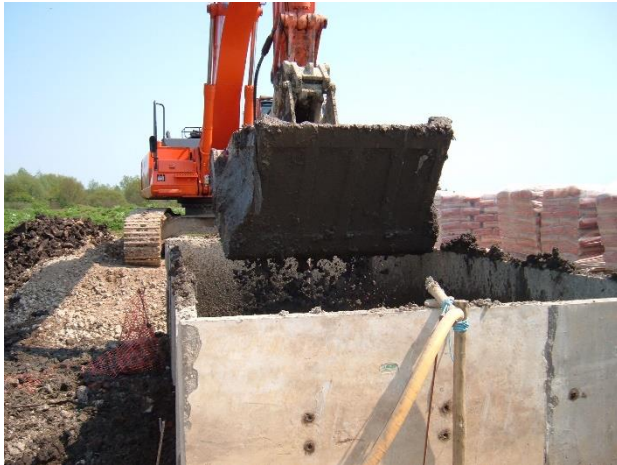
Figure 4 – The ex-situ mixing operation

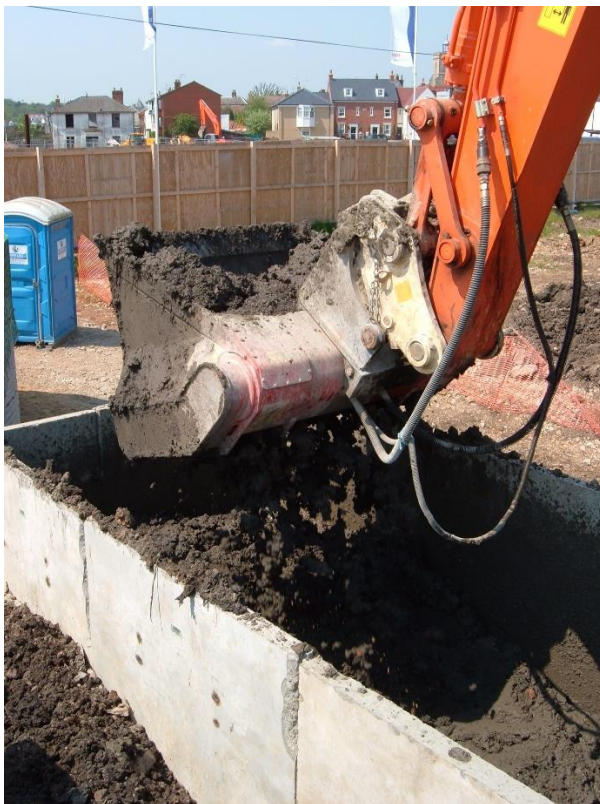
Figure 5 – The ex-situ mixing operation

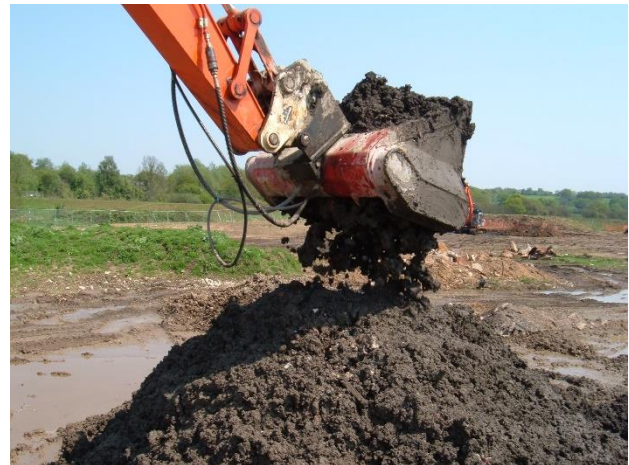
Figure 6 – The stabilised / solidified soils

Cementitious materials were added to the soil / E-Clay mix to produce a stabilised / solidified mass which could be reused on site, this is shown in figure 6 below
