**Development**

Remediation of Former Coking Works,  
Sunderland

Homes &  
Communities  
Agency  
homesandcommunities.co.uk

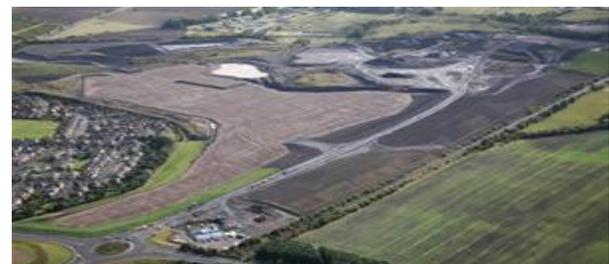
Figure 2 – Site Overview

Environment Agency approval for the remedial scheme was sought and gained in early 2009, with installation commencing in June 2009. The reactive barrier comprised of 270m of relatively impermeable sections and 200m of permeable reactive sections and was completed 2 weeks ahead of schedule and within budget.

Prior to installation Envirotreat agreed a post installation monitoring regime with the Environment Agency to demonstrate the efficacy / performance of the barrier. In summary this consisted of the monitoring of water quality through the barrier at four borehole locations.

Three additional boreholes were installed upstream of the permeable reactive barrier system to provide background information on the contaminated groundwater migrating towards the barrier system.

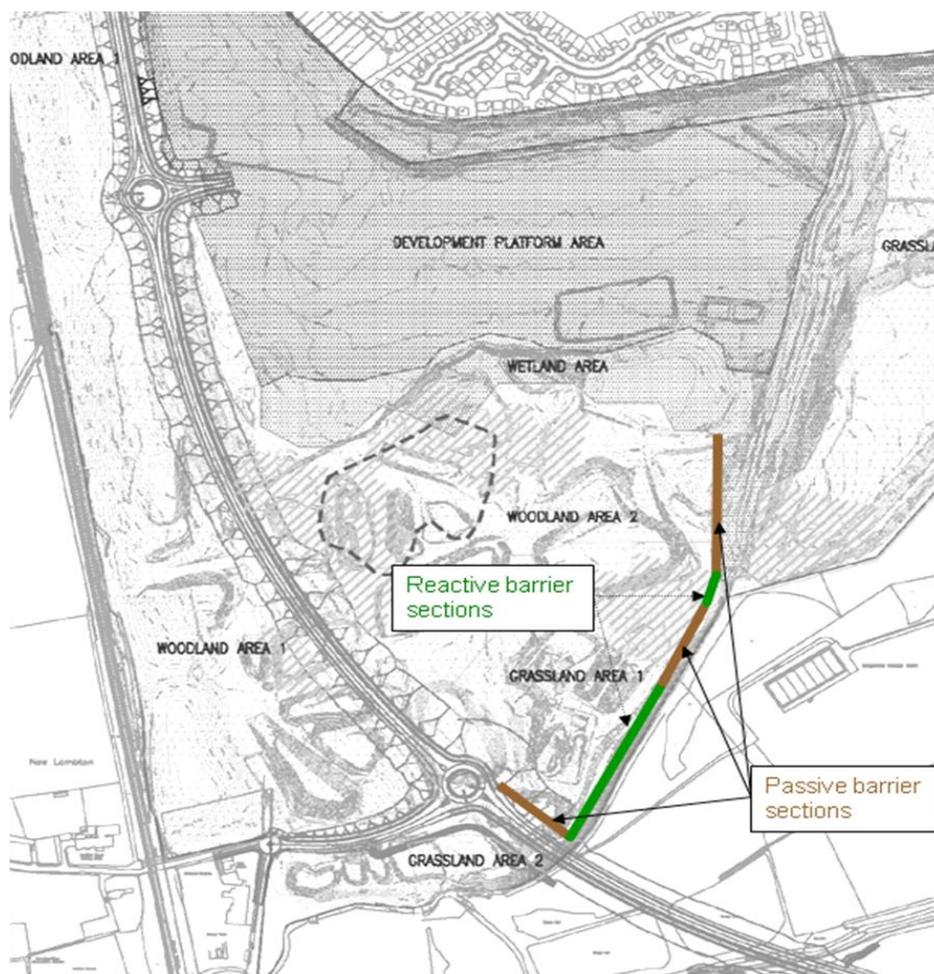
Figure 3 – Barrier Installation

The barrier system was installed using a piling rig equipped with a soil mixing drill head. The treatment slurries were injected through the auger stem and mixed with the soil medium to form overlapping soil mixed columns. Proprietary treatment media were employed for effective treatment of ammonia(ium) contaminated groundwater .

Strict Quality Control was adhered to throughout the installation process - this was achieved through the use of flow meters to measure the volumes of treatment slurry injected, digital gauges to monitor the drilling depth and data collection from the rig on board computer.
