Development:	Retail Outlet
Client:	Arrowcroft Northwest Ltd
Consultant Engineer:	Gifford & Partners Ltd
Principal Contractor:	Eric Wright Construction Ltd
Civils Contractor:	Mowlem Remediation

Site Overview

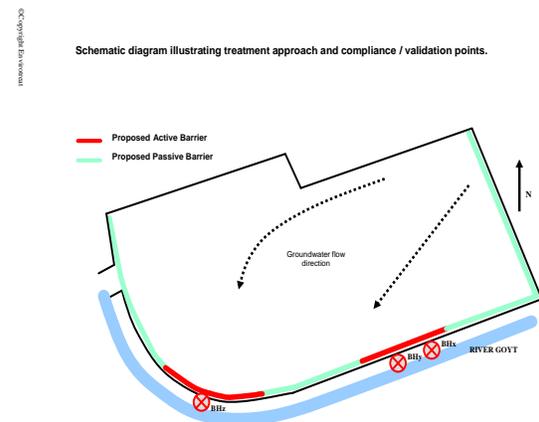
Figure 1 – Schematic diagram showing SMRBS layout

The SMRBS was designed with 3 passive and 2 reactive sections of barrier (Figure 1). The reactive sections incorporated the E-clay® with the treatment capability to chemically absorb and immobilise organic contaminants, along with the cationic and anionic metallic species. The adsorption and immobilisation of contamination occurs as the groundwater passes through the reactive sections of barrier, which remain permeable.

The passive, relatively impermeable sections of barrier comprised a combination of bentonite and Ordinary Portland Cement (OPC) in varying ratios and were positioned to protect other critical areas from further contamination. The north-eastern section of barrier also served to prevent the ingress

of contaminated groundwater from entering the site from the adjoining gas works site.

The SMRBS (Figure 1) was installed using continuous flight auger technology based on advanced soil mixing techniques. The soil mixed columns for both the active and passive sections comprised a double row of overlapping columns to ensure the integrity of the barrier system.

On completion of the project, three monitoring boreholes were installed downstream of the reactive

sections (Figure 1). Groundwater samples were collected monthly for the first year and quarterly for the subsequent year. The samples were analysed for the contaminants of concern on behalf of Envirotrear by an accredited laboratory.

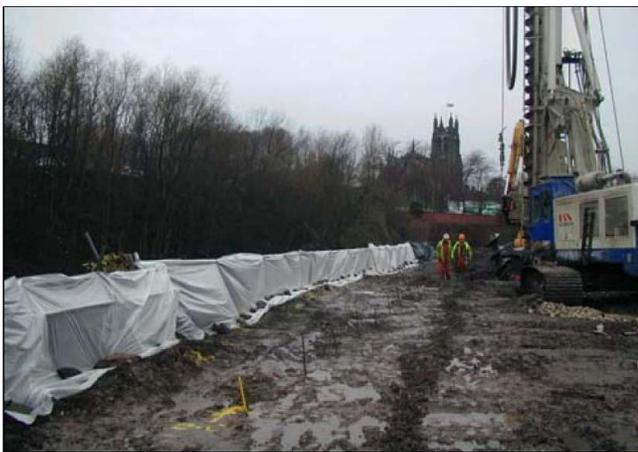
A purpose designed E-clay[®] treatment slurry was produced using batching plant facilities and injected under pressure down the hollow stem of the CFA. The E-clay[®] slurry and passive materials were mixed in situ with the ground material to form soil mixed columns of treated material (Plate 2).

Plate 2 Installation of soil mixed columns using a continuous flight auger

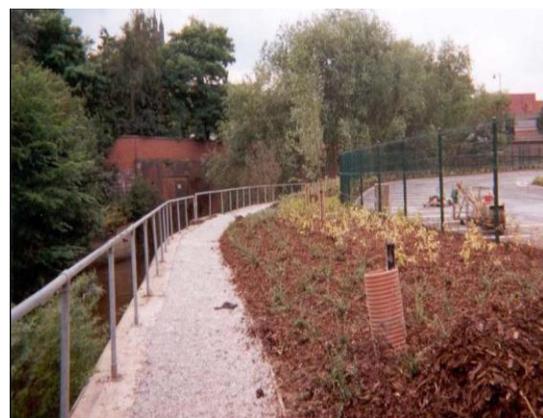
Plate 3 SMRBS along the river wall, landscaped following site development
