The *ex-situ* remediation works involved the treatment of circa 11,000m<sup>3</sup> of contaminated soils and gas works waste.

The site was formerly occupied by Pitwines Gas Works located in close proximity to Poole Harbour which is classified as a Site of Special Scientific Interest (SSSI). The site occupies an area of 4.23 hectares and has remained vacant for 20 years.

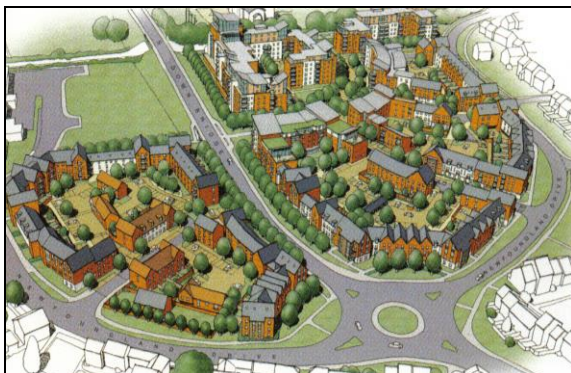
Figure 1 – Proposed Residential Development

The developer [Crest Nicholson (South) Limited] has been granted planning consent for the construction of 500 residential units on the site. The proposed site development is shown in Figure 1 below.

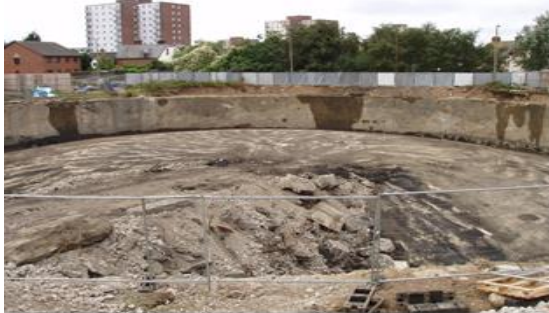
Figure 2 – Excavated Gas Holder

The contamination was primarily identified within the 60m diameter gas holder (see Figure 2 below), the retort house and other localised hotspots across the site. The soils were excavated, stockpiled and treated on-site utilising E-Clay Stabilisation.

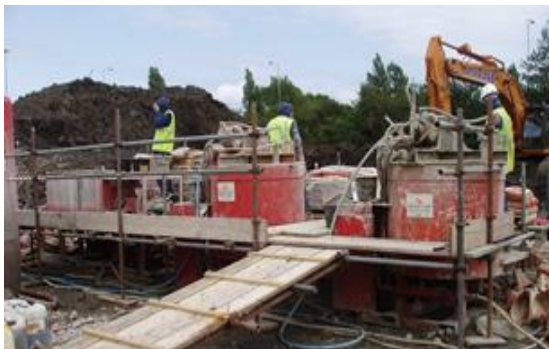
Figure 3 – Slurry Production Units

The treatment was carried out utilising three slurry production and mixing units operating in parallel to achieve the target throughput objective of 450m<sup>3</sup> – 600m<sup>3</sup> per day. The slurry production units are shown in Figure 3 below.

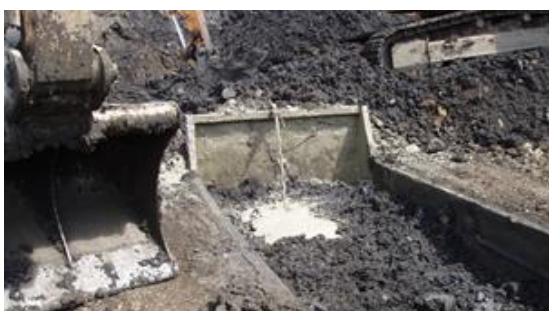
Figure 4 – Addition of E-Clay Slurry

The E-Clay slurry was pumped across to the mixing zone. The contaminated soils were then treated in the mixing zone by adding the designated volumes / amounts of E-Clay slurry and cementitious materials to the contaminated soils (see Figure 4 below). The treatment materials and soils were then mixed in 10m<sup>3</sup> batches to produce a homogeneous treated [E-Clay Stabilised] material utilising excavators mounted with conventional buckets as shown in Figure 5 below.
