Objectives

Methodology

Site Background & History

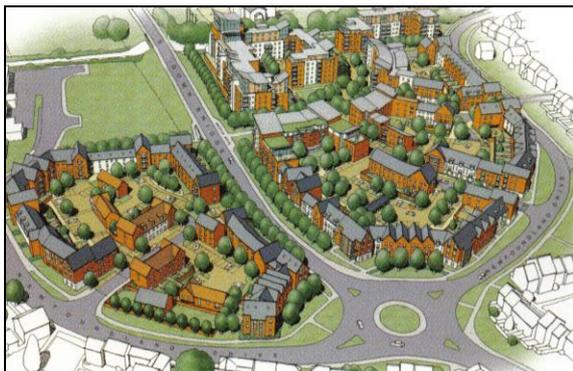
Figure 1 – Proposed Residential Development

The developer [Crest Nicholson (South) Limited] has been granted planning consent for the construction of 500 residential units on the site. The proposed site development is shown in Figure 1 below.

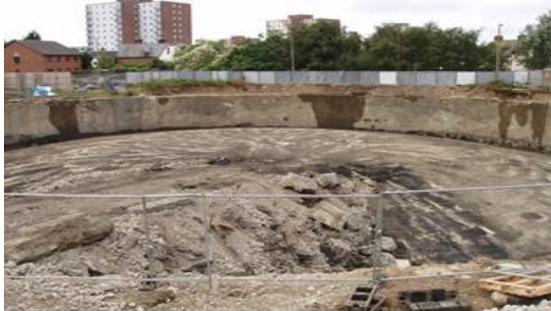
Figure 2 – Excavated Gas Holder

The contamination was primarily identified within the 60m diameter gas holder (see Figure 2 below), the retort house and other localised hotspots across the site. The soils were excavated, stockpiled and treated on-site utilising E-Clay Stabilisation.

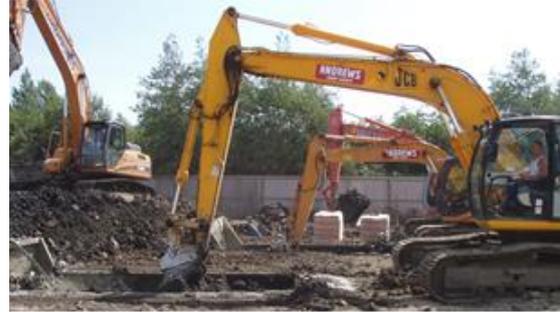
Figure 5 – Treatment (Mixing) Process

The E-Clay slurry was pumped across to the mixing zone. The contaminated soils were then treated in the mixing zone by adding the designated volumes / amounts of E-Clay slurry and cementitious materials to the contaminated soils (see Figure 4 below). The treatment materials and soils were then mixed in 10m³ batches to produce a homogeneous treated [E-Clay Stabilised] material utilising excavators mounted with conventional buckets as shown in Figure 5 below.

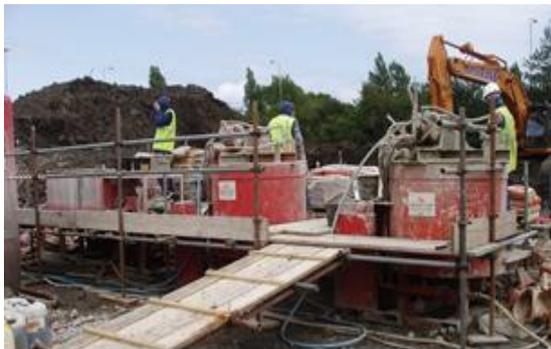
Figure 3 – Slurry Production Units

The treatment was carried out utilising three slurry production and mixing units operating in parallel to achieve the target throughput objective of 450m³ – 600m³ per day. The slurry production units are shown in Figure 3 below.
