Blenheim House
construction

The agreed remediation strategy was source treatment by E-Clay stabilisation and groundwater treatment through the design and installation of an E-Clay Permeable Reactive Barrier.

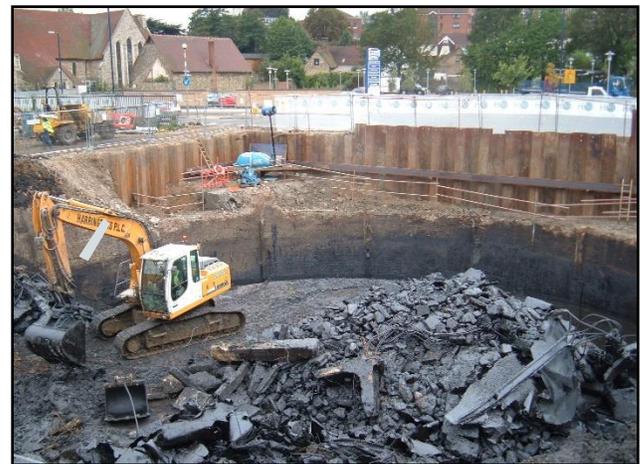
Figure 1 - Excavation of the gasholder base

The remediation work was conducted in two stages; the first phase was based on excavating and treating materials from the former gasholder bases and from hotspots in the vicinity of the former purifier boxes. During the second phase a reactive soil mixed barrier system was installed adjacent to the River Medway, the function of which was to protect the river from groundwater contamination.

Phase 1 involved the excavation and *ex-situ* treatment of a total of 4,690 m³ of contaminated material from the gas holders and purifier boxes. The material was contaminated with typical gasworks pollutants, including PAH, TPH, Ammonia, Cyanide, Heavy Metals and Phenol.

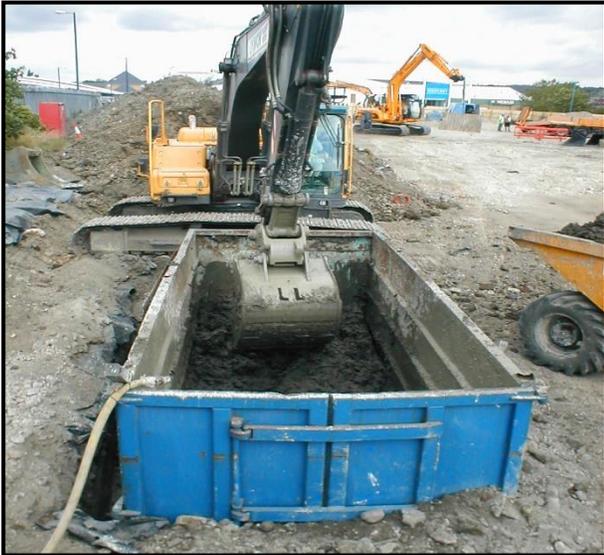
Figure 2 - The processing bucket mixing contaminated soils with E-clay slurry

The contaminated soils were excavated, stockpiled and treated on-site (see figure 2) using the Envirotreat E-Clay technology.

The material was tested for leachate against pre-agreed clean up criteria before being reused on site, here it was redeposited in the void spaces left by the former gasholder bases.

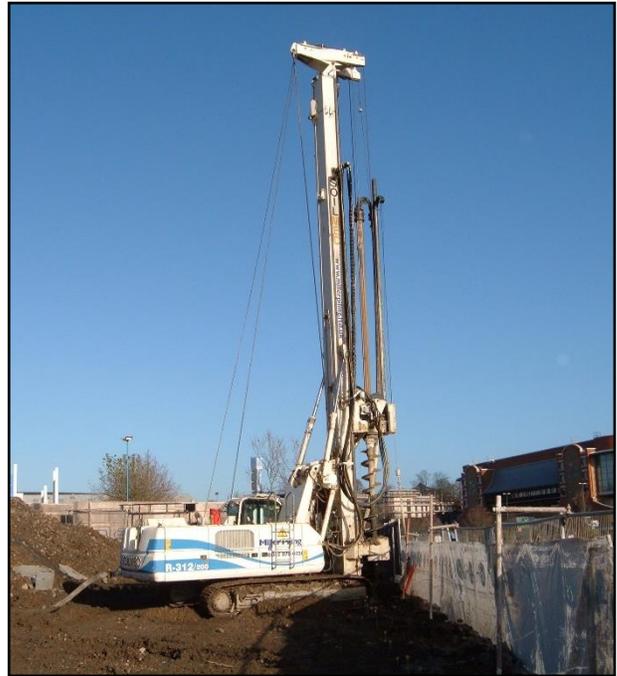
Figure 3 - Barrier installation using a CFA and piling rig.

Phase 2 works consisted of installing a 120m long reactive barrier system. This was installed using soil mixing techniques along the river retaining wall and across the site to intercept contaminated groundwater as it flowed towards the River Medway (figure 3). Along the river wall and between the historical gas work purifier boxes the barrier was designed to be of low permeability. The next (second) interlocking section, installed perpendicular to the river, was designed to be permeable and reactive towards the groundwater contaminants. This section was installed using a pillared organoclay (E-Clay). This allowed groundwater to pass through while ensuring that contaminants were retained within the barrier by the E-Clay.

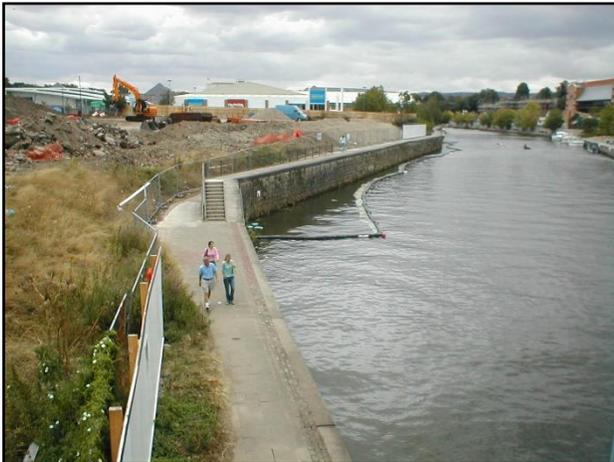
Figure 4 - The main receptor the River Medway; floating spill booms were used as a precautionary measure.

The remediation strategy for the Maidstone site was designed to address the on-site source contamination and indirectly the pathway contamination issues with the intention of protecting both human health and groundwater/surface water receptors; in particular the adjacent River Medway (figure 4).
