The site was acquired by the Tauheedul Education Trust with the aim of developing the site as a girl's school. Planning permission was granted by Coventry City Council subject to the satisfactory discharge of planning conditions – these included conditions relating to contaminated land which essentially comprised:

### Site Background & History

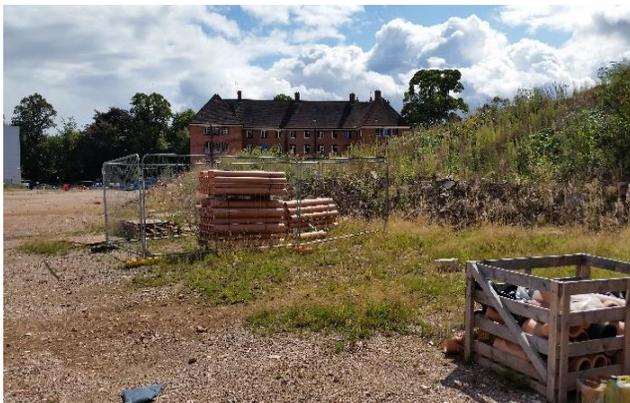
Figure 1 – Site Prior to Redevelopment

The site forms part of the former Coventry and Warwickshire Hospital Site which was demolished in 2012. This area of the former hospital site was not currently redeveloped - other parts of the site have been redeveloped to create the City of Coventry Health Centre and Swanswell Point.

The site prior to redevelopment is shown in Figure 1 below.

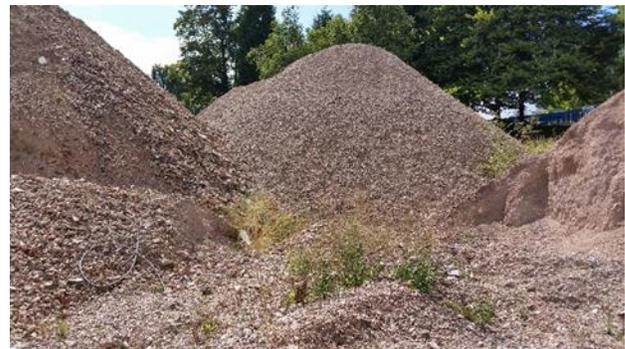
Figure 2 – Stockpiled Materials (Demolition Rubble)

The stockpiled materials are shown in Figure 2 below.

One stockpile (estimated at circa 10,000 tonnes) comprised of un-screened demolition waste and arisings from the City of Coventry Health Centre and Swanswell Point Developments. This material was not considered to be suitable for reuse on-site without further processing – consequently this material was designated for offsite disposal as it was geotechnically unsuitable for potential reuse on-site.

Several other stockpiles were present on site (estimated to be > 14,000 tonnes in total) – these stockpiles comprised of graded demolition waste. Previous site investigations and subsequent testing undertaken by Envirotreat identified elevated levels of hydrocarbon and asbestos contamination within the respective stockpiles.

The stockpiled material was initially regarded as hazardous waste – it was therefore decided to carry out an intensive investigation on this waste material followed by delineation as far as practically possible. Envirotrear undertook to carry out this process and was able to arrange the removal of > 98% of this waste material to a local inert landfill by investigation / delineation with supporting analysis.

These stockpiled materials were considered to be suitable for reuse on-site as a sub-base material without the need for further processing. Envirotreat carried out a risk assessment to determine the suitability for use in specific areas / locations within the site – it was possible to recover all of these stockpiled materials by a combination of targeted testing (to confirm compliance with designated remediation target criteria) and delineation as necessary to achieve the target objectives.

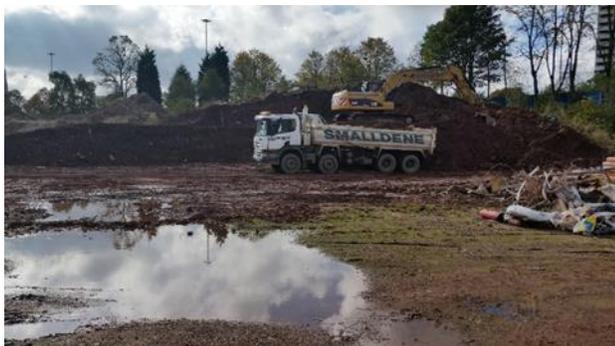
Figure 3 – Offsite Removal of Geotechnically Unsuitable Material

The removal of this material is shown in Figure 3 below.

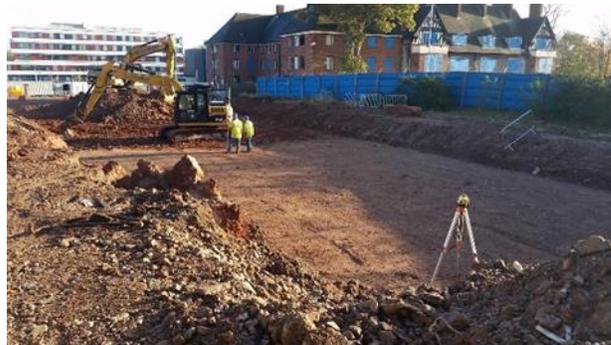
Figure 4 – Reduced Dig (Main Building Area)

A reduced dig was required in several areas of the site to accommodate the proposed developments. The reduced dig under the footprint of the proposed Main Building involved reducing the ground level by ↑ 1.5m below the existing ground level with the foundations requiring a further reduced dig of ↑ 2.5m.

The reduced dig in the Main Building footprint area is shown in Figure 4 below.

Note that sub-base is being constructed from reused / recovered demolition waste

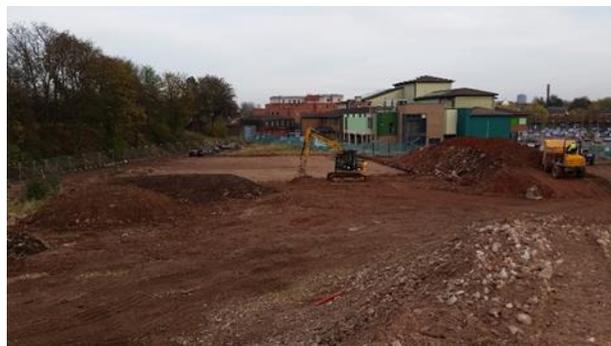
Figure 5 – Reduced Dig [MUGA]

A reduced level dig of ↑ 1m below existing ground level was required under the footprint of the proposed Multi-Use Games Area [MUGA]. The reduced level dig in this area is shown in Figure 5 below.

Note that sub-base is being constructed from reused / recovered demolition waste
